electrical

focus

In this issue...

Cooking appliance functional switch causes an unsafe installation

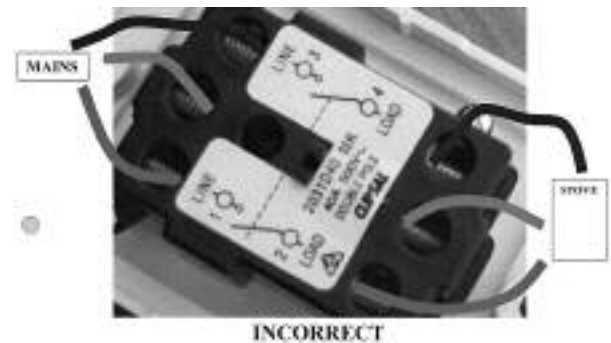
In a recent incident, an electrician connected a popular brand functional switch without reference to the manufacturer's instructions. He mistakenly connected the final sub circuit earthing conductor through the switch by connecting it to the "earth" terminal and the "loop" terminal – there is no connection between the earth terminal and loop terminals. He also connected the active and neutral conductors to the "line" terminals, thus utilising the switch as a double pole switch.

It was later discovered that the cooking appliance was not earthed and was unsafe. The electrician clearly did not check that the cooking appliance was earthed. Testing of the continuity of the earthing conductor would have identified this fault immediately.

This is how the switch was incorrectly connected

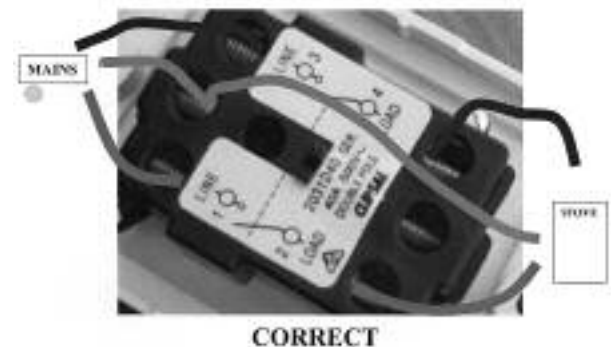
This particular switch is designed to switch two active (line) conductors. The switch also has a "loop" terminal to join the neutral conductors and an "earth" terminal to join the earthing conductors.

This is how the switch should have been connected

- reading and following manufacturers' instructions;
- reading and understanding the markings on terminals of electrical accessories and equipment; and
- carrying out adequate checking and testing of the electrical work.
