FINAL REPORT

**General Inspection Report One: A general inspection
into metal roof construction in Western Australia**

April 2016

ROOF CONSTRUCTION: A general inspection report into the construction of sheet metal clad timber framed roofing in Perth metropolitan and South West regions

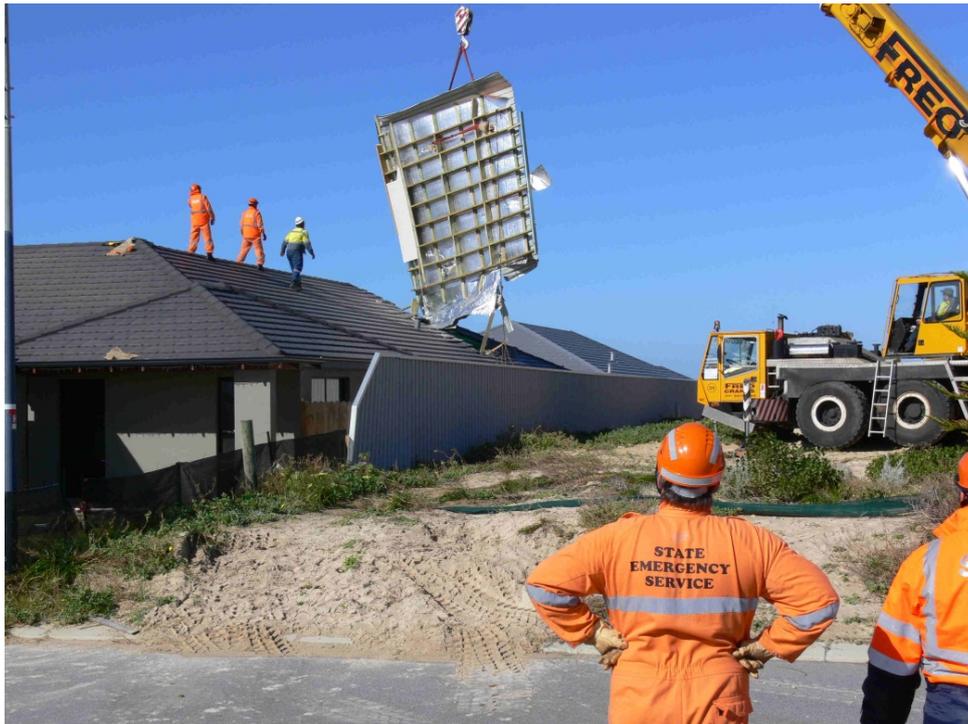
Figure 7. Photograph showing the result of a metal skillion roof lifting in high winds and landing on and damaging an adjoining property

Although a skillion roof is not necessarily representative of the majority of conventional roof framing found and analysed in this general inspection this event indicates both a failure to construct correctly and not supervise adequately. The result of this type of failure is a community concern with risk consequences beyond the failure of the specific roof system involved.

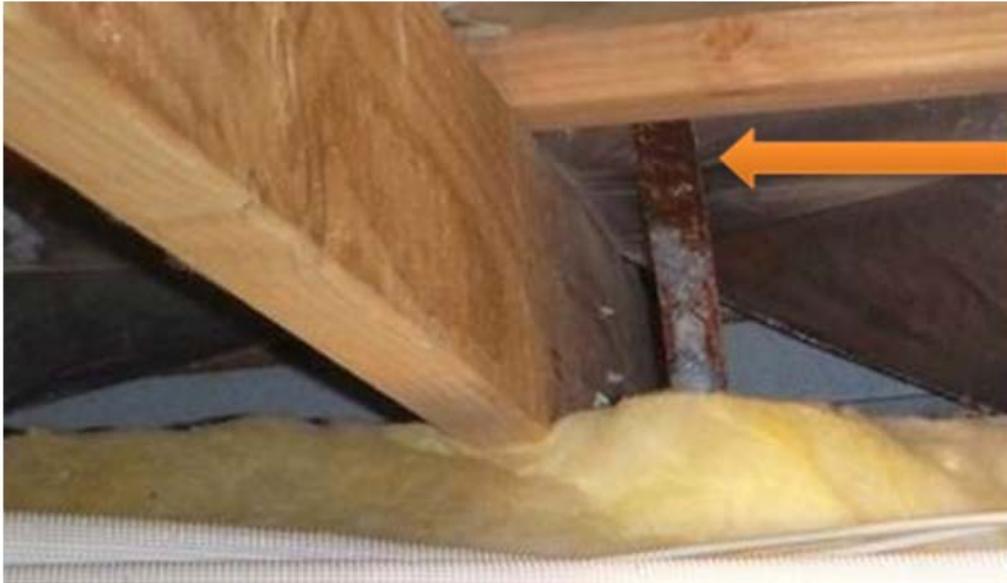
Figure 8. Photograph showing the result of installing a strap without the correct corrosion protection

A dwelling (Figure 8) inspected in connection with a building service complaint was found to have severely corroded roof tie-down straps, only 4 years after installation. The degree of corrosion is consistent with the use of non-compliant tie-down straps for buildings within 0–1 km distance of a coastline with breaking surf and may lead to premature failure of the roof/roof components.²¹

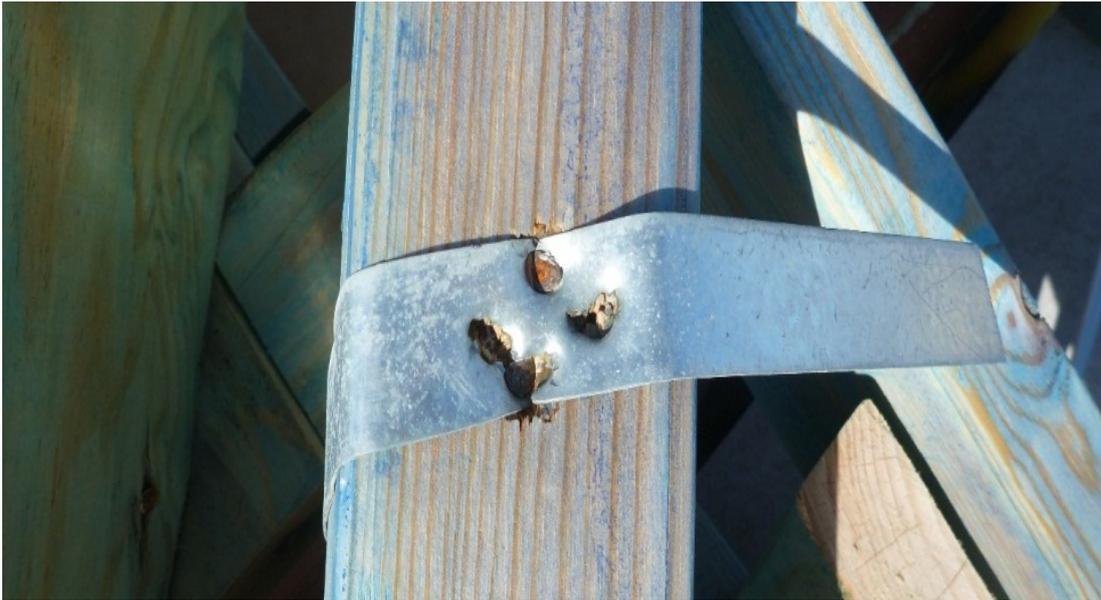
Figure 9. Photograph showing a metal tie-down strap fixed to a batten via the use of machine driven nails. The over-driving of nails has damaged the strap, greatly reducing the connection capacity.

- Figure 9 below demonstrates a typical example of the type of damage to the tie-down strap roof connection observed during the general inspection).

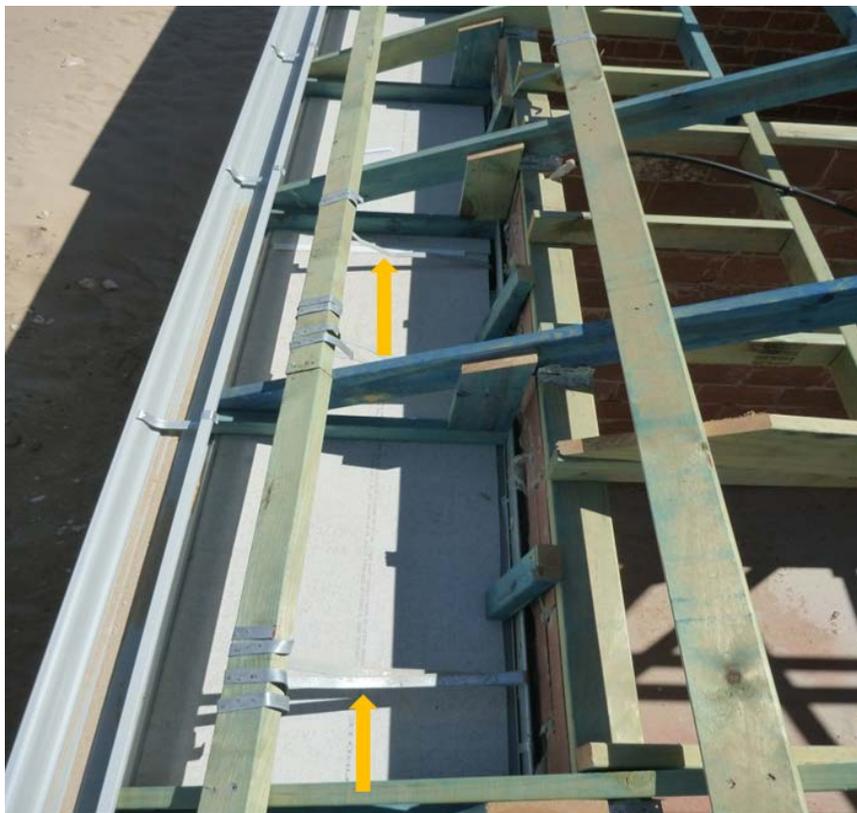
Figure 10. Photograph showing poor tie down strap installation (strap being fixed down the roof line)

- The use of specific battens for top fixing tie-down straps, has its benefits. Tie-down battens of this type are not catered for within the AS 1684 standard series and require design by a suitably qualified structural engineer. A number of tie-down straps were fixed to the roof-frame in places not immediately above the cavity (see Figure 10). In this situation, the loose straps are not able to provide a vertical resistance force at that point. Unless the roof is restrained at other places it is free to lift and/or move sideways until the strap is entirely vertical and taut.

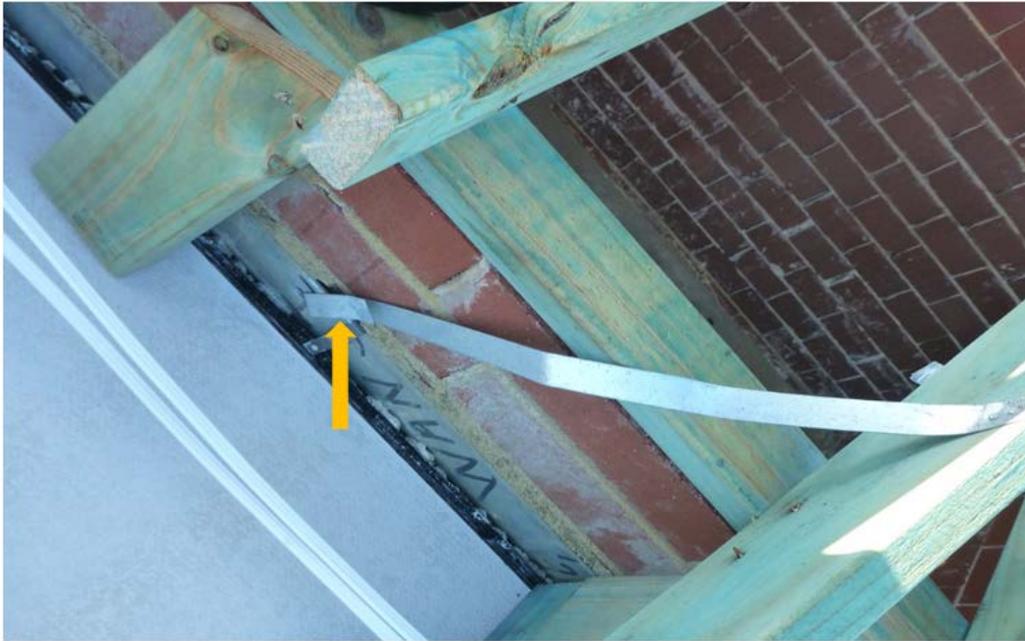
Figure 11. Photograph showing tie-down strap looped through a slot in a lintel

- A strap connected to a lintel (when the lintel is supporting a limited weight of masonry) may not be able to resist the design wind uplift forces (see Figure 11).

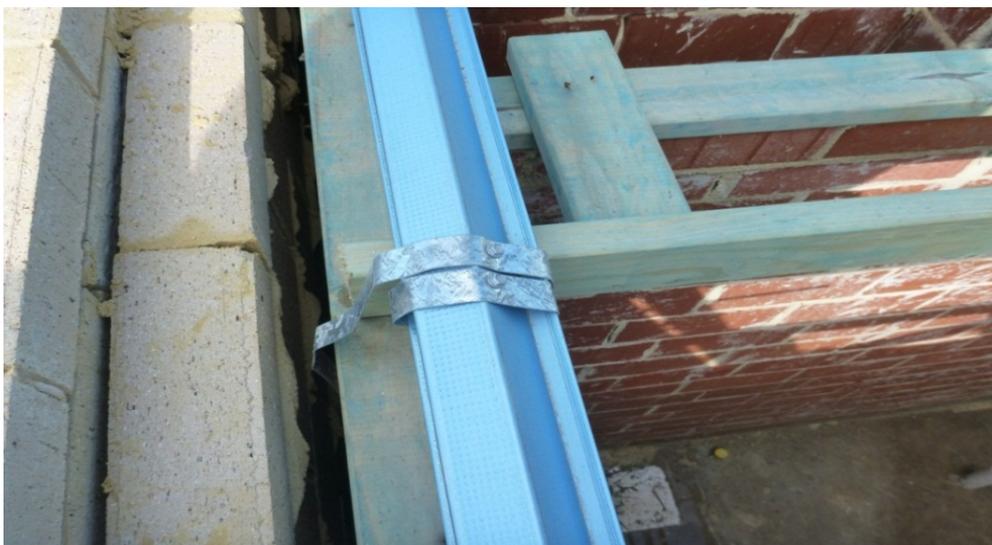
Figure 12. Photograph showing tie-down wrapped around metal batten (Note: the tie down is loose)

- Straps installed but not fixed-off to the roof frame by the carpenter.
- Fixing to metal battens where the batten may crush or distort when loaded during peak design wind events (see Figure 12).
- Carpenters commented that when they sought to tension the strap prior to fixing it to the roof frame on occasion the strap pulled out of the masonry. This indicates that in some cases the straps may not be installed within the brickwork to adequately resist the uplift loads.
- Figure 13 indicates a typical example of poor workmanship observed where the tie-down was not pulled tight and has an incorrect nail type with no corrosion rating. This strap is also below the requirements for minimum size and galvanised coating thickness.

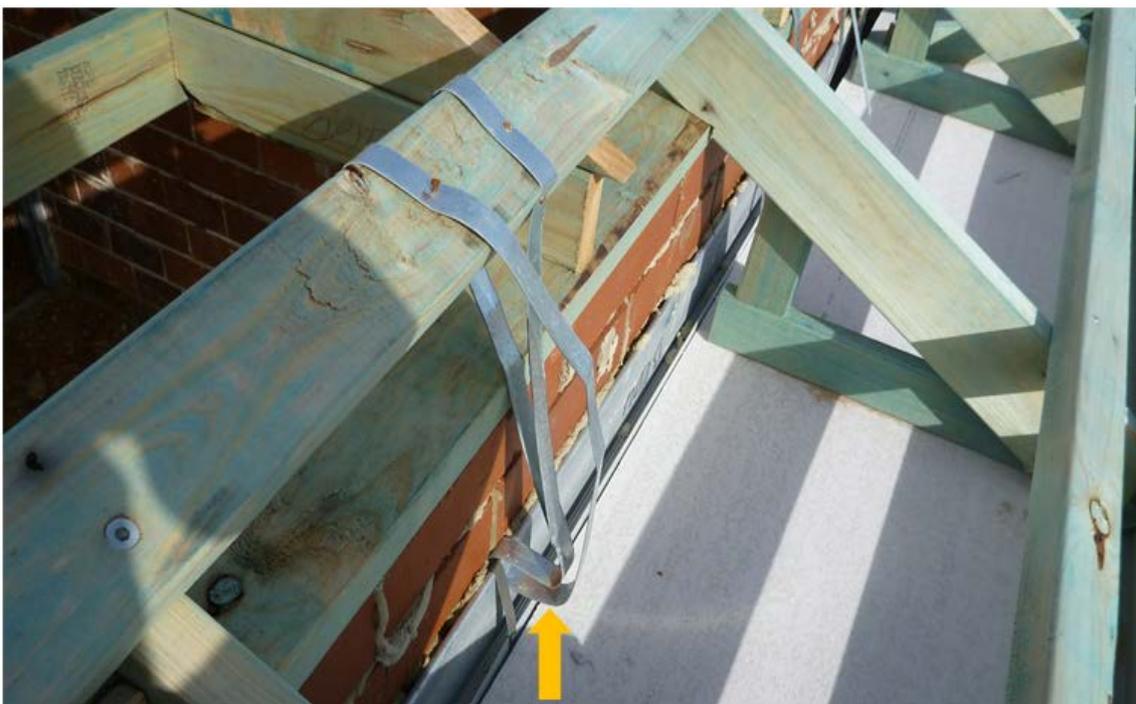
Figure 13. Photograph showing poor installation of tie-down straps

- Failing to pull the strap taut when fixing it off.
- Pulling the strap along the cavity at excessive angles in order to reach a fixing point – eg the rafter.
- Not connecting the strap adequately when looping it through a lintel – eg see Figure 11. In this instance only one leg of the strap has been nailed off, with the other end just turned up after placement through the slot. This strap would have no capacity to prevent wind uplift and is typical of a lot of sites inspected where there seemed to be a lack of understanding of the importance of adequate tie-down strap installation.

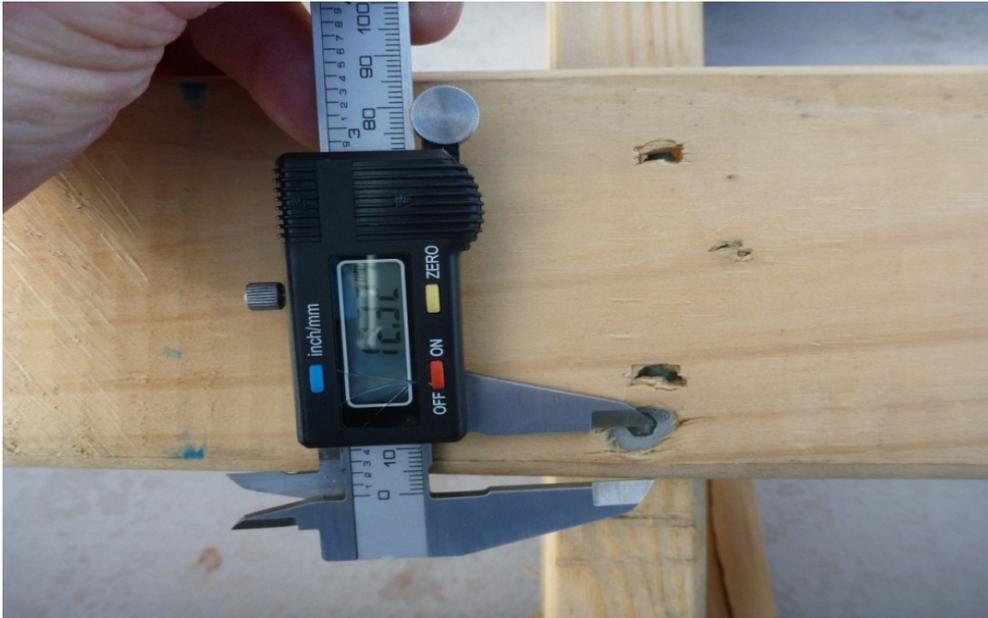
Figure 15. Photograph showing a batten non-compliant screw close to the edge of the batten

- AS 1720.1: 2010, Section 4.3, requires a screw fixing to be located 5 times the shank diameter from the edge of the timber. AS 1684.2, Table 9.25, where a single screw is required, shows the fixing in the centre of the batten. Roof carpenters should install the screw as close to the centre of the batten as possible.
- Figure 15 (below) shows a screw fixed within 12 mm of the batten edge compared to the standard requirement of a minimum edge distance of approximately 26 mm.

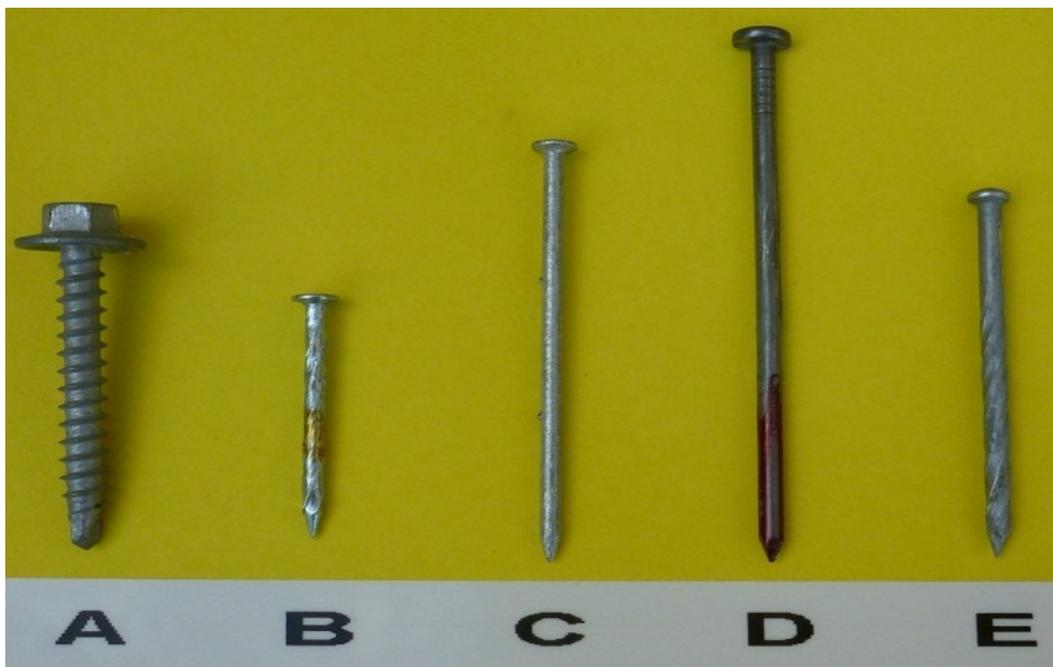
Figure 16. Typical examples of fixing of metal battens observed

- A variety of connectors used to attach metal battens to the rafters were observed including hex-head screws and a variety of nails from 32 mm to 75 mm long – Figure 16 (A) represents a manufacturer's recommended screw for fixing metal battens and Figure 16 (C & D) were the most frequently used nail fixings identified in the audit.

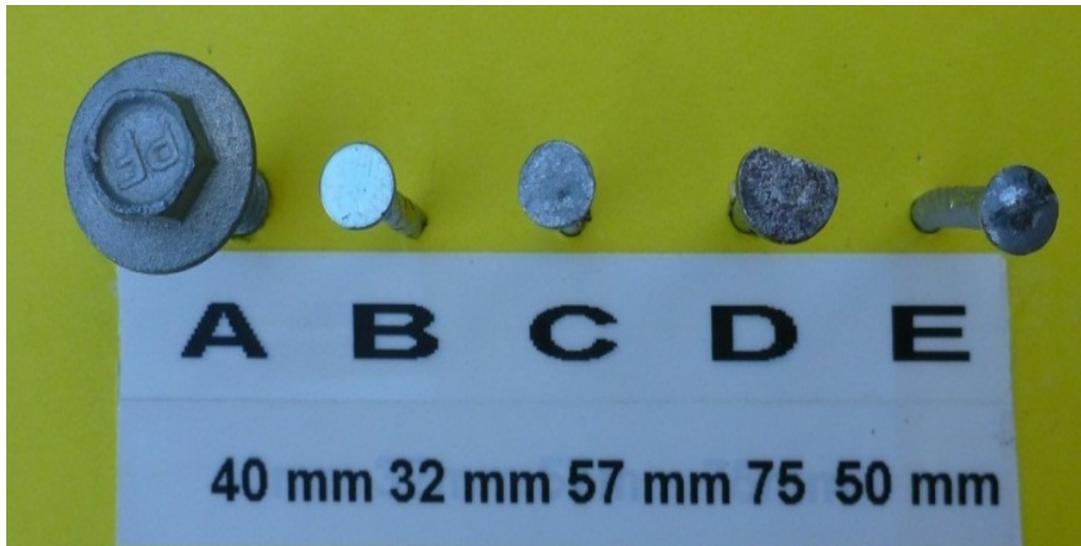
Figure 17. A comparison in the size of the fixing heads between the screw fixings

- Metal batten manufacturers generally recommend using two hex-head screws per batten rafter connection – Figure 17 (A) is a 15 mm diameter head (as recommended by manufacturers). The commonly used nails have head diameters (B) – 5.5 mm; (C) – 5.6 mm; (D) – 5.5 mm x 7 mm; and (E) – 5.4 mm head.

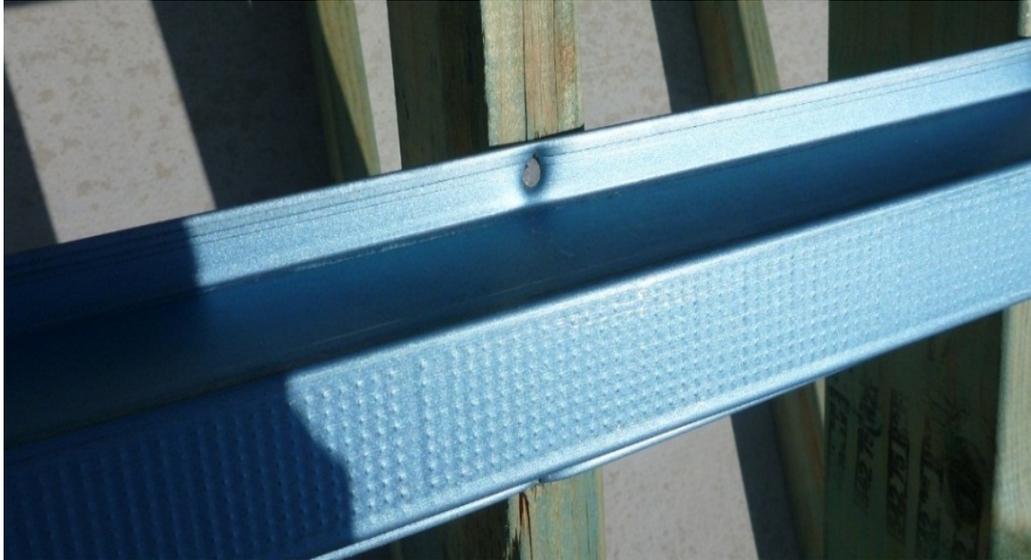
Figure 18. Photograph showing a 75mm x 3.06mm nail over driven when used to fix a metal batten

- Often 75 mm roof framing nails were observed over-driven into the metal batten, which may weaken the batten rafter connection and make the 0.55mm thick batten more susceptible to pull-through failure (see Figure 18 for a typical example of an over-driven nail fixing on metal battens).

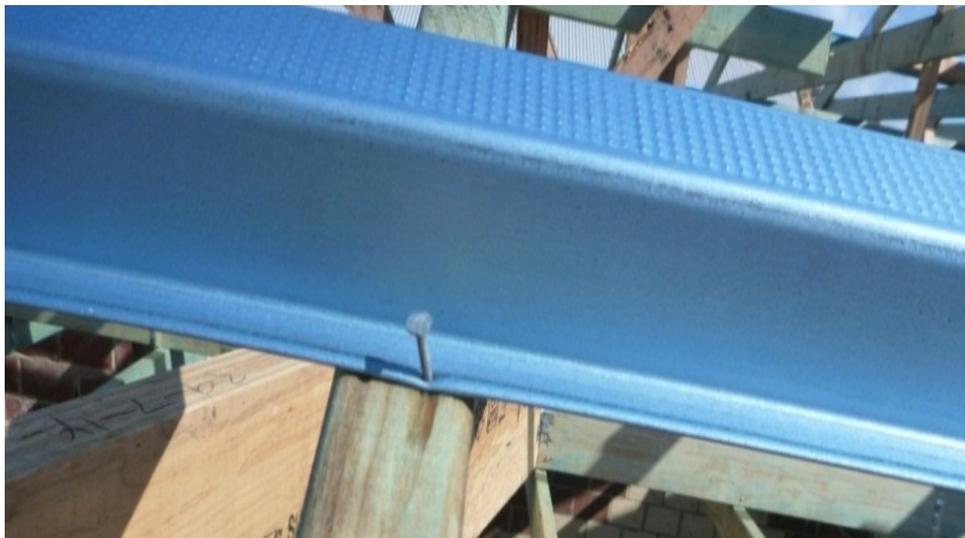
Figure 19. Photograph showing a typical under driven nail fixing a metal batten around this roof

- In some roofs, more often when fixed with the 57 mm long x 2.6 mm diameter shank, the nails are under-driven – ie sitting up above the face of the metal batten and in some places observed by as much as 10 mm. Where this occurred it was often commonly found throughout the whole roof – eg see Figure 19 for typical examples of under-driven nails on metal battens observed during the general inspection.

- Under-driving the nail is undesirable as less of the nail is embedded into the receiving rafter. The reduced nail penetration may give lower withdrawal capacity due to nail strength being a function of embedment depth.
- No evidence of over-driving or under-driving (or damage and deformation of the metal batten) was observed when the metal battens had been fixed with screws.

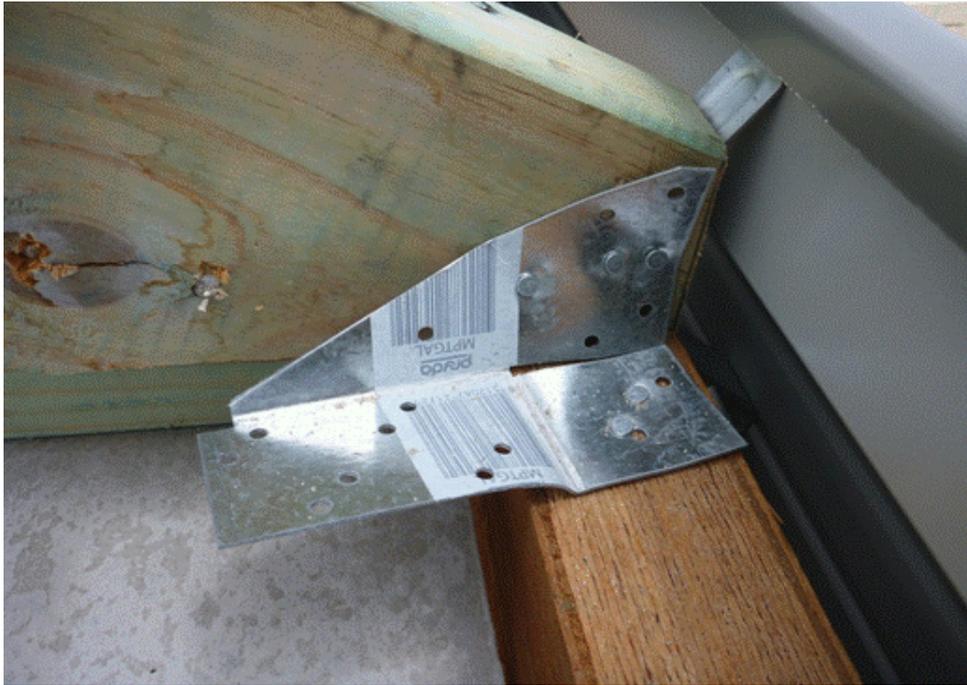
Figure 20. Photograph showing a poorly installed metal connector making the connection between an alfresco beam and rafter

- Metal connectors were often observed laid on their side and in some cases nailed with as little as one nail per face (see Figure 20) compared with AS 1684.2 Table 9.21 (b) which shows four nails to each end.
- Failing to install metal connectors in accordance with the standard (or the manufacturing recommendations) may reduce connector capacity to resist wind uplift force.

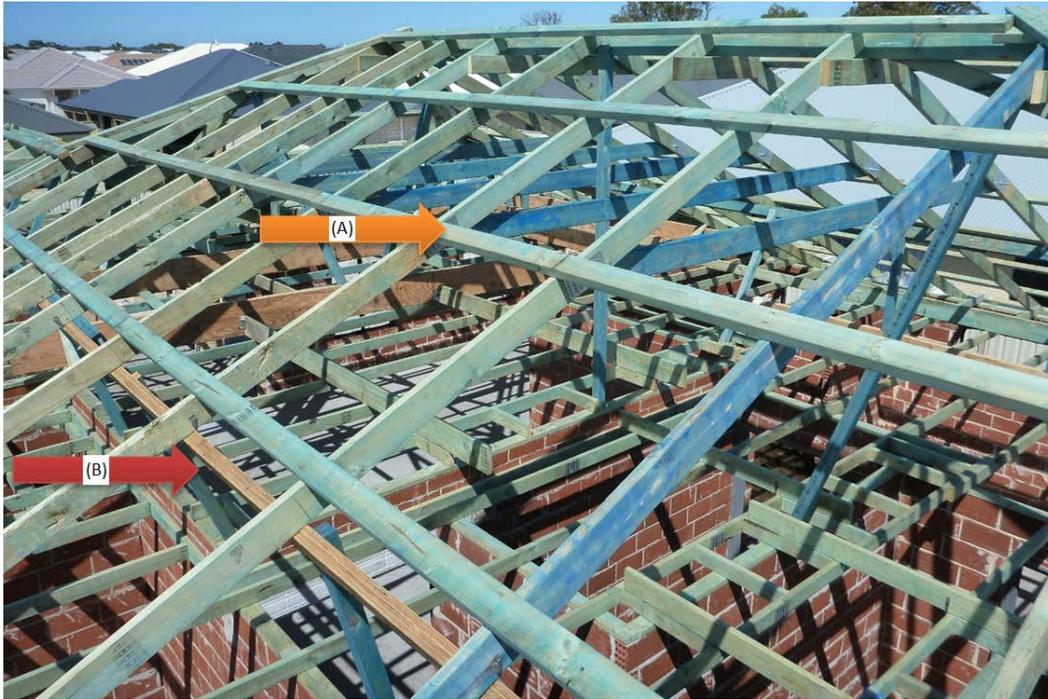
Figure 23. Photograph showing non-compliant collar tie installation

- In Figure 23 below the orange arrow (A) indicates location of collar ties compared to the red arrow (B) where the underpurlin is located.
- Collar ties should be located immediately above underpurlins as outlined in Figure 24 below.
- Figure 24(A) shows the standard method of fixing collar ties when two underpurlins are necessary.
- Figure 24(B) shows the standard method of fixing scissor collar ties when two underpurlins are necessary.

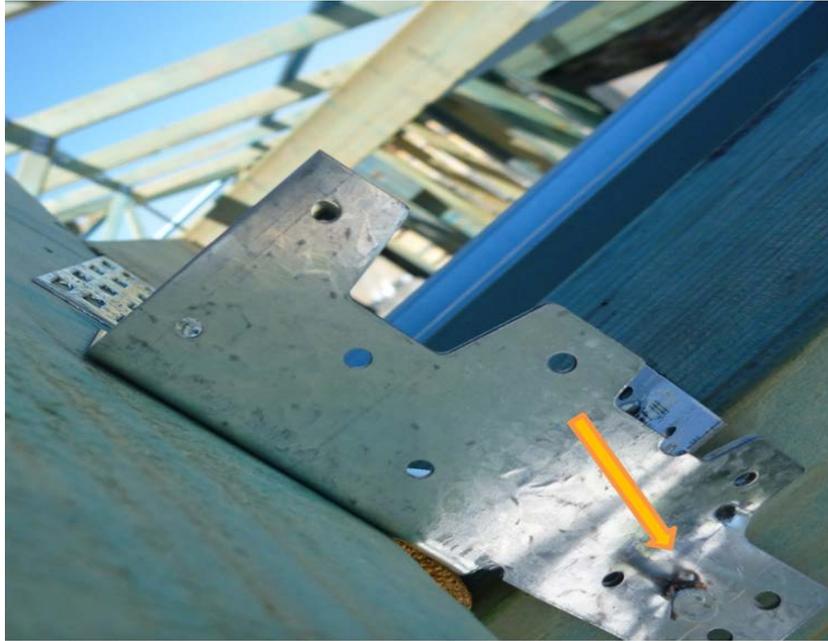
- Insufficient nails per metal connector. In some cases only 25% of the nails required by the standards were present (see Figure 25 as an example of one nail used where four nails per tab are normally required).
- Incorrect installation of metal connectors – ie installed horizontally instead of vertically.
- Incorrect support of the truss over the internal framework – ie blocking between the bottom chord of the truss and the internal top plate at places where the truss is not designed to be blocked.

*Figure 25. Rafter top plate connection with only one horizontal nail into the top plate tab
(Manufacturer recommends 4 nails)*

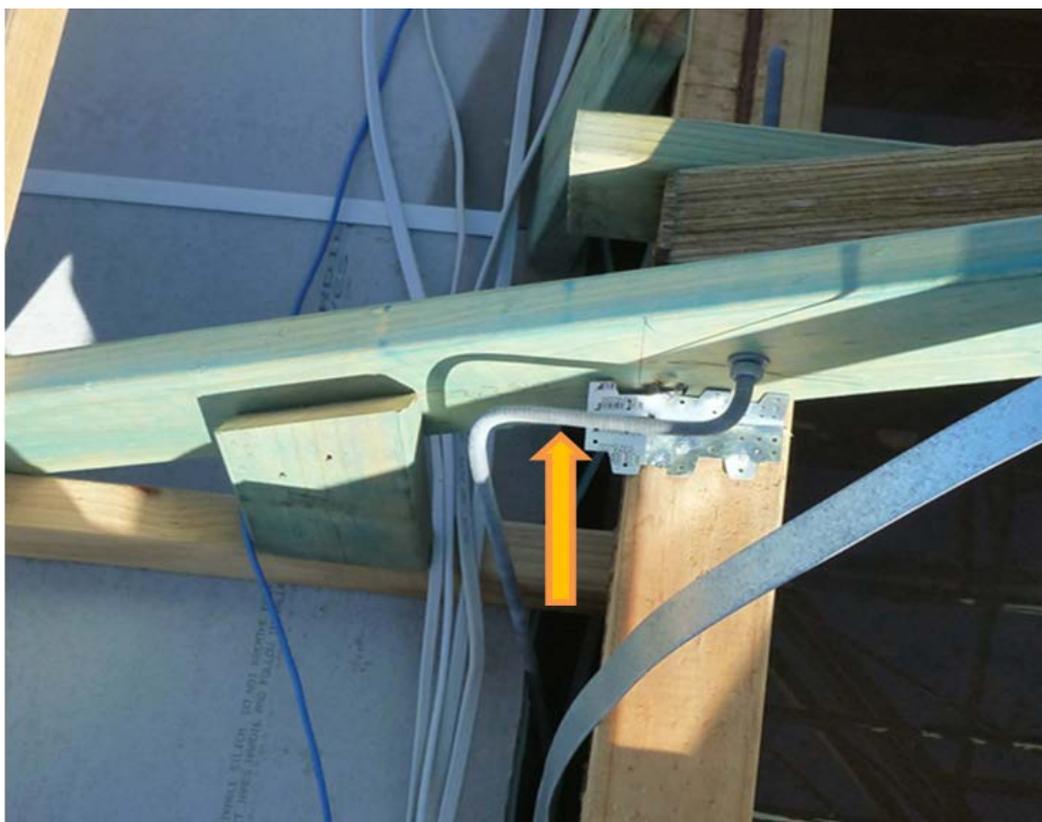
Figure 26. Photograph showing a tie down rod bent to make the connection to the beam

- Figure 26 shows a tie down rod bent to make the connection the beam which is unlikely to provide an acceptable tie-down at high design wind speeds.

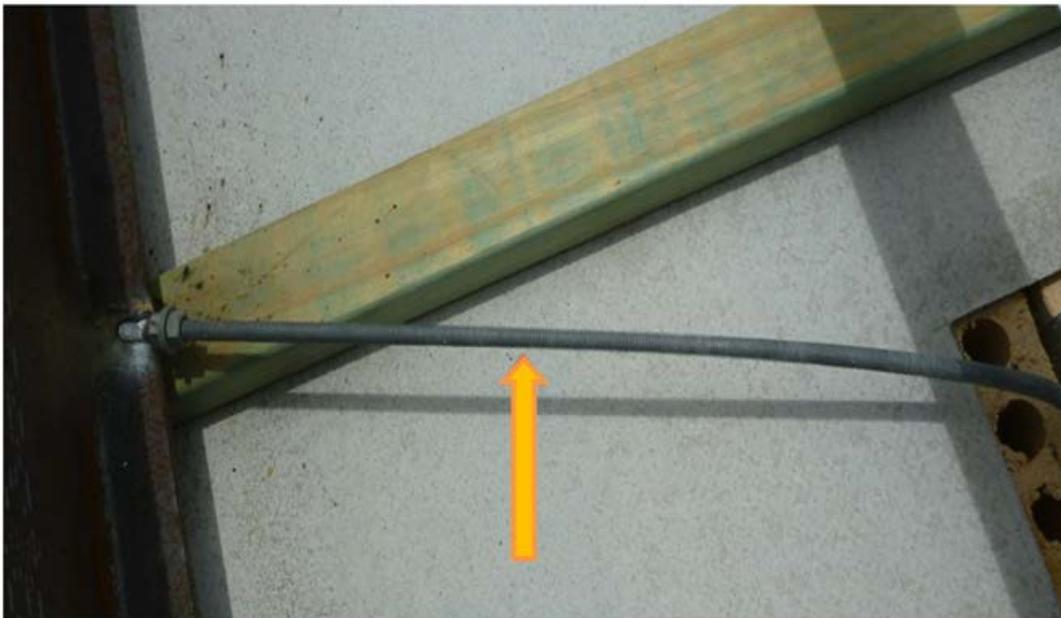
Figure 27. Photograph shows poor installation of a bent tie down rod

- A number of inspected roofs did have provision for the steel beams to be tied down, however, there were some very poor techniques used to attach the beam to the tie-down.
- Often the tie-down rod was located in a position in the masonry that required it to be bent at excessive angles in order to connect with the beam – eg see Figure 27 where a tie-down rod is bent and pulled across the roof horizontally to be fixed to the steel beam some distance from the location of the rod in the masonry.

- In some instances, where the rods were missing or poorly placed, a review of the plans indicated the poor installation resulted from failure of a bricklayer to install the rods in accordance with the plans.
- The BCA acceptable construction practise and deemed-to-satisfy provisions does not provide complete information regarding the tie-down requirements of steel beams in roofs.
