Safety alert 14/2012

Elevating work platform fatality

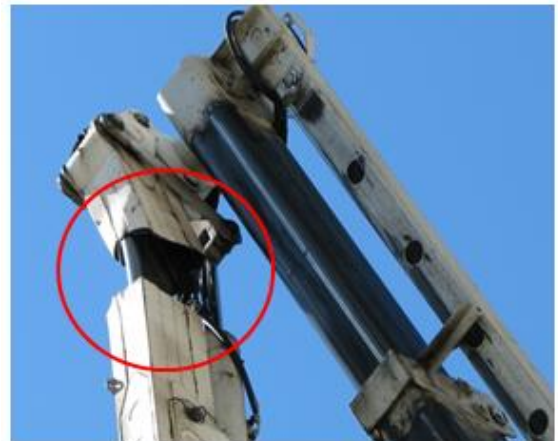
An operator was killed when the jib supporting the bucket of the EWP he was operating failed, causing him to fall approximately 20 metres with the bucket. The EWP was an Italmec model Ital Jib 42N. The failure occurred between the jib luffing ram attachment points.

- Angle fishplates had been welded to each external corner of the hollow jib section.
- The failure was located at the end of one of the angle fishplates on the bottom face of the jib.
- A metallurgical examination indicated the angle fishplate welding was associated with the failure.

Figure 1 Area of jib failure

1. All Italmec EWPs to undergo radiographic testing of their boom and jib welds.
2. Remove from service any EWP identified as unsafe until all defects have been corrected under the supervision of an engineer.
