Exposure to asbestos during renovation works

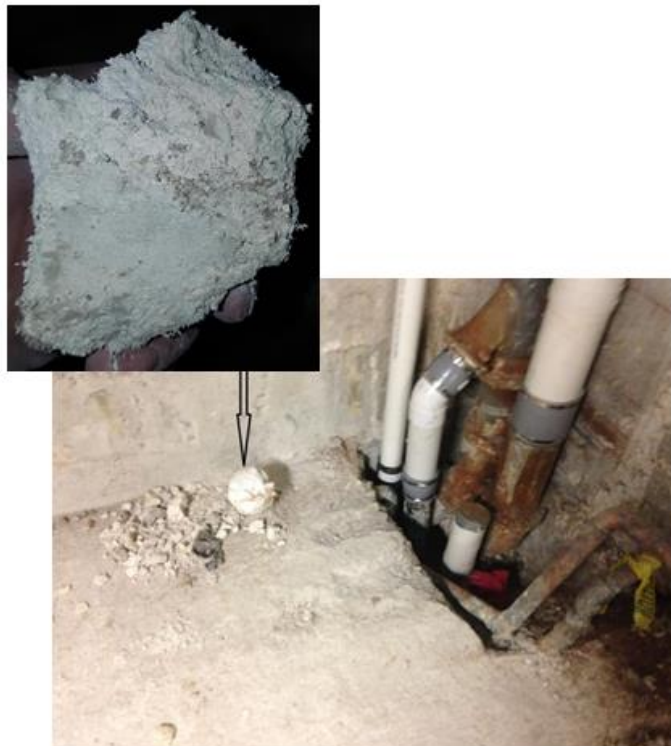
Recently construction workers were exposed to asbestos whilst carrying out renovation work on a multi-storey building. A worker was using an electrical jackhammer to remove old waste pipes from a penetration in a concrete floor slab. As the work progressed, the worker noticed that the consistency of the concrete material changed and appeared to become softer. Material on the underside of the slab was dislodged and fell approximately 5 metres onto the floor below, contaminating a large area with dust and debris. Other construction workers were in this area at the time of the incident.

After workers raised concerns, laboratory testing was conducted and it was confirmed that the material contained a mixture of plaster, white asbestos and synthetic mineral fibre. Only the worker using the jackhammer was wearing respiratory protection. The incident resulted in a number of workers being exposed to asbestos. The affected area required extensive remediation to remove the asbestos contamination.

Work area showing asbestos-containing debris and close up of asbestos-containing debris

- The work was carried out in a multi-storey building built in the early 1970s, when asbestos was frequently used in construction materials.
- The asbestos-containing material was in an inaccessible location, as it had been covered by approximately 600mm of concrete.

1. Before construction or renovation work, conduct a risk assessment to determine the presence of asbestos and other hazardous materials.
2. Note that asbestos registers are generally based on non-intrusive inspections and only contain information on visible materials. Areas of the building that are inaccessible are likely to be out of the scope of the asbestos register.

3. Consider carrying out exploratory investigations and testing to determine the presence of asbestos before major works.
4. If there is any risk that asbestos may be present, implement adequate dust control measures and ensure workers wear adequate respiratory protection.
