ELECTRICAL INCIDENT REPORT

POWER POLE FAILURE AND BUSH FIRE BALINGUP WESTERN AUSTRALIA 14 FEBRUARY 2009

April 2009

EIS 2009-578

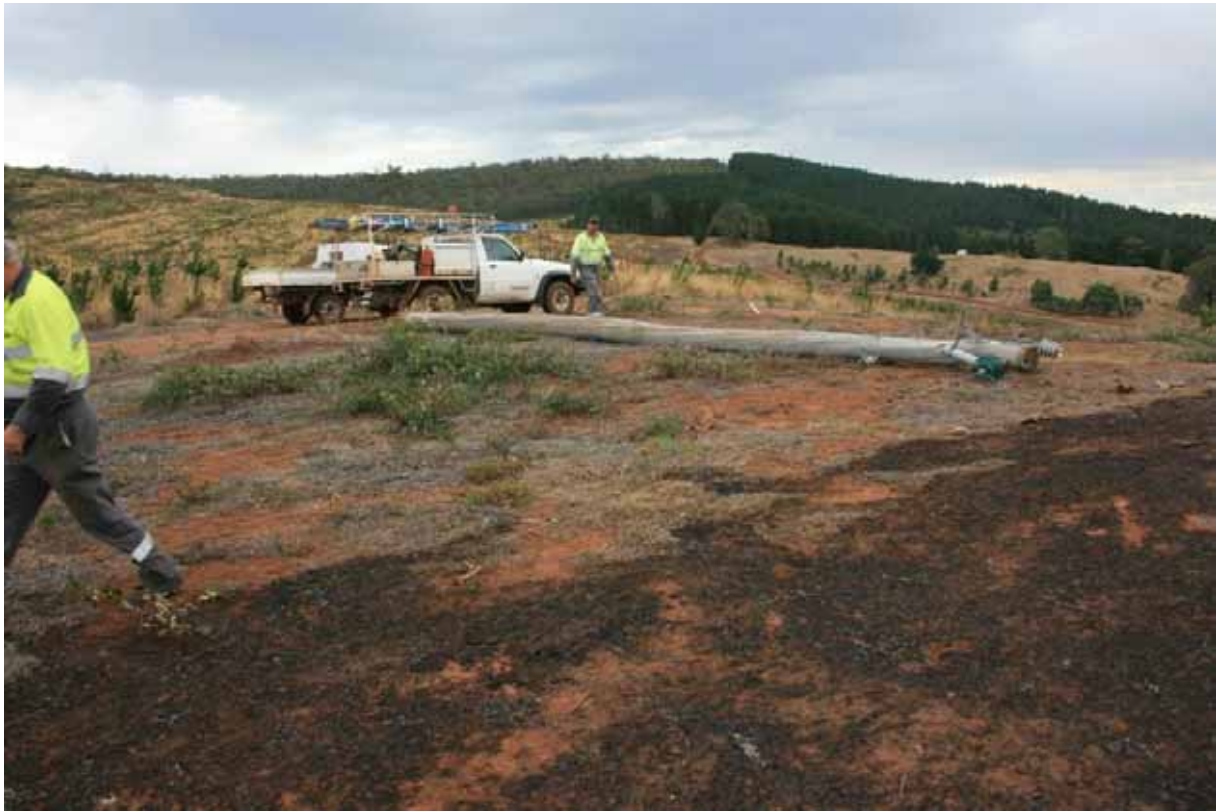
The K360/36 single-phase 12,700 volt (12.7kV) spur line consists of an active 12,700 volt conductor and an underslung running earth conductor at earth potential. At 1344 hours on 14 February 2009, pole number K360/36/3 fell over with the live 12,700 volt active and running earth conductors still attached. Electrical arcing occurred when the live active conductor contacted the ground, which ignited the dry vegetation in that vicinity [Appendix B, Photographs Numbers 1 and 2].

DEC's Fire Investigator advised that the bush fire's point of ignition was on the ground in dry vegetation next to where the live high voltage conductors on Western Power's pole number K360/36/3 fell to the ground [Appendix B, Photographs numbers 1 and 2].

Photograph No 1: Fallen Pole Number K360/36/3 as Found by DEC

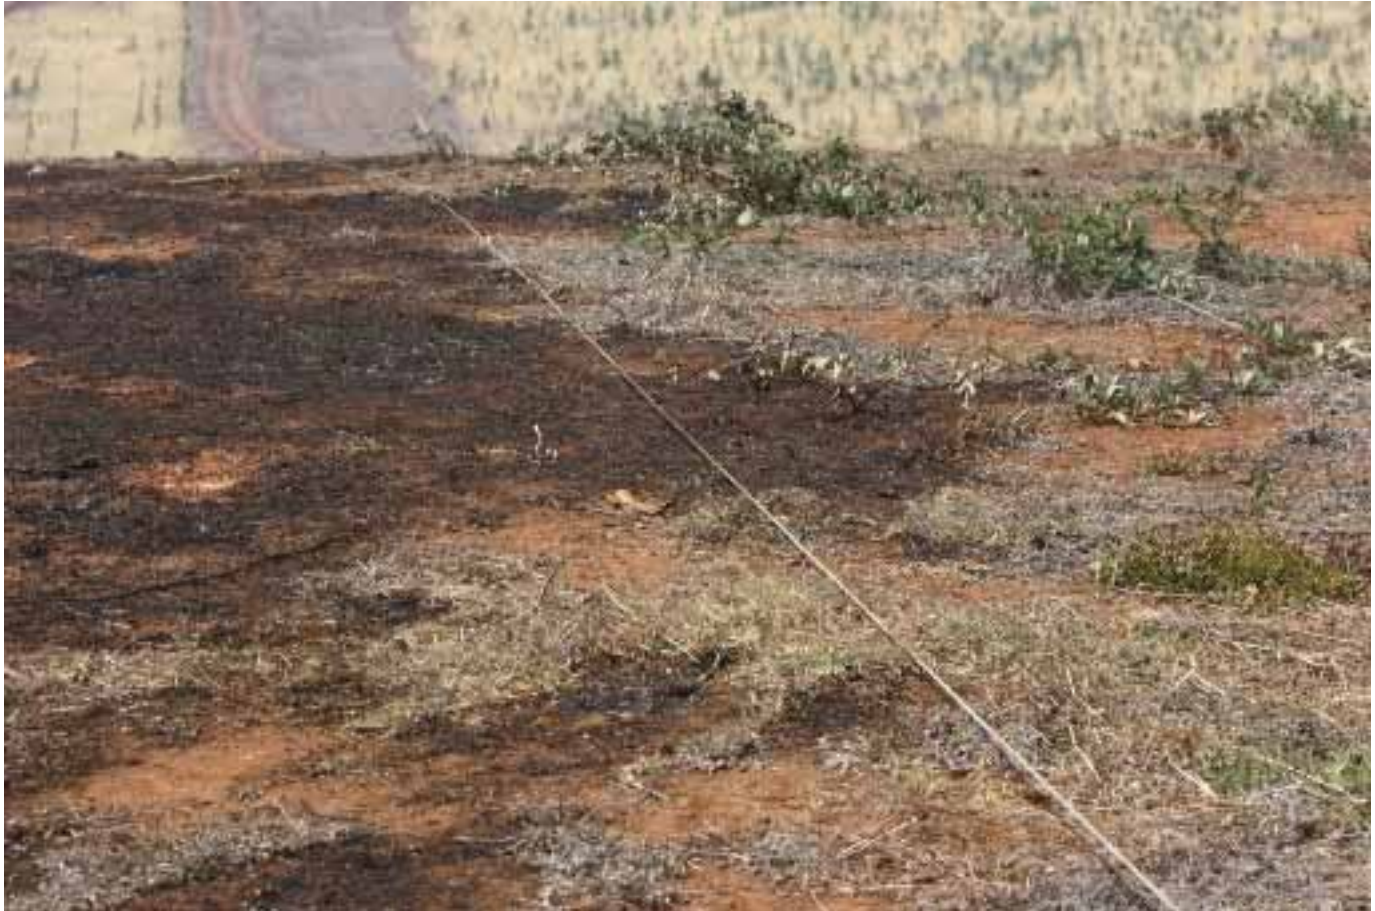
An inspection of the ignition point indicated that an area of grass and bush had burnt out adjacent to the Western Power 12.7 kV overhead power line. The bush fire had continued in a West /North West direction. This is consistent with the bush fire being driven forward from the point of ignition by wind from the East/South East.

Photograph No 2: Fire Origin and Conductors on the Ground.

The active conductor is shown in the centre of the picture.

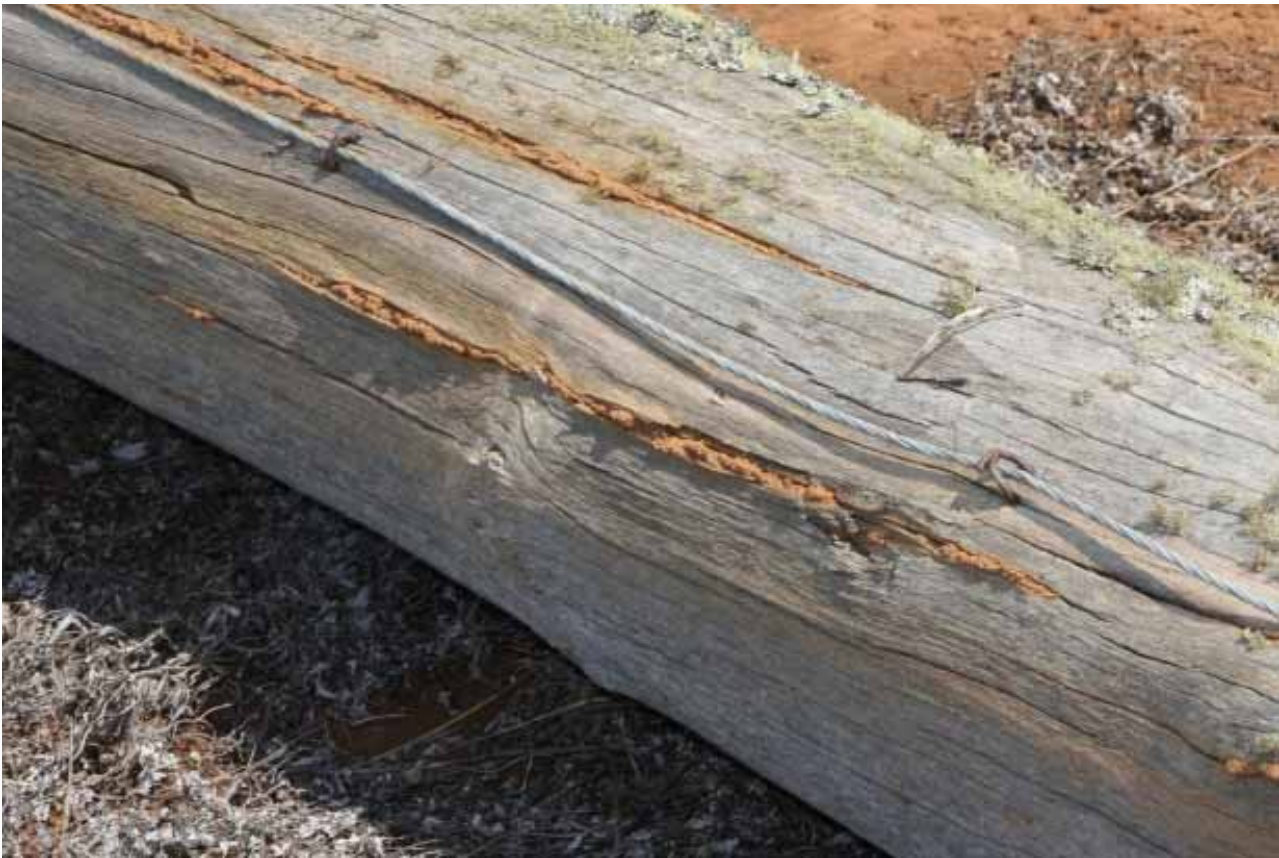
- Live termite activity extending up the pole, but no evidence that the pole had been treated for termites [Appendix B, Photograph Numbers 3 and 4].
- Advanced rot with little or no pole strength remaining.

Pole number K360/36/3 was found to be infested with an active termite colony. There was no label on the pole indicating the termite activity had been identified and/or treated. Also other poles in the spur line have a yellow termite treatment notice identifying when the termite treatment was administered. Pole number K360/36/5 is one such pole fitted with a termite treatment notice [Appendix B, Photograph Number 7].

Examination of sections cut through the pole by WP showed clear evidence of active termites, both at and above the ground line. While the termite galleries were present, the wood rot at the ground line contributed more to the loss of strength and pole failure than the termite activity.

Photograph No 3: Termite Infestation on Pole Number K360/36/3

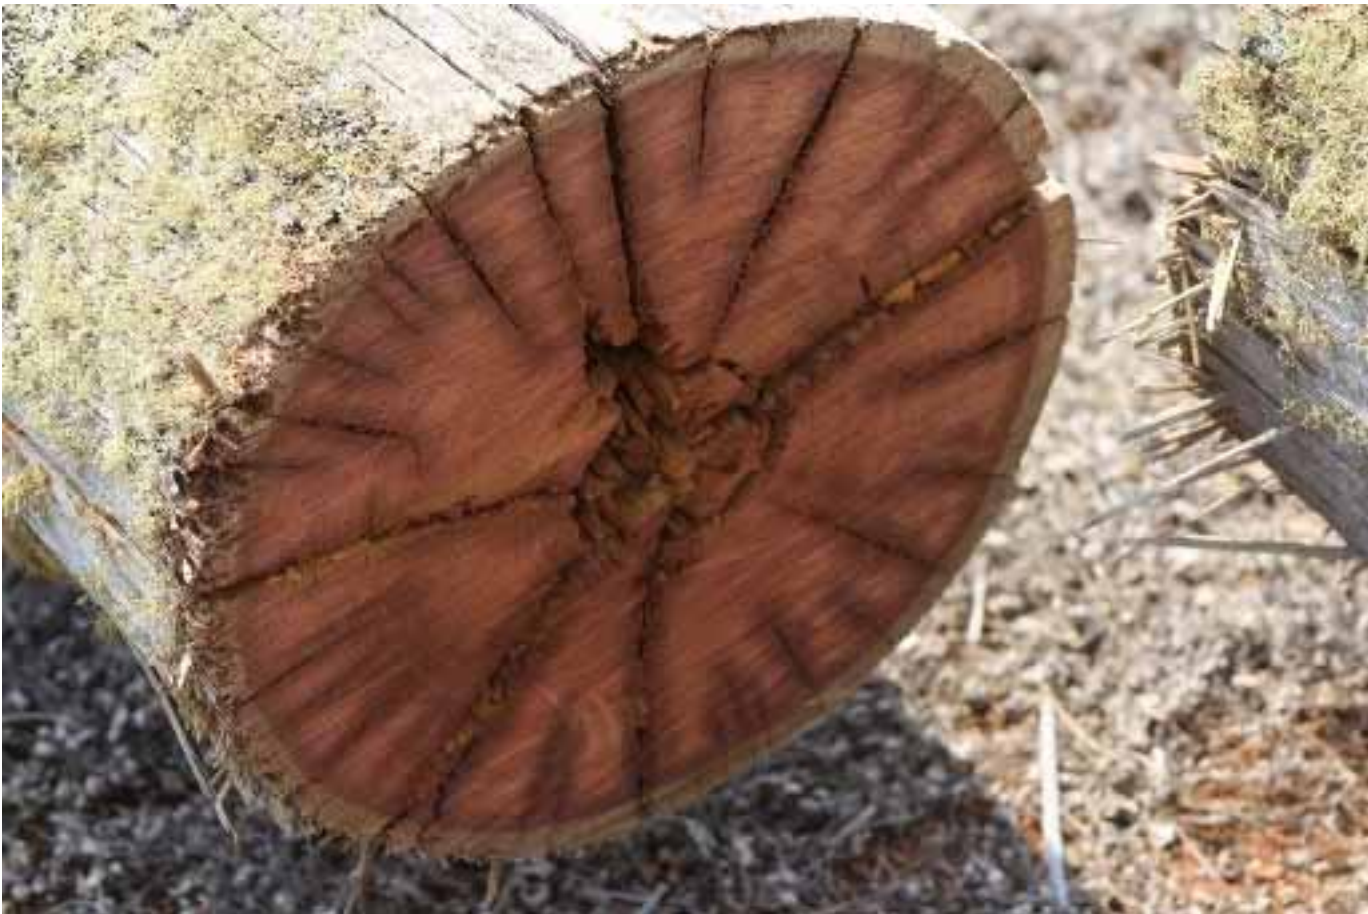
- Termites were active in the pole at and above the ground line. While the termite galleries would have reduced the pole's strength and serviceability to some degree, this was considered to be of lesser significance in the pole falling over than the ground line rot, which was advanced.

Photograph No 4: Termite Infestation and Damage to Pole Number K360/36/3

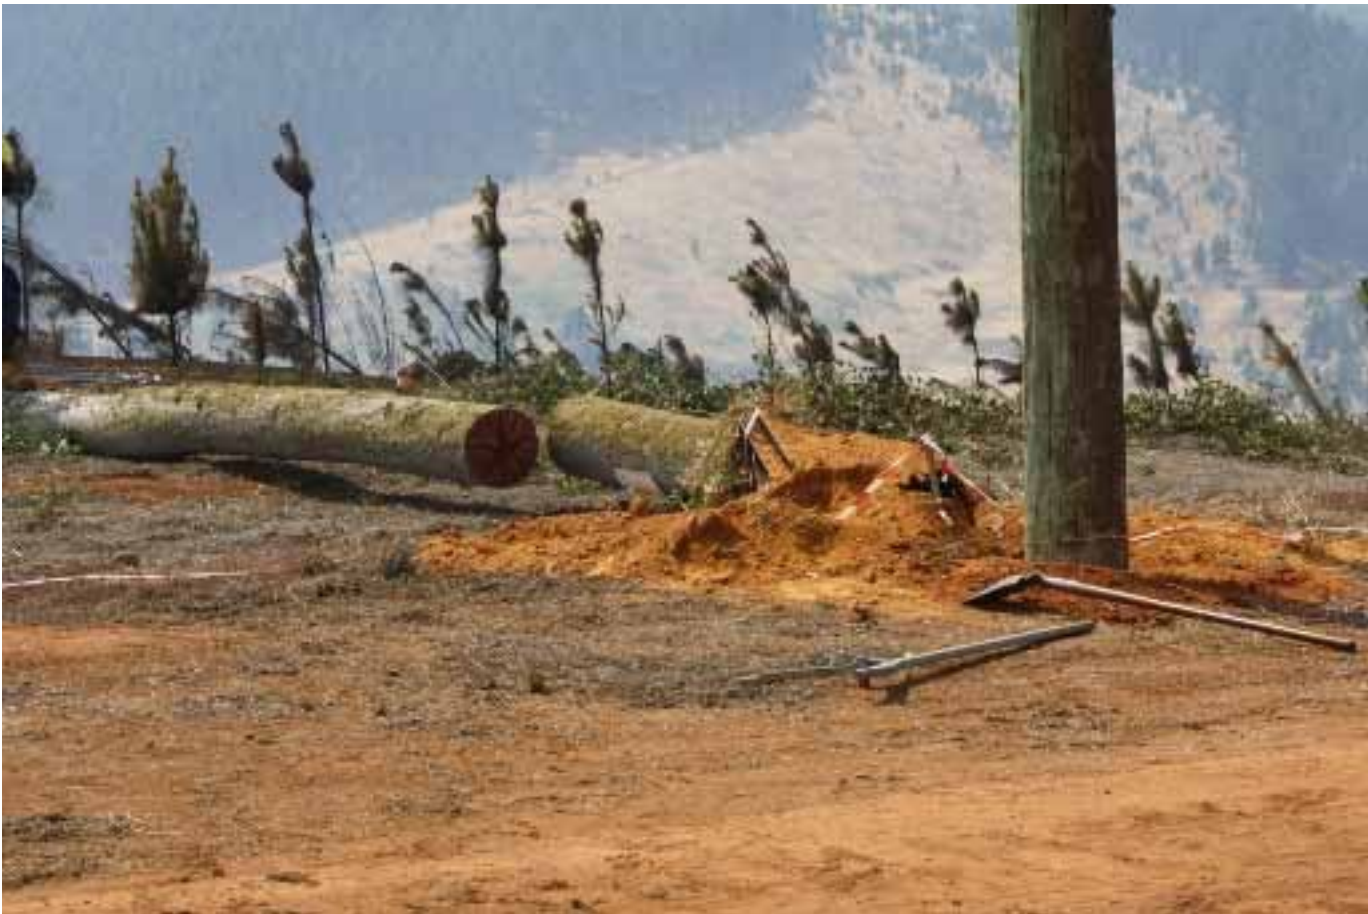
When EnergySafety's Senior Electrical Inspector, Mr Ross Reid, visited the scene on Sunday 15 February 2009, a replacement pole had already been installed. The fallen pole was still lying on the ground and had been cut above the failure point [Appendix B, Photograph Number 5]. WP later removed and transported part of the pole butt and pole immediately below and above the ground line to Perth for examination under the established evidence process.

Photograph No 5: Fallen Pole Number K360/36/3 on the Ground

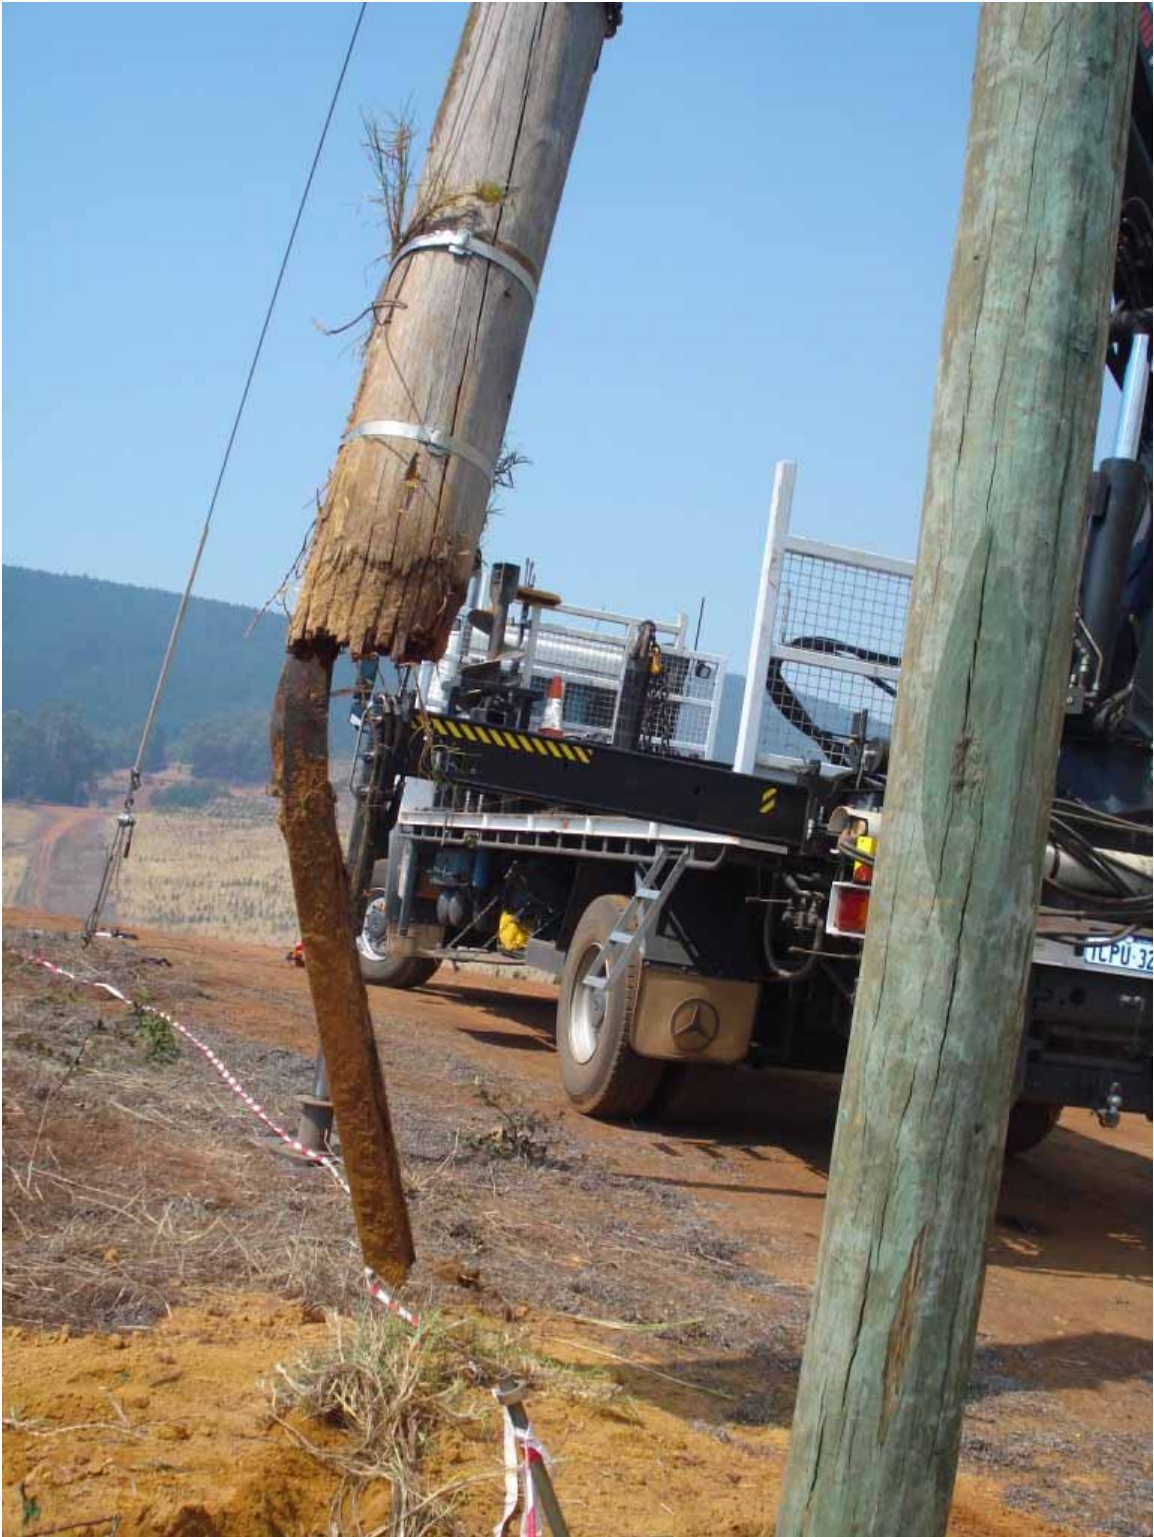
Pole number K360/36/3 was reinforced with a single "H" section steel column driven into the ground and secured to the pole by two steel banding straps [Appendix B, Photograph Number 6]. This reinforcing stake did not support the pole as intended when the pole broke and fell over on the 14 February 2009.

Investigation found that pole number K360/36/3 failed just below the ground line and fell at 90° to the power line. The steel reinforcing was still attached to the pole and was bent at the place of pole failure [Appendix B, Photograph Number 6].

Pole number K360/36/3 was fitted with a single "H" section steel reinforcing stake driven into the ground alongside the pole. This stake is secured to the pole above ground by two large banding straps. The "H" section steel stake bent at the ground line, allowing the pole to fall over, but remained secured to the pole by the banding straps above the ground. The banding straps stretched, but did not break.

Western Power uses these reinforcing stakes to guard against pole failures caused by ground-line rot and to extend the safe service life of its wood poles. The reinforcing stake on pole number K360/36/3 did not support the pole when it broke.

- The pole base reinforcing stake failed to support the rotted pole as was intended. This was a contributing factor to the pole falling over and the fire starting.

Photograph No 6: Bent Steel Reinforcement Attached to Pole Number K360/36/3

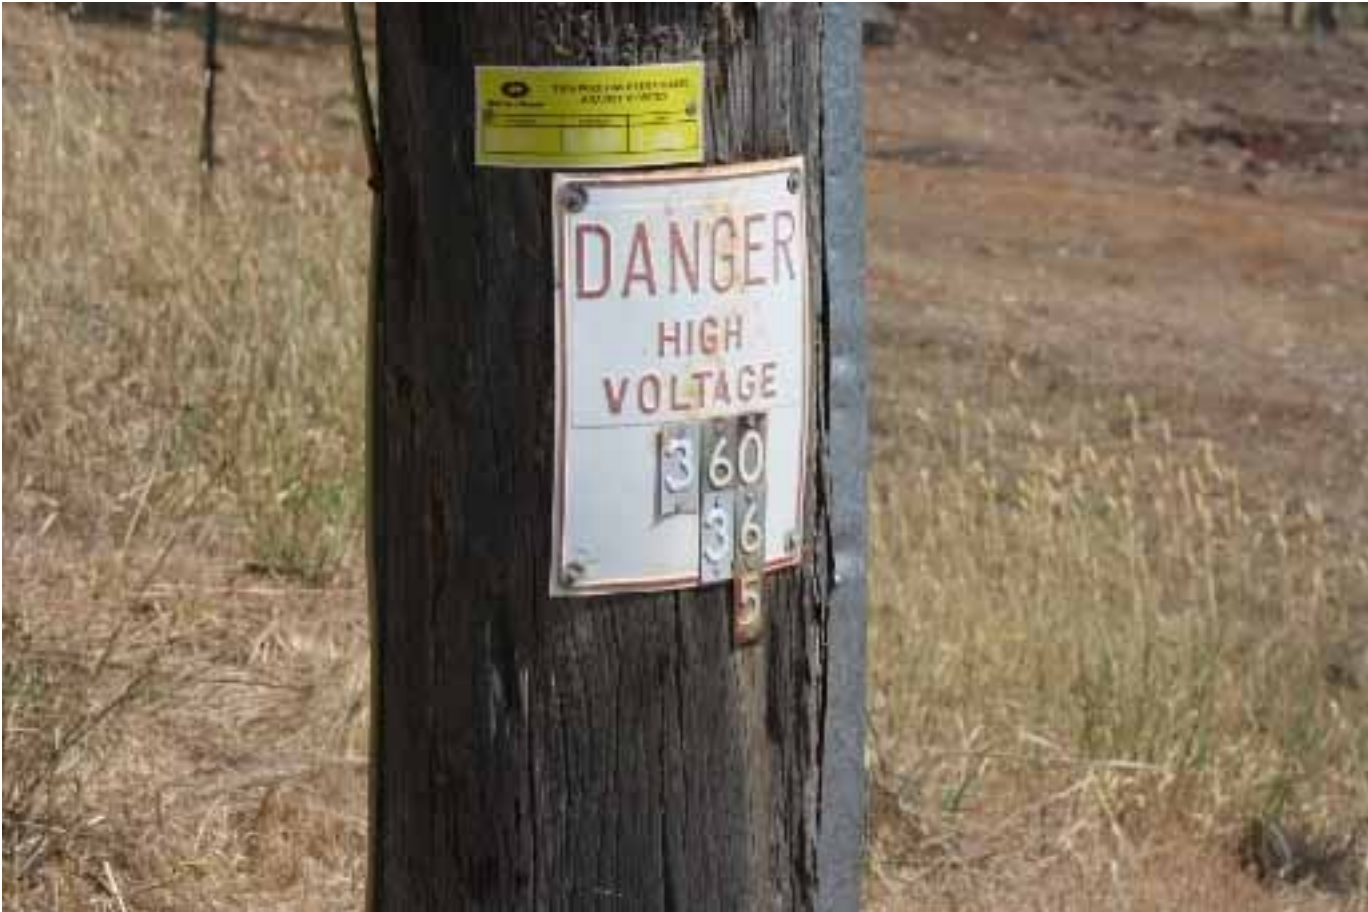
Photograph No 7: Termite Treatment Notice on Pole Number K360/36/5
