ELECTRICAL INCIDENT REPORT

POWER LINE FAULT AND BUSH FIRE NEAR CAPE NATURALISTE LIGHTHOUSE DUNSBOROUGH WESTERN AUSTRALIA 7 FEBRUARY 2009

3 March 2009

EIS 2009-559

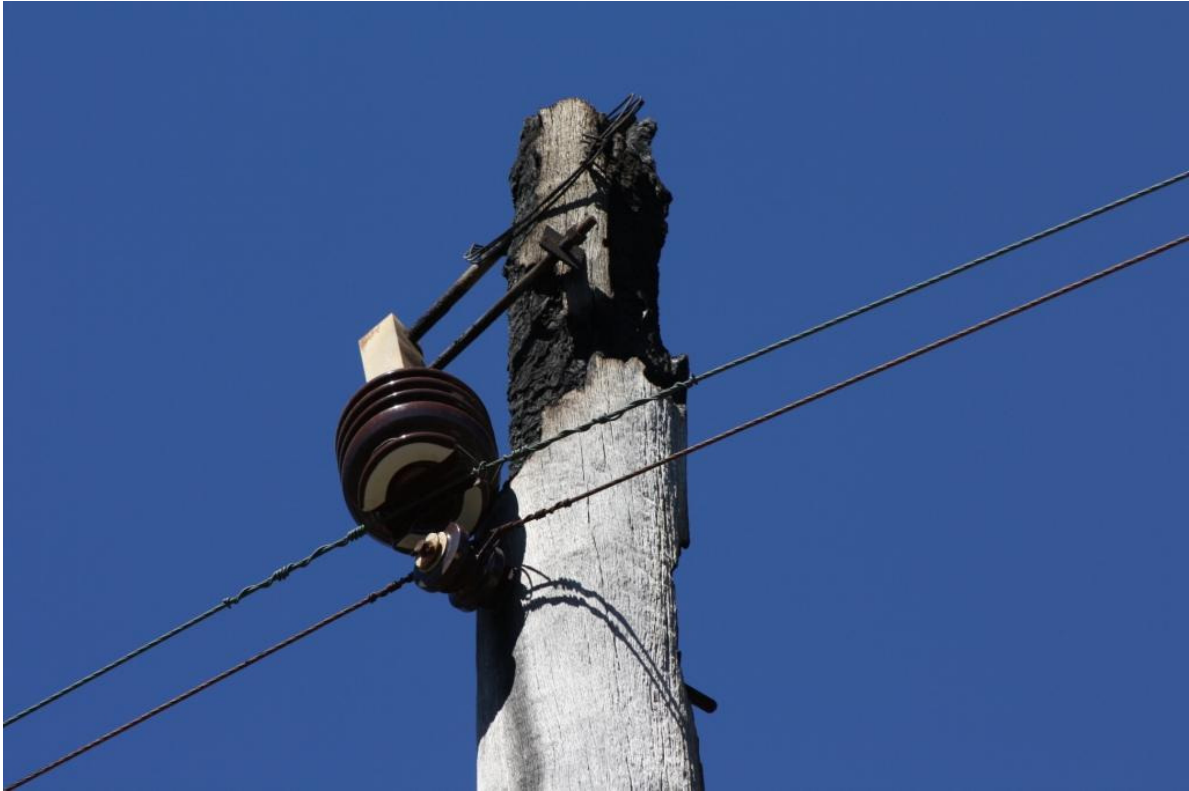
APPENDIX B: PHOTOGRAPH OF THE TOP OF POLE NUMBER 108

Dust or salt spray deposition on the insulator combined with light rain and high humidity, resulted in a high level of leakage current. The leakage current generated enough heat to ignite the wood at the point of contact between the wood and metal surface of the active conductor insulator's support bracket. This type of incident is referred to as a pole top fire.

As a result of the pole burning at the insulator support bracket, the active conductor, with insulator attached, came adrift and was found hanging from the pole top [Appendix B, Photograph].

Inspection found evidence of damage to the top of pole number 108 caused by a pole top fire. The damage consisted of burning near the top of the pole and insulator support bracket. The active conductor with insulator still attached came adrift from the pole and was found hanging (Appendix B, Photograph).

The top of pole number 108 caught fire as a result of leakage current from the active conductor to the underslung return conductor. Dust or salt spray deposition on the insulators, combined with light rain and high humidity, caused a high level of leakage current. The leakage current generated enough heat to ignite the wood at the point of contact between the wood and metal surface of the insulator support bracket.

Photograph taken on 8 February 2009 by Senior Electrical Inspector Ross Reid, EnergySafety. Photograph shows the burnt pole top.

- Further investigations are required to identify the risks of future pole top fires in the area and the scope of the preventative work required to minimise this risk.
