Technical & Safety Division

Inside This Issue ...**Energy Bulletin**

Electric Shock Fatality

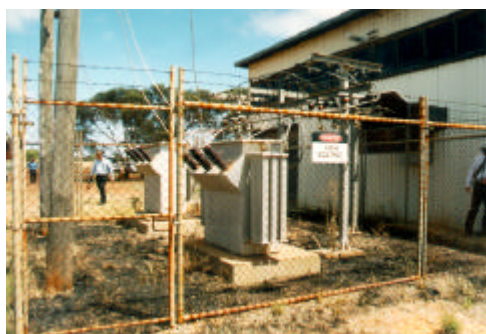
The young engineer apparently walked into the arcing horn of a high voltage bushing on the live transformer and received a severe electric shock. He was thrown to the ground and badly burned in a resulting intense fire in long grass within the transformer compound. He subsequently died from injuries received from the electric shock and the burns.

Investigations revealed that the transformer compound had been built around 1971 and did not comply with the current Australian Standard AS 2067 - 1984 which, amongst other things, defines safety clearances to any exposed live equipment. The incident highlighted the need for all utilities and HV installation owners to ensure that such hazardous installations are brought up to current standards. Furthermore, until such hazardous installations are brought up to current safety standards, it is recommended that access to them must be completely denied unless they are made safe by isolation and earthing of live conductors before entry. It is essential that there is also clear signage at entry points and regular warnings advising all field personnel of the dangers and emphasising the need to wear proper safety gear within substations.

Transformer compound at Ladyloch Pumping Station

It is recommended that all installations with open bushing transformers are checked to ensure that they meet current standards and

that appropriate action is taken where necessary, to ensure the safety of personnel.
