## **ELECTRICAL INCIDENT REPORT**

### **INVESTIGATION OF WILDFIRE AT ALLANSON, WESTERN AUSTRALIA ON 4 FEBRUARY 2005**

6 April 2005

2005-221

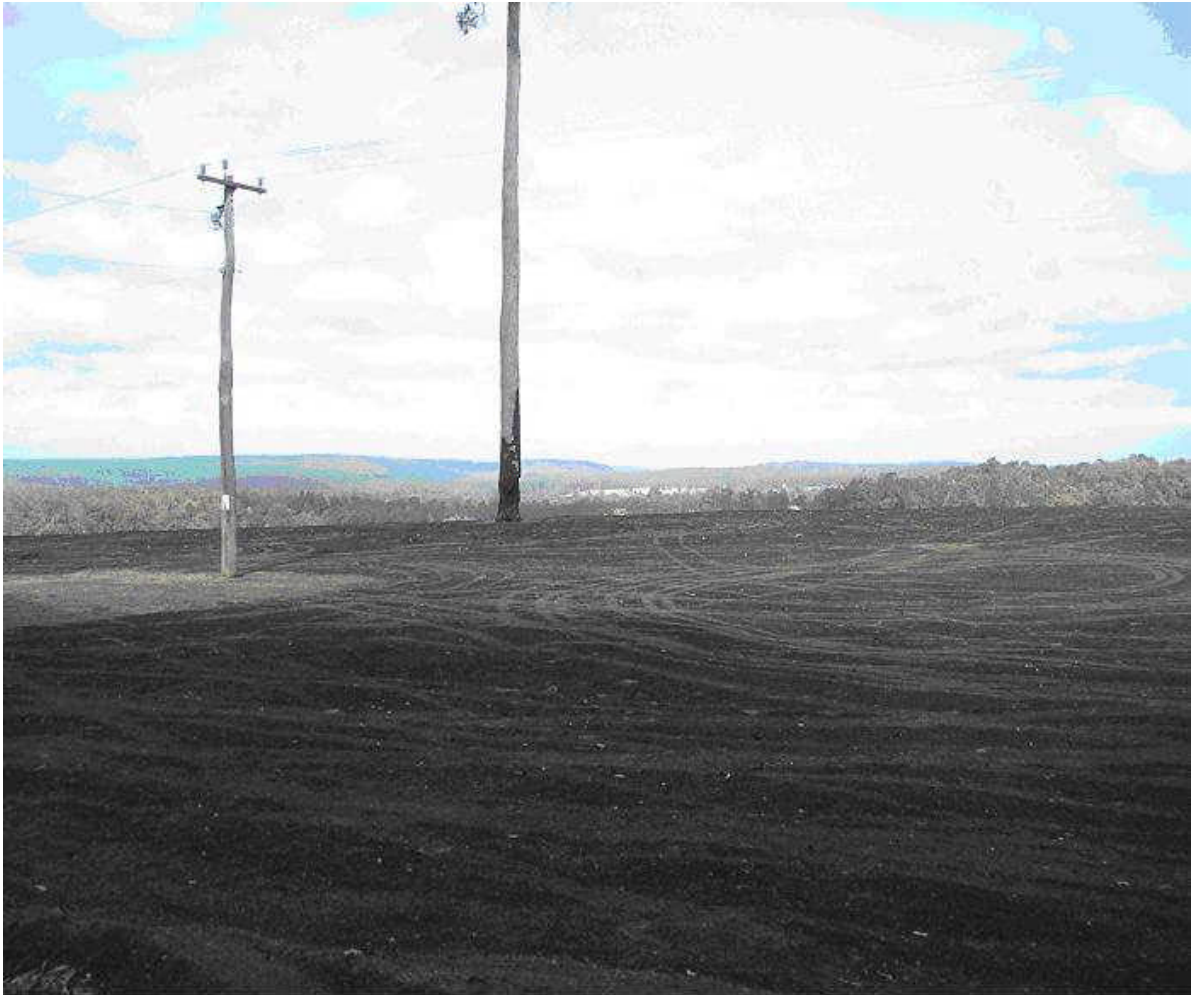
Photograph of Fire Area

The ground fire burned approximately 40 hectares of pasture, a hay shed (including hay) and extensively damaged the fences.

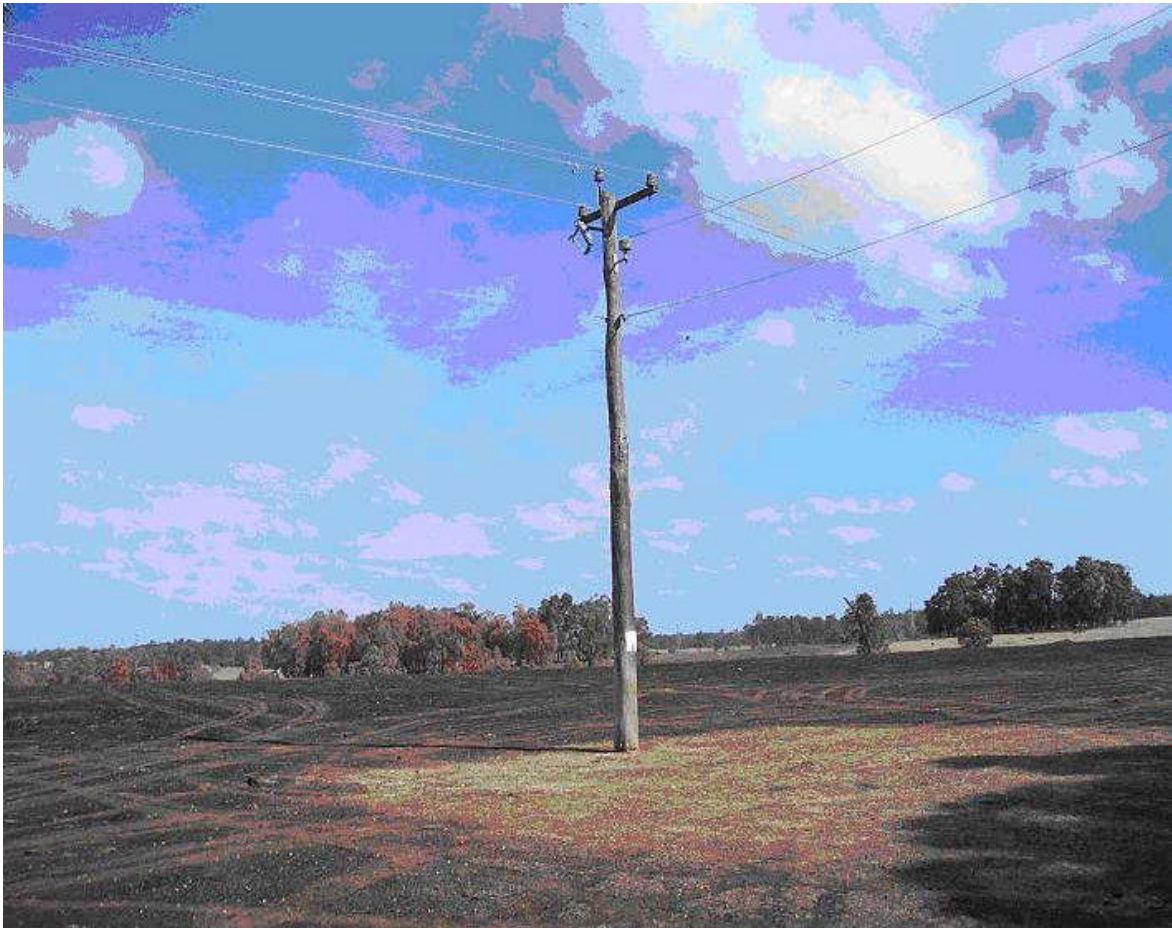
Both property owners identified the position of the fire in the same location, in the vicinity of the WPC power pole # WD62 / 33. It was therefore concluded that the fire started in a grazing paddock on the farm at Section 1127, McAvoy Road, Allanson WA, in the vicinity of WPC power pole # WD/62/33.

- There were no suspicious circumstances relating to the origin of the fire and no evidence of lightning in the area.
- Taking account of the burn pattern on the ground and the evidence from the two property owners, it is concluded that the fire originated in the dry pasture on the ground in the area adjacent to WPC's power pole # WD62 / 33.
- No evidence was found that indicated that Western Power's equipment was responsible for the ignition of the fire.
- The cause of the fire is undetermined.

**Fire Ignition Point Near Western Power Corporation's Power Pole # WD62/33**

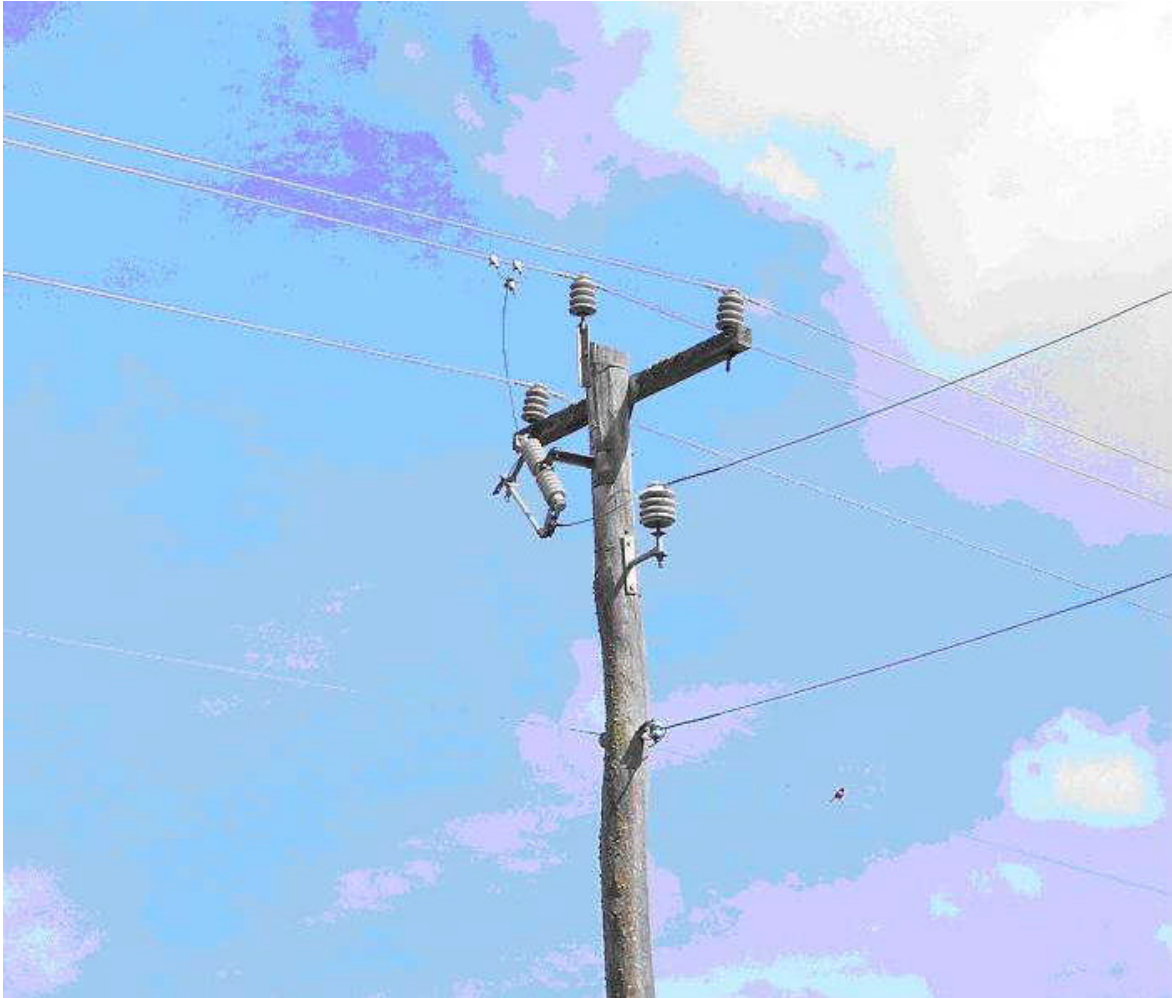
On Western Power's Pole # WD62 / 33 is mounted a high voltage expulsion drop out fuse (3 ampere) which protects the supply to a 10kva transformer supplying a single consumer. Western Power Corporation stated that this fuse did not operate.

- The high voltage expulsion drop out fuse, located in the vicinity of the ignition point of the fire, near pole #WD62 / 33 did not operate;
- The power-line conductors are in good condition;

**Western Power Corporation's Pole Top Hardware at Power Pole # WD62/33**
