## **ELECTRICAL INCIDENT REPORT**

**INVESTIGATION OF WILDFIRE  
ON 10 DECEMBER 2004  
AT LOCATION 1482  
SOUTH COAST HIGHWAY  
ESPERANCE WESTERN AUSTRALIA**

24 May 2005

2004-1370

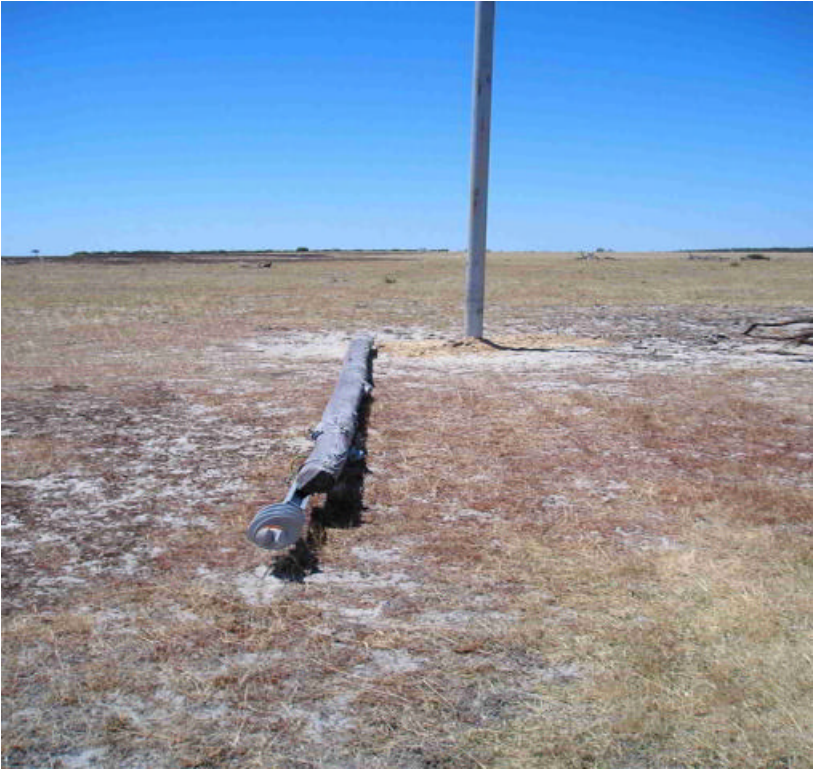
- Pole (D577/4 east) failed because the structural strength of the pole had deteriorated to a level where the pole was no longer able to perform its normal duties.

**Photograph of Fire Scene with the Replacement Steel Pole and Failed Wooden Pole (D577/4 east)**

1. Changes its wood pole inspection practices and procedures to ensure that the inspector who conducted the pole inspection can be clearly and positively identified;
2. Inspects all the poles in the rural area to the west of Esperance that were erected in 1985 or earlier to determine the remaining structural strength and factor of safety (FOS) of those poles;
3. Reinforces or replaces all poles that do not have a residual FOS of 2.0 in respect of the loads specified in ESAA C(b)1; and
4. Prepares a plan and program to manage this work.

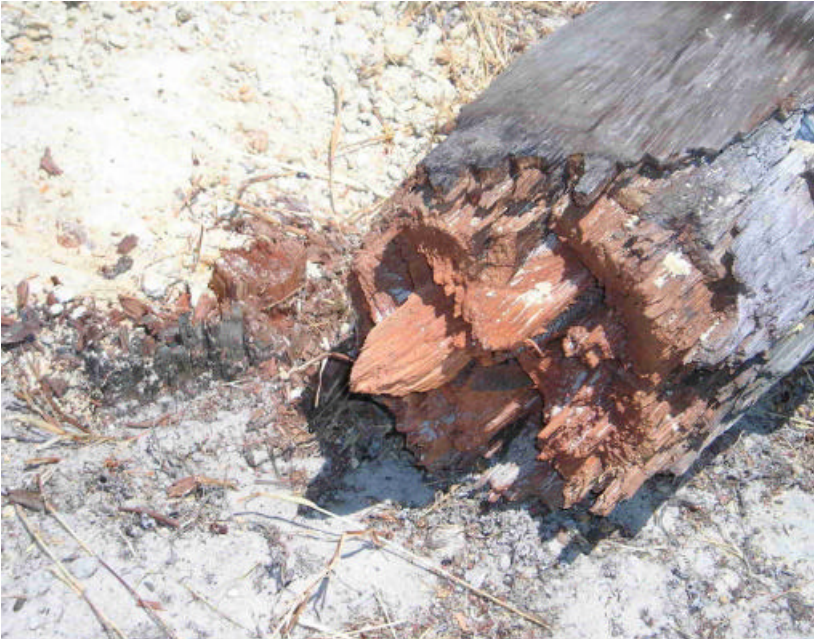
- It is considered this pole remained in this condition for eight days until the calf contacted the live conductor.
- Pole D577/4 east failed because the structural strength of the pole had deteriorated to a level where the pole was no longer able to perform its normal duties.

- The failed WPC pole (D577/4 east) was lying in a southerly direction toward a dead calf, which is consistent with the strong northerly winds associated with Thursday 2 December 2004 and not the southerly winds on the day of the fire.

**Photograph of the Failed Wooden Pole (D577/4 east)**

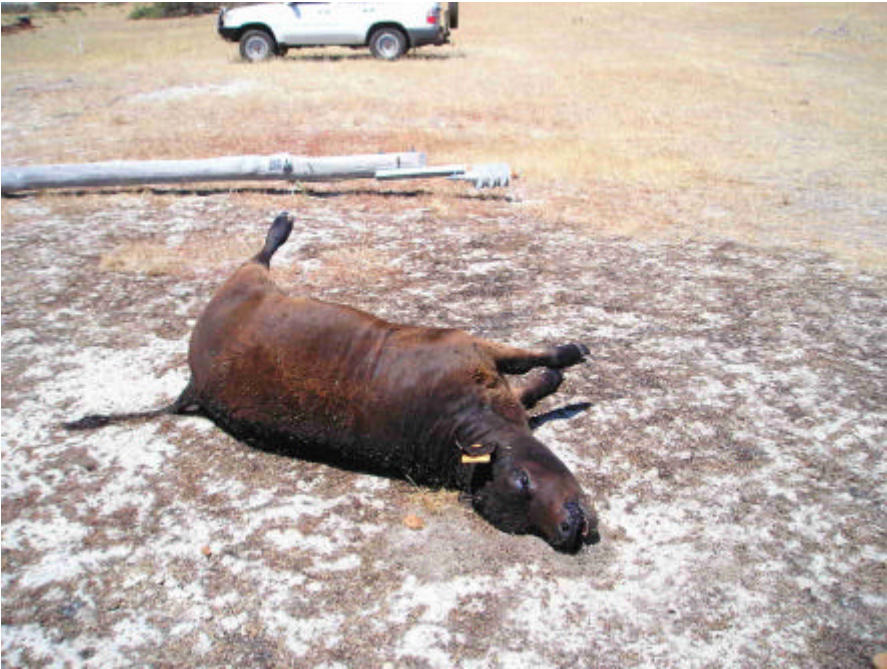
In summary, it was concluded that the fire was ignited when a calf came into contact with a 19.1 kV phase conductor connected to a failed WPC wood pole (D577/4 east) lying in an elevated position in a southerly direction [Photographs, Appendix A]

- WPC repair crew staff stated that they arrived at the scene of the fire on the afternoon of Friday 10 December 2004, to isolate the 'live' 19.1 kV powerline. The WPC crew advised that they found a dead calf between the active and running earth conductors about five metres west of the fallen WPC pole (D577/4 east). The crew also stated that the phase conductor and insulator, that was attached to the fallen pole, was suspended about one metre above the ground. The phase and earth conductors were both attached to the insulators still fixed to pole D577/4 east.

**Photograph of Fire Scene with Original Wood Pole (D577/4 east) and Dead Calf**

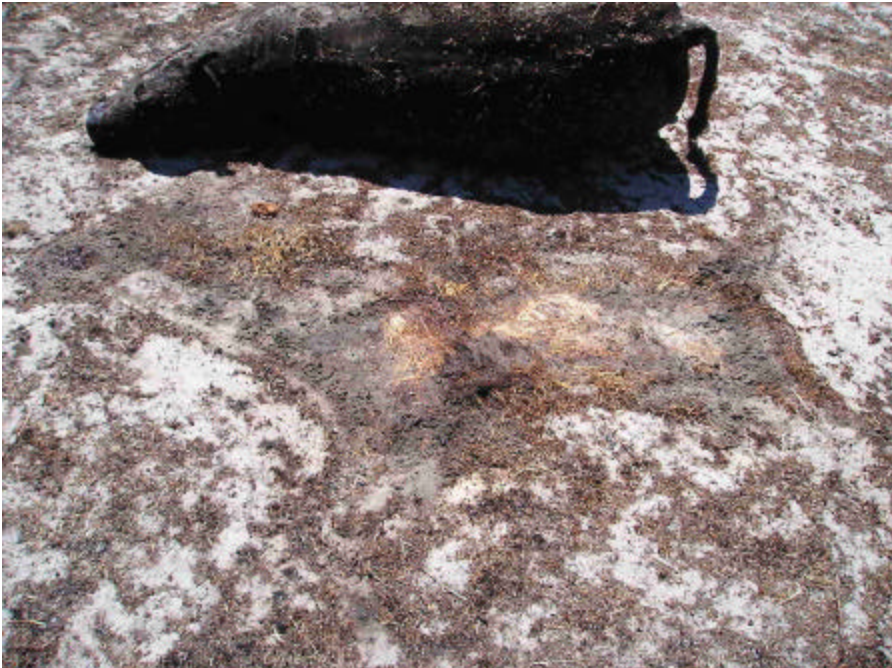
The dead calf had distinctive burn marks around the calf's facial area and there was unburnt paddock grass observed underneath the carcass [Photographs, Appendix A].

**Photograph of Fire Scene showing the Unburnt Area Under the Dead Calf**

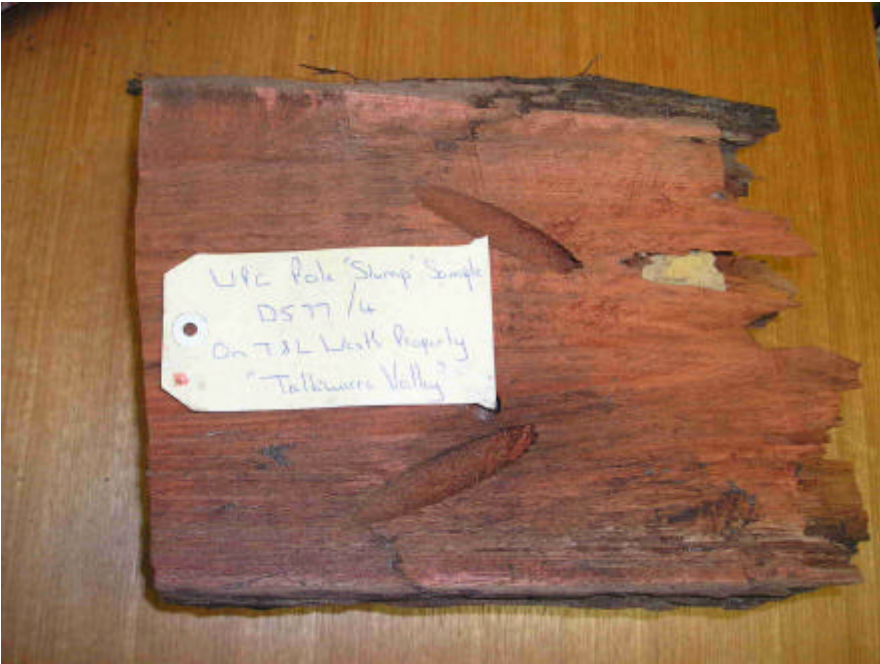
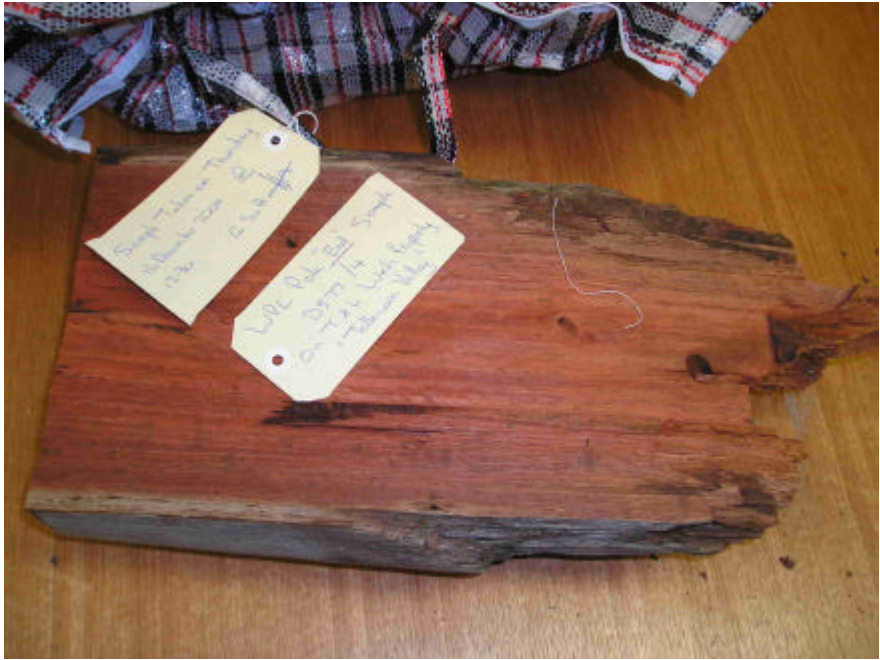
A newly installed pole would have a splintery fracture around the outer heartwood, although there will always be a brittle fracture in the inner heartwood. The photograph shows at the break that the outer heartwood also had the characteristic brittle fracture that occurs in an aging pole.

It should be taken into account that the stresses in the timber range from a maximum at the circumference to zero in the inner heart. When the outer heartwood becomes more brittle, the pole strength is reduced.

This section confirmed the assessment of the condition of the stump section, i.e. that the wood would have appeared sound at the time of the last inspection, although information of timing was not received. It was noted that the (non-durable) sapwood above the ground was in good condition apart from some developing white rot.

Overall it was considered that the cause of the pole failure was the increasing brittleness of the wood with increasing age and years in service. Jarrah is rated in Australian Standard AS5604-2003 'Timber – Natural durability ratings' as CSIRO Durability Class 2, i.e. the outer heartwood should give 15 to 25 years service in ground.

Photograph of WPC Pole (D577/4 east) Stump End and Pole End Samples
