## **ELECTRICAL INCIDENT REPORT**

**INVESTIGATION OF WILDFIRE  
ON 2 DECEMBER 2004  
AT LOCATION 1478  
SOUTH COAST HIGHWAY  
ESPERANCE WESTERN AUSTRALIA**

10 May 2005

2004-1367

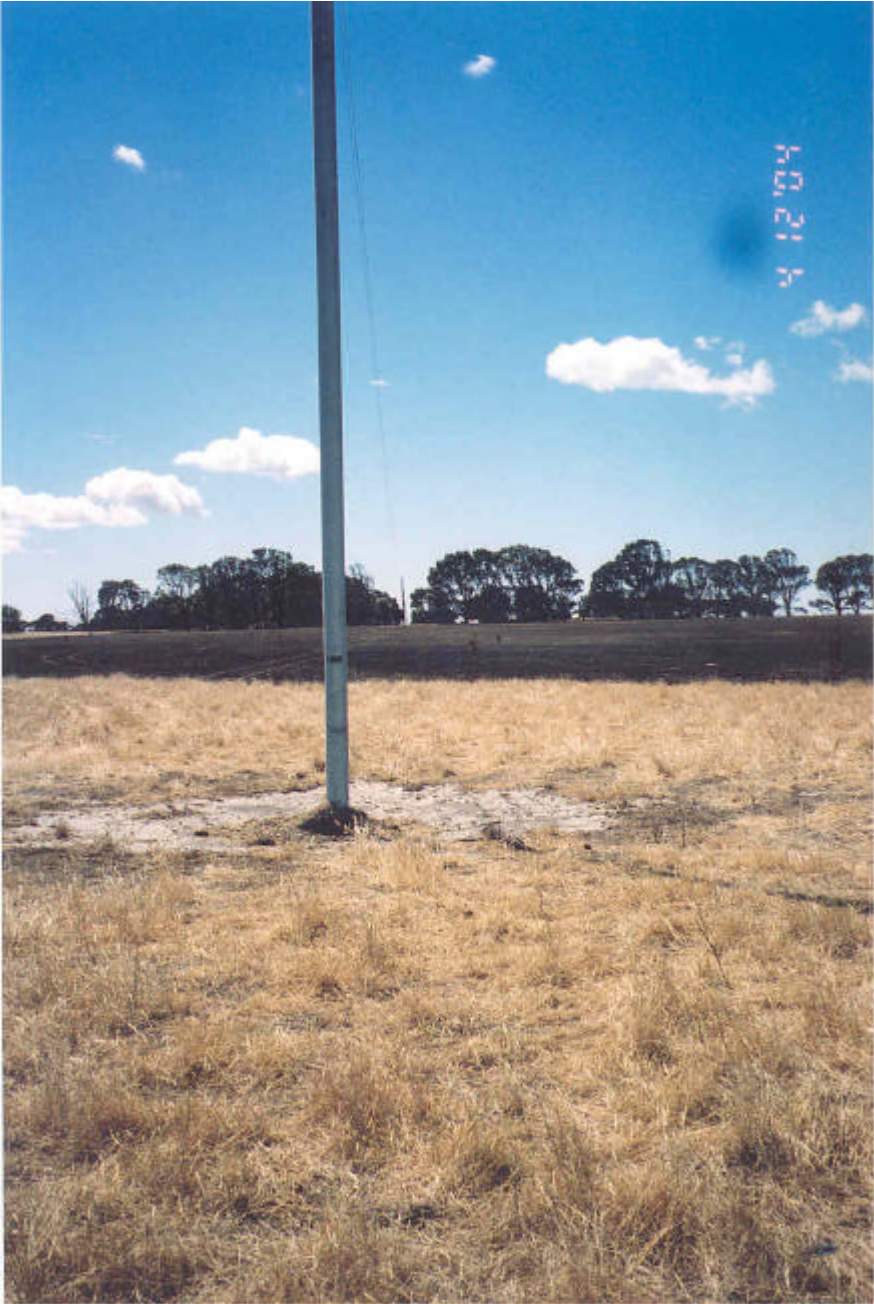
**Photograph of Fire Scene with the New Replacement Steel Pole (D595/8 south)**

The northerly most point of the wildfire was near where WPC wood pole (D595/8 south) failed. The origin of the fire was approximately 100 metres from the failed pole towards the next pole east, which is consistent with the 19.1 kV aerial phase and earth conductors clashing.

In summary, it was concluded that the fire was ignited when the 19.1 kV phase conductor clashed with the underslung running earth conductor when the WPC wood pole (D595/8 south) failed and fell over in a south easterly direction [Photographs, Appendix A].

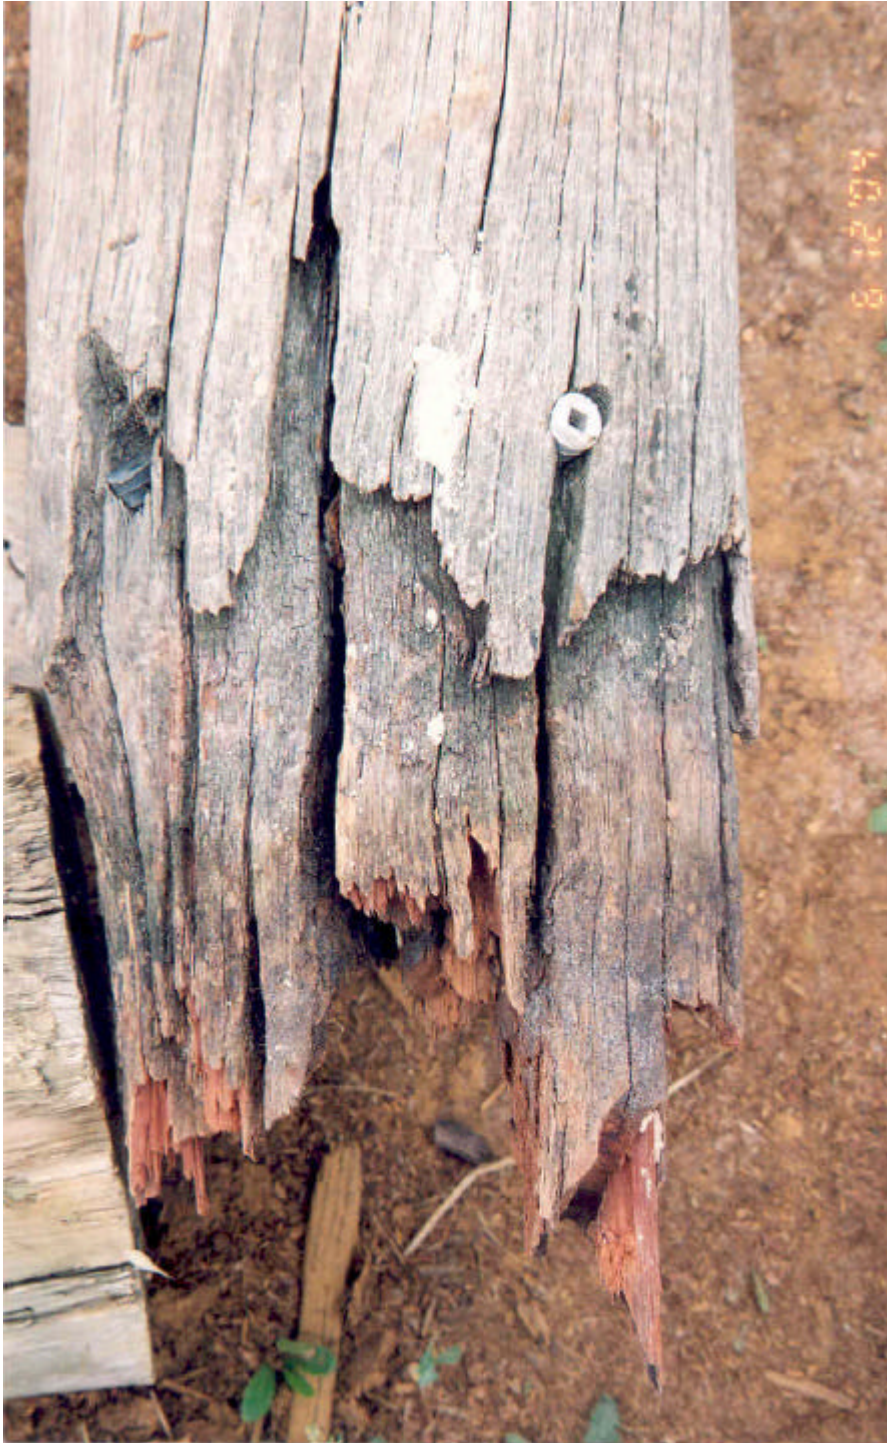
**Photograph of Broken End of Pole D595/8 South**

Overall it was considered that the cause of the pole failure was the increasing brittleness of the wood with increasing age and years in service. Jarrah is rated in Australian Standard AS5604-2003 'Timber – Natural durability ratings' as CSIRO Durability Class 2, i.e. the outer heartwood should give 15 to 25 years service in ground.

- Pole (D595/8 south) failed because the structural strength of the pole had deteriorated to a level where the pole was no longer able to perform its normal duties.

1. Changes its wood pole inspection practices and procedures to ensure that the inspector who conducted the pole inspection can be clearly and positively identified;
2. Inspects all the poles in the rural area to the west of Esperance that were erected in 1985 or earlier to determine the remaining structural strength and factor of safety (FOS) of those poles;
3. Reinforces or replaces all poles that do not have a residual FOS of 2.0 in respect of the loads specified in ESAA C(b)1; and
4. Prepares a plan and program to manage this work.

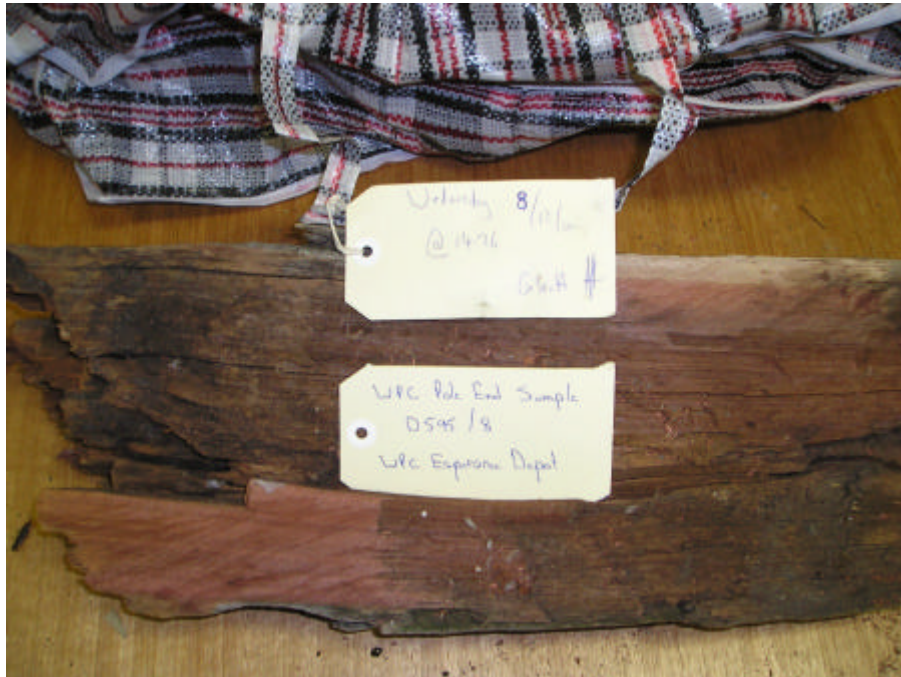
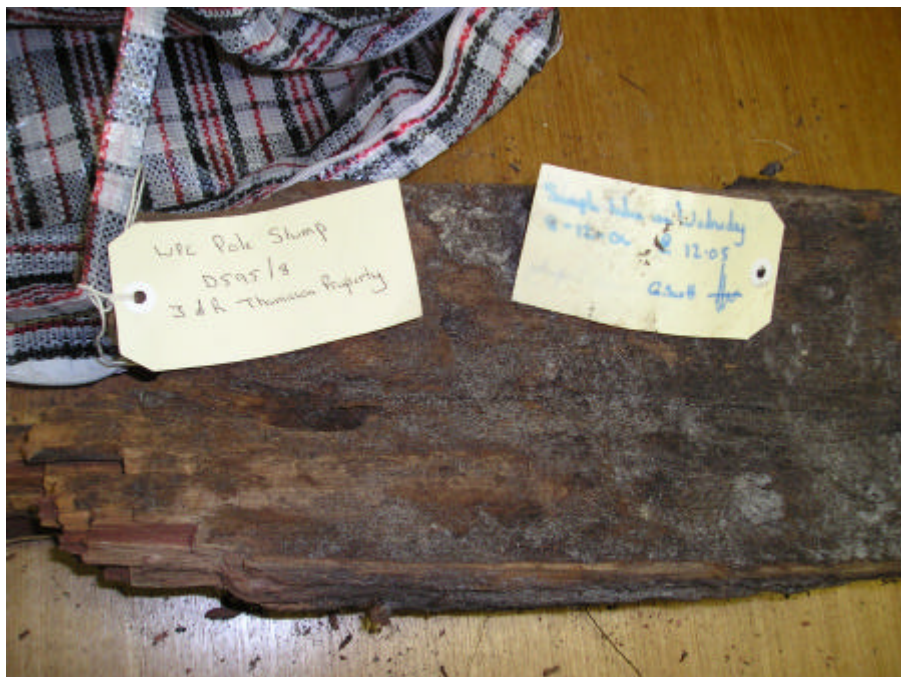
Photograph of WPC Pole (D595/8 south) Stump End and Pole End Samples

The pole was split below the ground line and there was 2-3mm of rot on the weathered surface that would have little effect on overall strength. As expected, the centre of the pole had a brittle heart. There was decaying sapwood below the ground line. Overall the wood appeared to be sound.

There was some splintery fracture around the circumference, and the brittle inner heartwood. Residual sapwood above the ground was in good condition. Drill holes were through sound wood, and the sapwood above the ground line was sound.

- Scientific testing of the pole sample stump and pole end by the Forest Products Commission indicated that the samples showed signs of brittleness due to age.
