ELECTRICAL INCIDENT REPORT

**INVESTIGATION OF WILDFIRE
ON 14 DECEMBER 2004
AT LOT 2 LOCATION 1039
MOONUP ROAD
ESPERANCE WESTERN AUSTRALIA**

25 May 2005

2004-1405

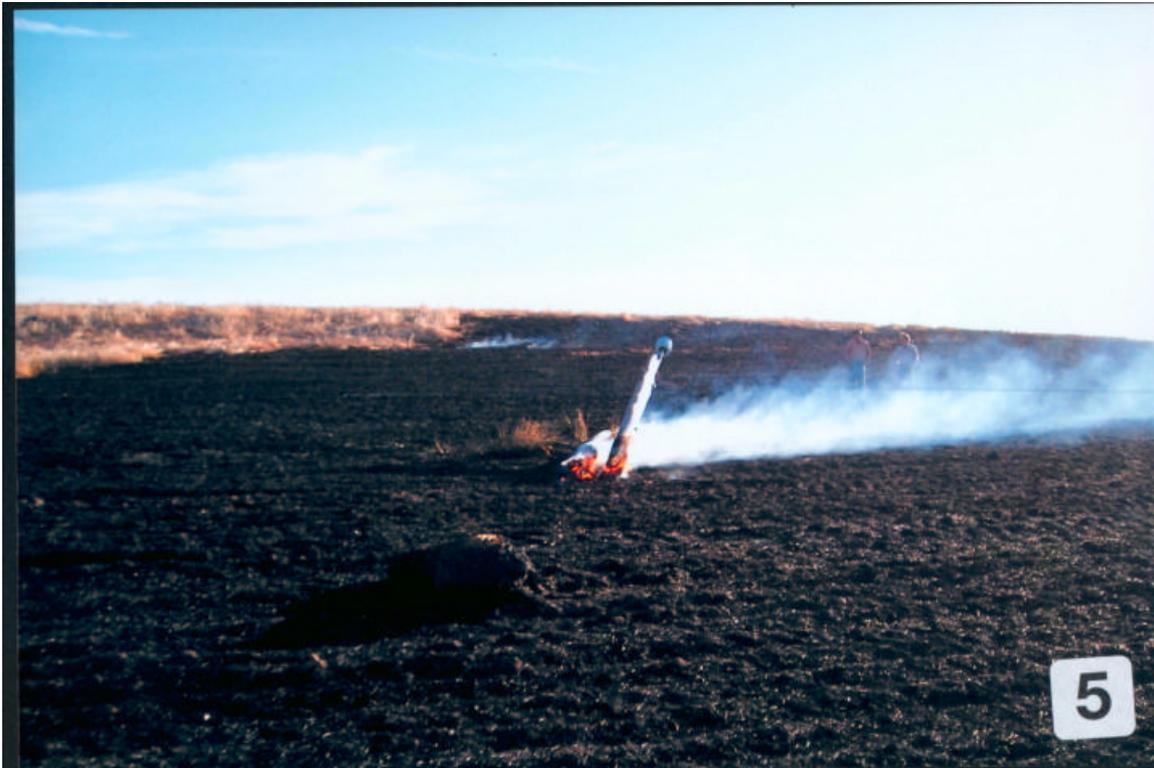
- On the 14 December 2004 a sheep came in contact with a 19.1 kV phase conductor, at or near ground level, resulting in the electrocution (death) of the sheep. The heat generated from the current flow through the sheep ignited the dry harvested stubble commencing the wildfire [Photographs, Appendix A].

- At 17.00 hrs on Tuesday 14 December 2004 the WPC pole (D318/35/10/8) was found lying on the ground in north/westerly direction with the insulator end approximately one metre above the ground. The phase and earth conductors were both attached to the insulators and still fixed to pole D318/35/10/8. The pole was lying in the direction of a dead sheep and the base of the pole was on fire [Photographs, Appendix A].

Photograph Showing WPC Wood Pole D318/35/10/8 and the Deed Sheep

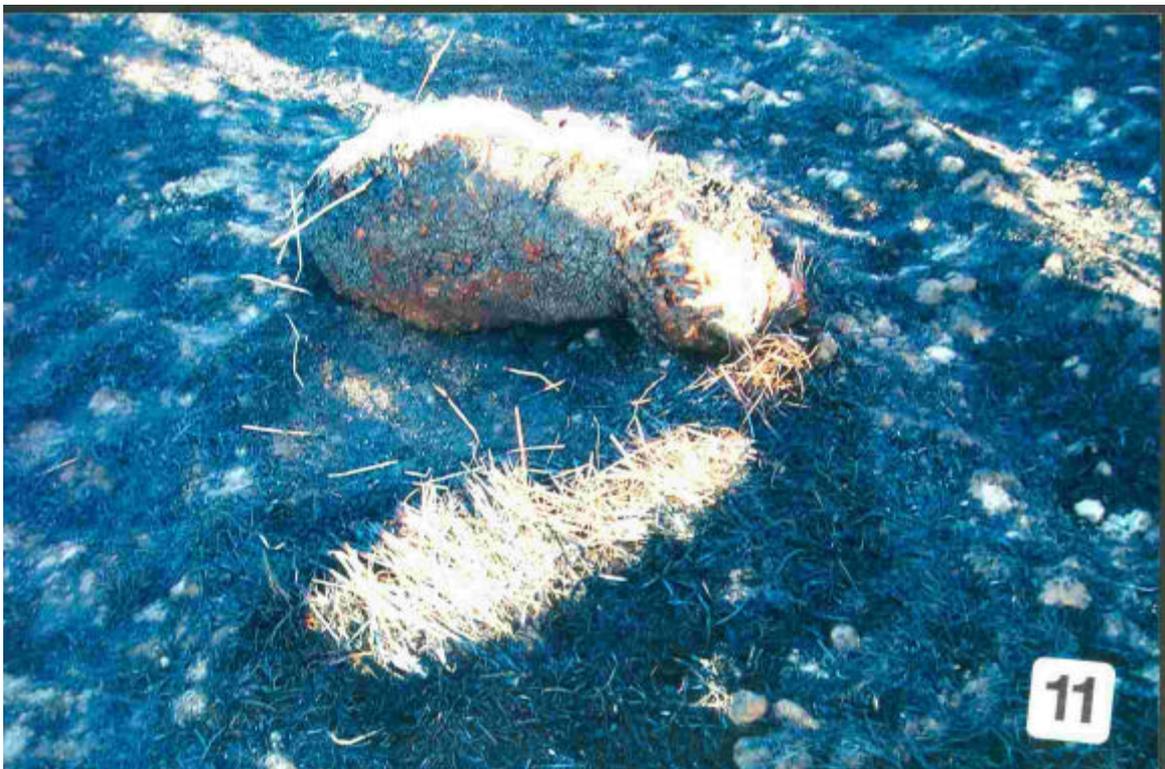
Photograph of the Deed Sheep

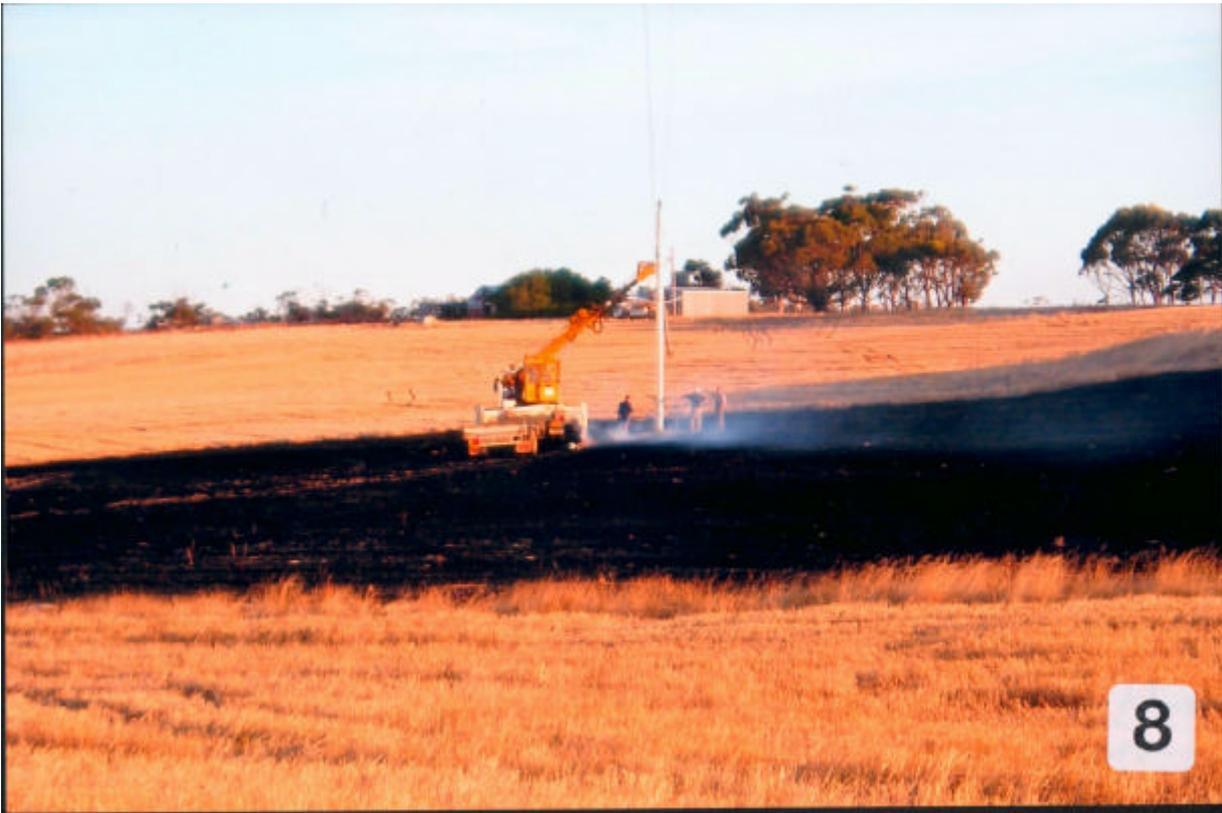
Photograph Showing the New Replacement Steel Pole (D318/35/10/8)

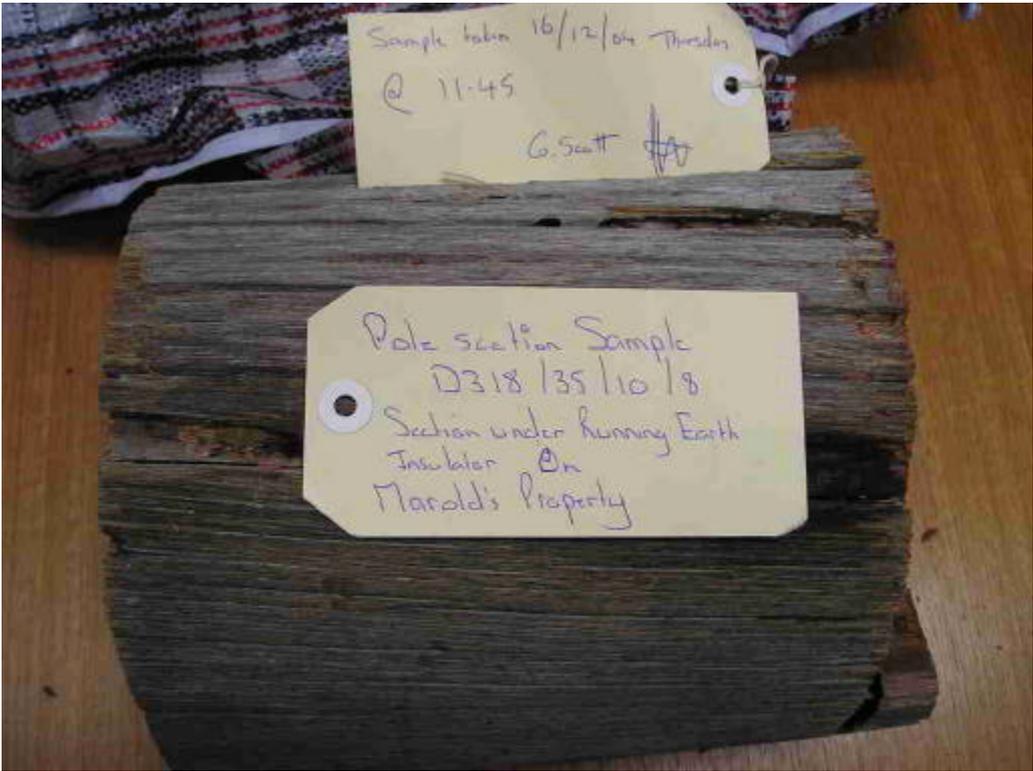
There was white rot developing in the sapwood, but overall the heartwood was in very good condition.

Consistent with the other pole failures in this region it was considered that the cause of the pole failure was the increasing brittleness of the wood with increasing age and years in service. Jarrah is rated in Australian Standard AS5604-2003 'Timber – Natural durability ratings' as CSIRO Durability Class 2, i.e. the outer heartwood should give 15 to 25 years service in ground.

Photograph of the Sample Taken from Pole D318/35/10/8

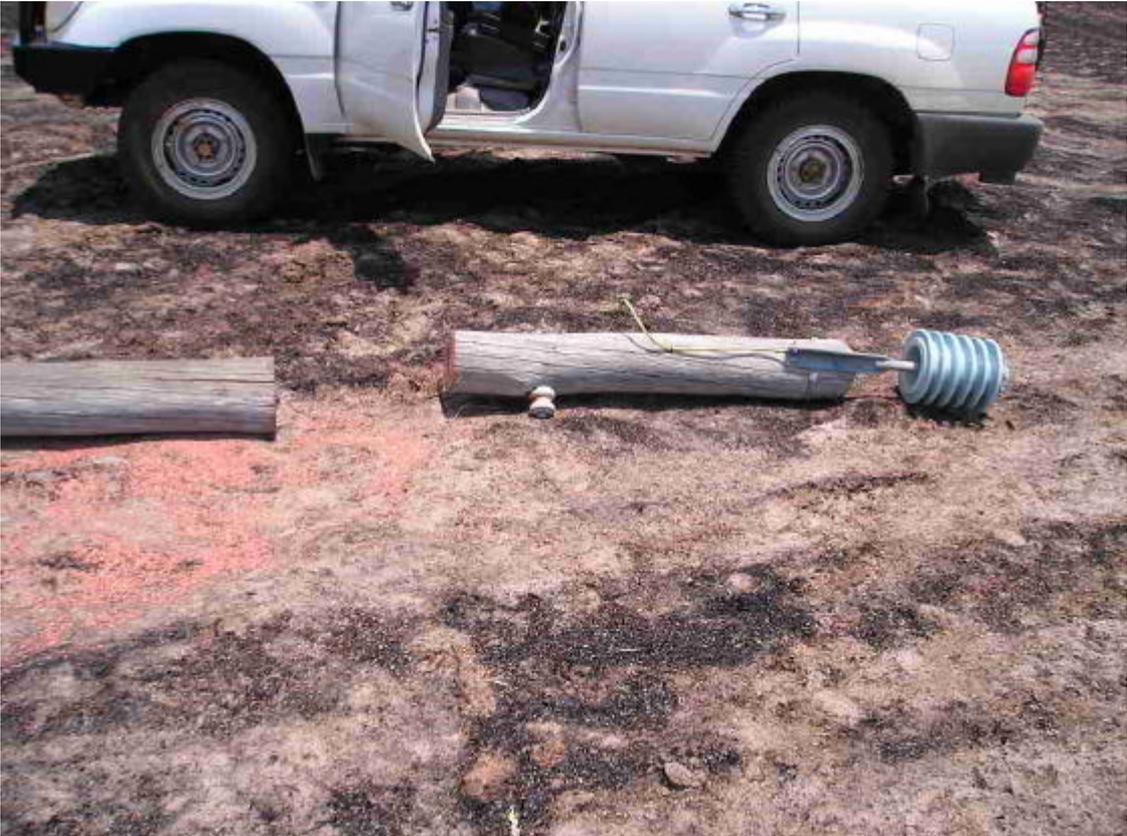
- The broken pole end and stump from pole D318/325/10/8 was entirely burnt out. Therefore a cross section (sample) of the pole, just under the running earth insulator was removed for scientific testing by the Forest Products Commission.

Photograph of the Pole D318/35/10/8 Showing where the Sample was Taken
