**Energy Safety Division**

## **ELECTRICAL INCIDENT REPORT**

### **POWER LINE FAULT & BUSH FIRE AT TENTERDEN, WESTERN AUSTRALIA ON 27 DECEMBER 2003**

16 January 2004

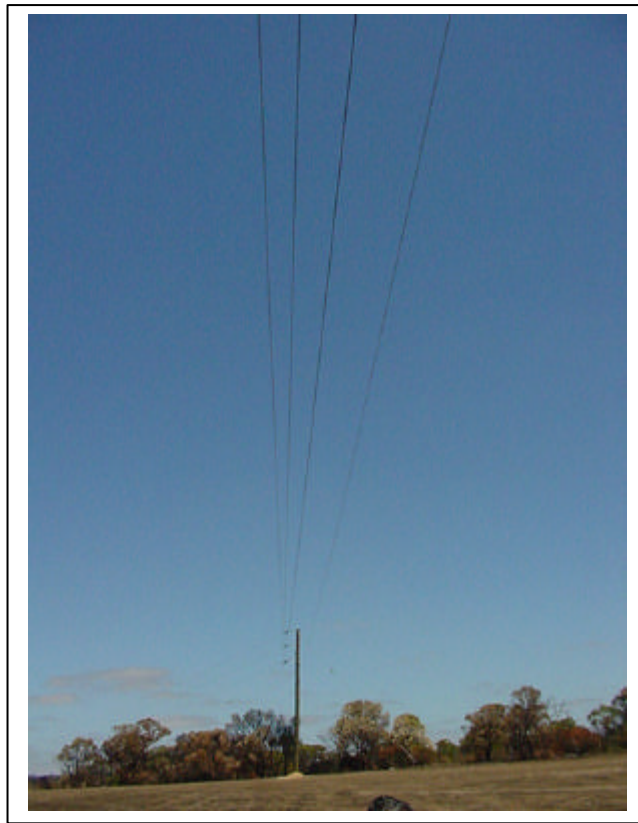
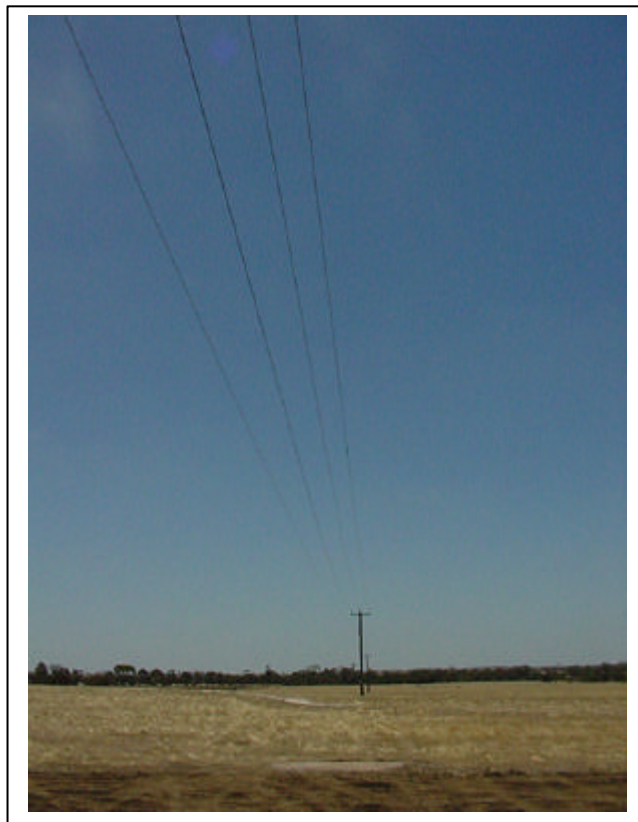
**APPENDIX 3 STRUCTURE OF THE OVERHEAD LINE**

There was evidence of damage to the overhead line conductors between poles 721 and 722 on the feeder. The damage consisted of electric arc burn marks on the aluminium of the conductor on the centre phase and on the underslung earth wire, subsequently broken, immediately below it. Damage to the poles themselves in the vicinity (including a fire in the top of pole 721) is considered to have most likely resulted as a consequence of sparks produced by the ground fire rather than being the source of ignition of the ground fire. This is because no reason for electrically caused “pole top fire” could be identified.

- The weather conditions at the time of the fire were hot and dry with a very low relative humidity and strong gusting winds from the North.
- The spans of conductor on the overhead power line, which at 187 metres are long, could have resulted in erratic movement (galloping) of conductors and this is highly probable due to the adverse wind, exposed terrain with a gentle rise and conductor sag conditions.

- The safe clearance of live conductors can be compromised by excessive sag of the wire between the supporting poles, usually in combination with erratic conductor movement. Such a situation would be exacerbated by high ambient air temperatures and the use of steel as an underslung earth conductor below an aluminium and steel current carrying conductor that has a greater coefficient of expansion than steel alone and sags more as a consequence. This is the scenario relevant to the 22 kV line in question.

It should be noted that a similar incident and ground fire occurred in this area, on the same 22kV feeder and not far from this recent fault, on 28 December 2000. As a follow up to Energy Safety’s investigation of that incident, Energy Safety requested Western Power to survey its overhead lines in the area and to take remedial action to prevent future conductor clashing, such as by installing poles in the middle of very long spans.
