ELECTRICAL INCIDENT REPORT

POWER LINE FAULT AND WILDFIRE NEAR CHATCUP ROAD TOODYAY WESTERN AUSTRALIA ON 3 FEBRUARY 2007

7 February 2007

EIS 2007-115

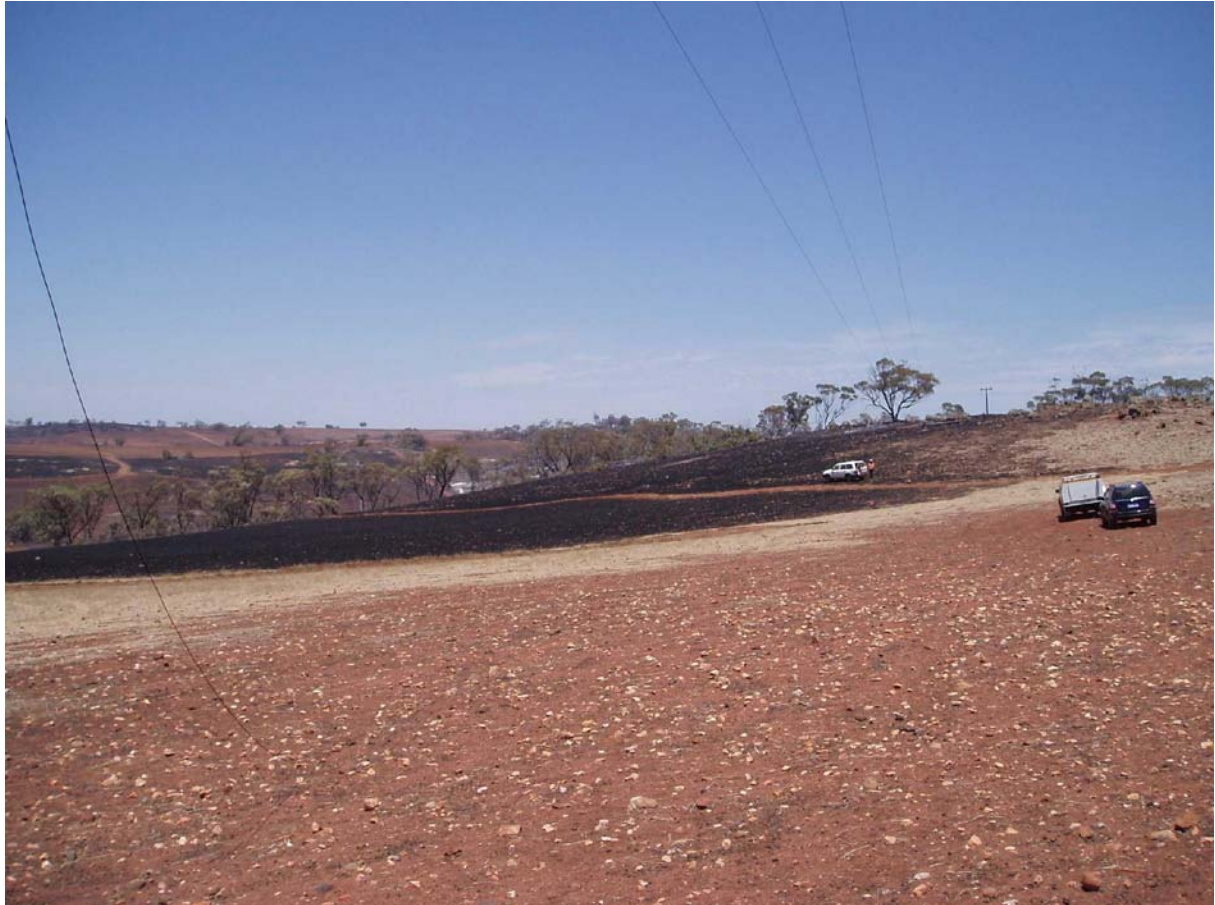
The FESA investigator estimated that the wildfire's point of ignition was on the ground in a paddock southwest of the Bindi Bindi -Toodyay Road between Church Gully and Chatcup Roads approximately 12 kilometres North of Toodyay.

An inspection of the ignition point indicated that a large area of grass paddock had burnt out adjacent to the Western Power 22 kV overhead power line. The wildfire had continued in a South Easterly direction, which is consistent with the wildfire being driven forward from the point of ignition by wind coming from the North West.

Photograph No 1: - Origin of wildfire

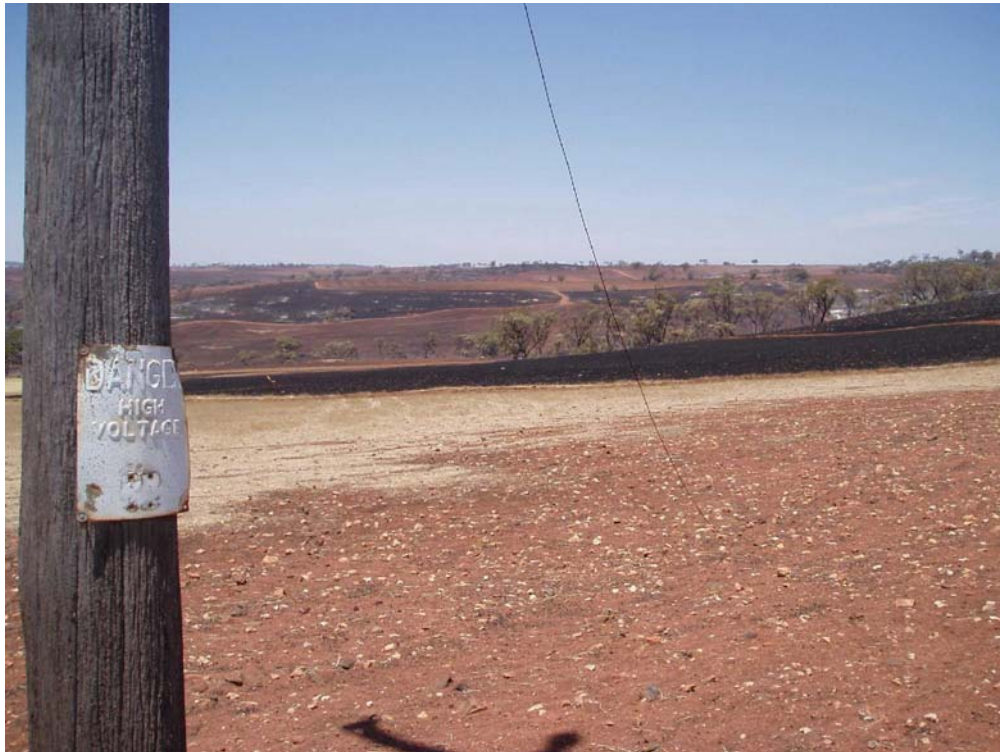
Inspection of the power line found evidence of damage to the overhead power line conductors between poles number 97 and number 98 on the Northam to Bolgart 22 kV Feeder (535.0). The damage consisted of electric arc burn marks on the outer steel cored aluminium conductor (red phase) and on the underslung earth conductor near and at the point where it was subsequently broken. This was immediately below the damage to the red phase conductor.

For example, the earth conductor exhibited damage at the break point that is consistent with electrical arcing between it and another conductor and there was evidence of multiple burn marks on the phase conductor.

Photograph No 2: - Pole 98 - Broken earth conductor

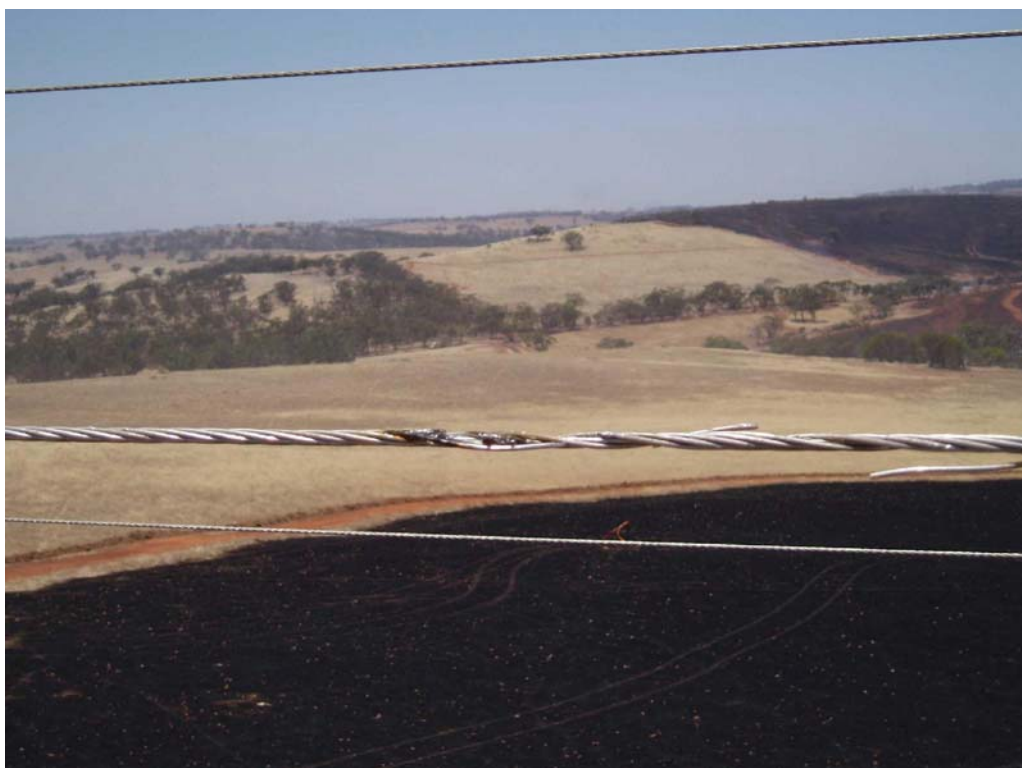
Notwithstanding the use of this type of construction, it is concluded that the red phase conductor and the underslung earth conductor made direct contact with each other in the strong gusting wind and high ambient air temperature.

Photograph No 3: - Contact marks and metal globules on the red phase conductor

- It is clear that significant further engineering investigation will be required by Western Power, in conjunction with EnergySafety, to deal with the above question and to assess whether this was an isolated problem, or whether it is an indication of a more systemic problem, and the type and extent of corrective action required.

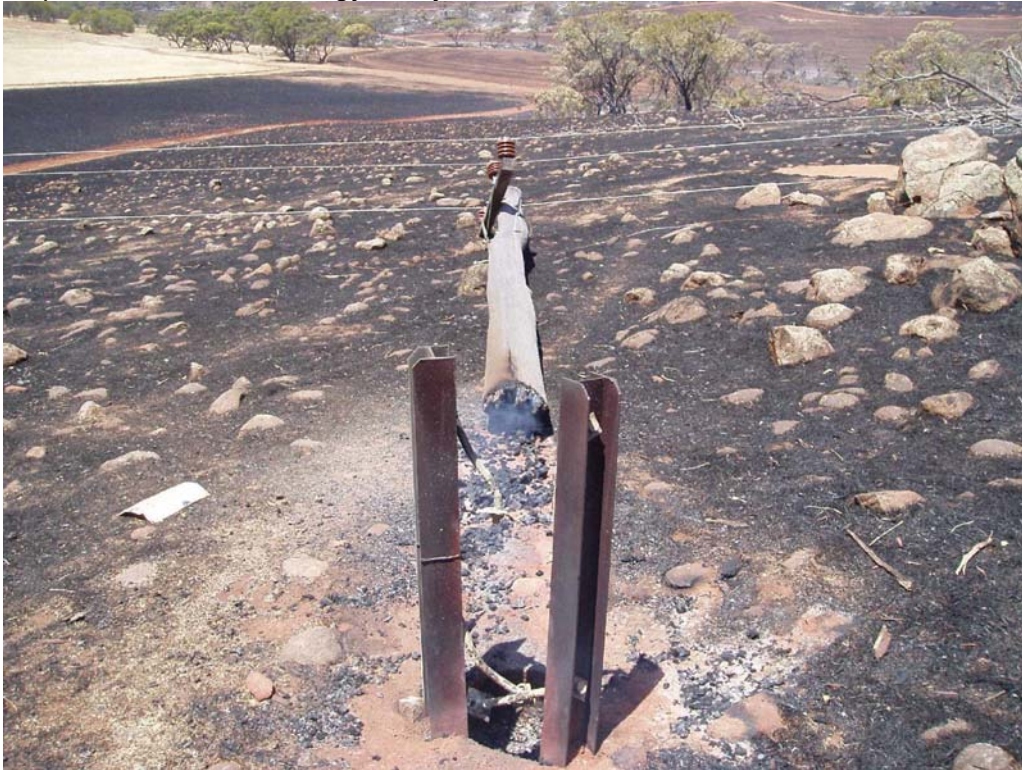
Pole number 97 was damaged by the wildfire on the 3 February 2007, causing it to fall towards the ground. The damaged power line was still live when discovered and the conductors remained suspended above ground by the crossarm. There was no evidence of a pole top fire, the pole base was burnt from the fire further suggesting it did not contribute to the point of ignition.

Photograph No 4: - Pole 97 - Damaged by fire

Western Power staff became aware of the damaged pole and replaced the pole on 4 February 2007.

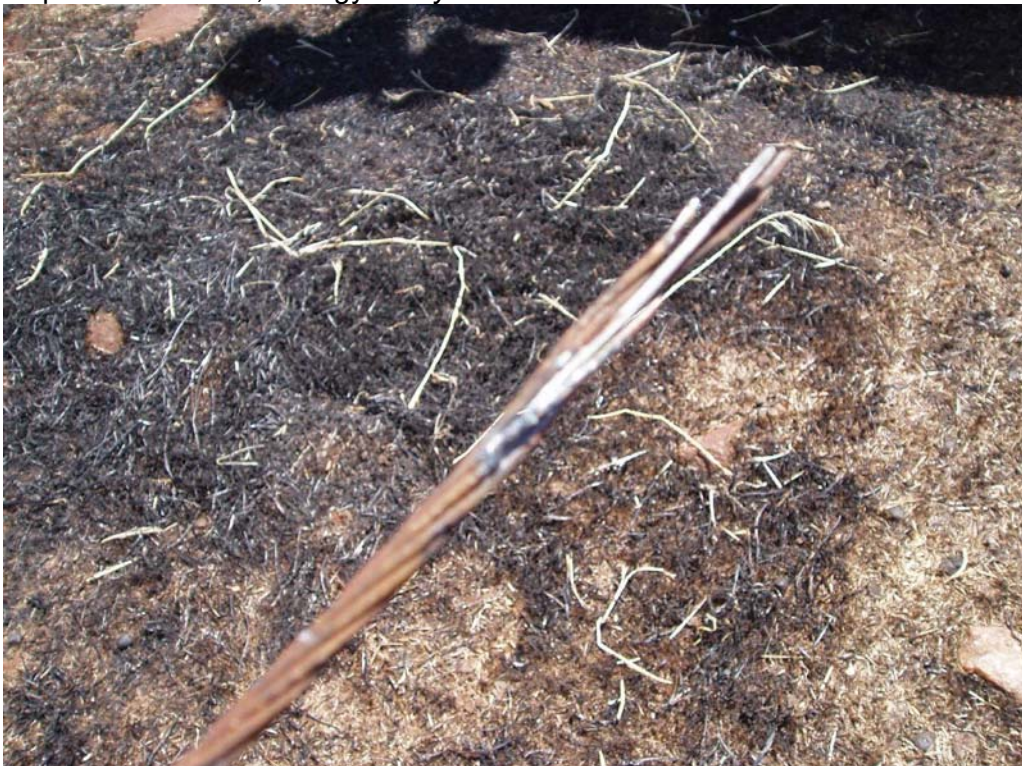
- The wildfire resulted from the ignition of the dry stubble on the ground due to hot metal globules falling from a 22 kV conductor clashing with an underslung earth conductor on the Western Power Northam to Bolgart overhead power line (Feeder 535.0), between poles number 97 and number 98.

Photograph No 5: - Contact marks and metal globules on the broken earth conductor
