ELECTRICAL INCIDENT REPORT

**INVESTIGATION OF WILDFIRE
ON 15 DECEMBER 2004
AT LOCATION 1434 WEST ESPERANCE
WESTERN AUSTRALIA**

4 October 2005

2004-1406

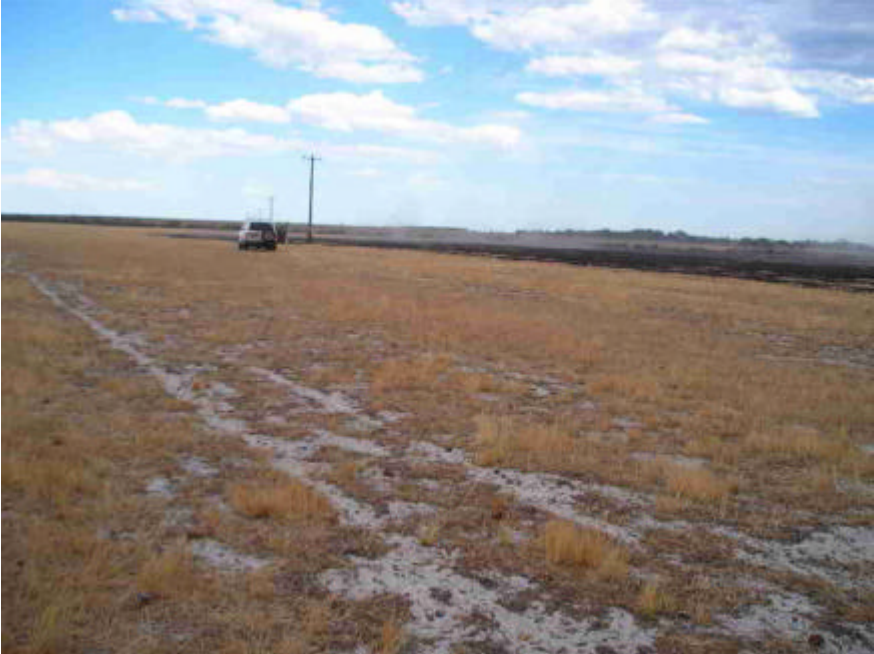
Photograph number 1: View of the Fire Scene looking toward WPC Pole D292

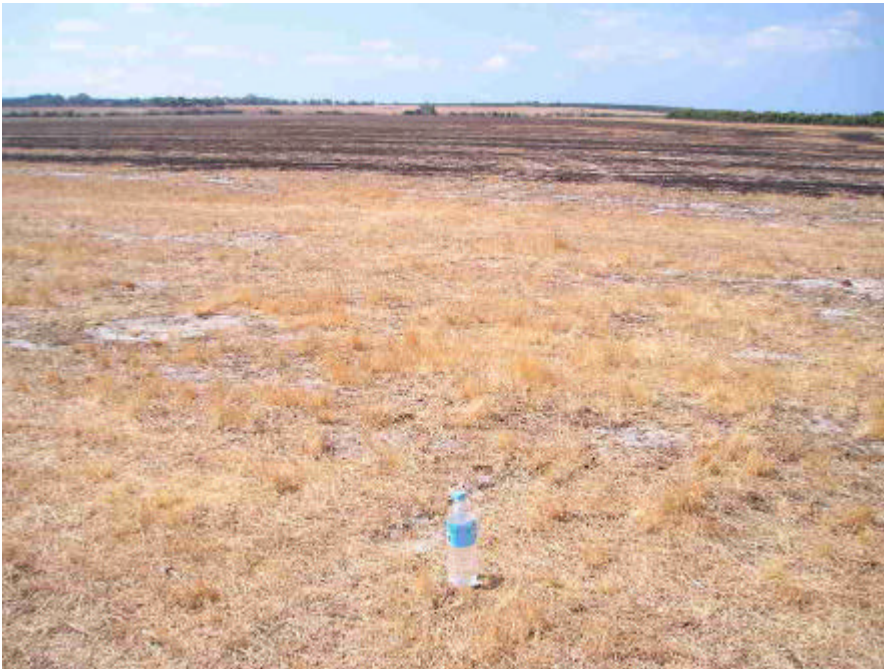
Photograph number 2: View of the fire scene looking south

The bottle is situated directly under the point where the conductors clashed on the powerline.

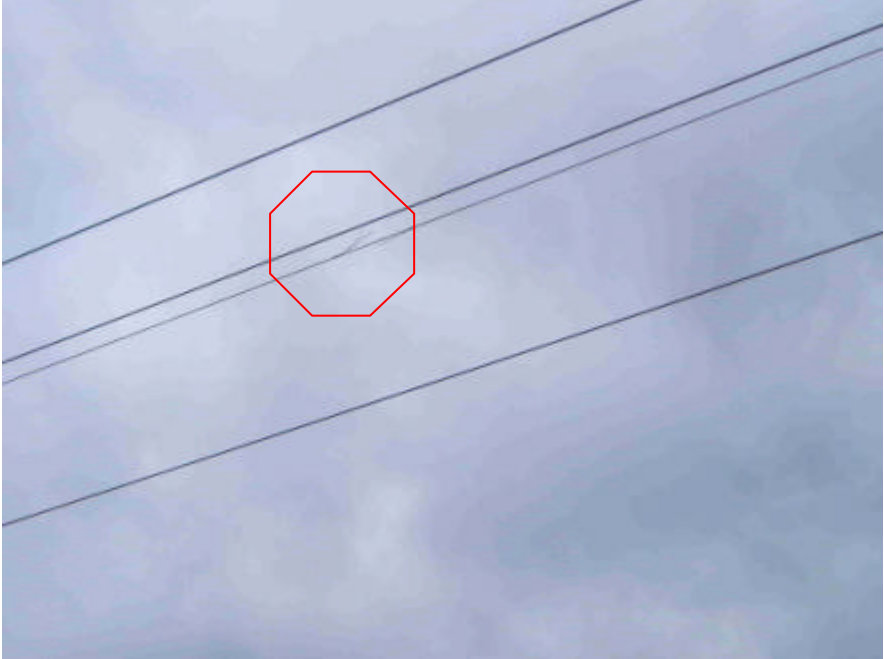
The broken ends of the earth conductor sample showed signs that they had melted, which is consistent with what would be expected from arcing or resistive heating. There was no significant Aluminium deposit on this sample.

Photograph number 3: Damaged underslung earth conductor

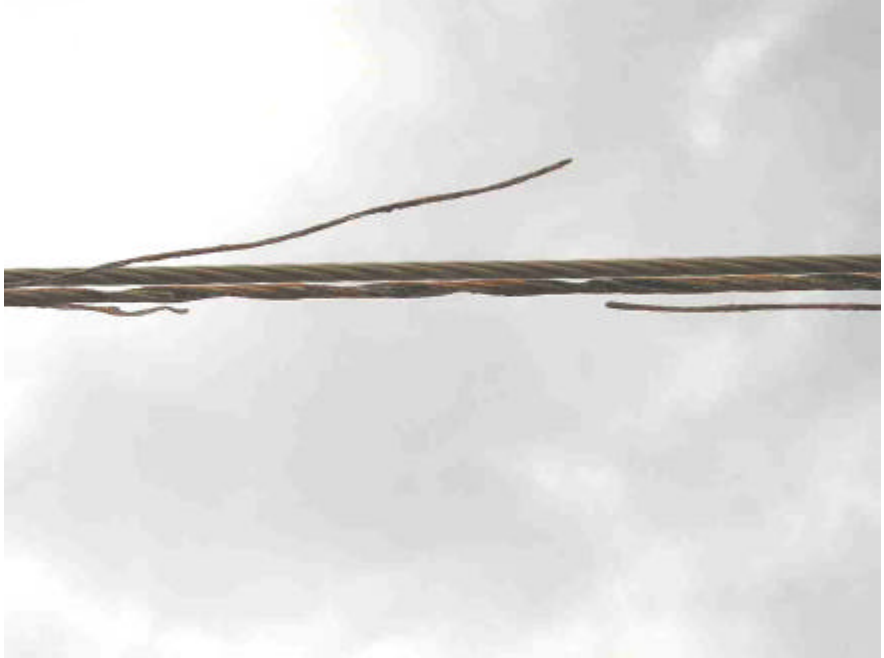
Photograph number 4: Damaged underslung earth conductor

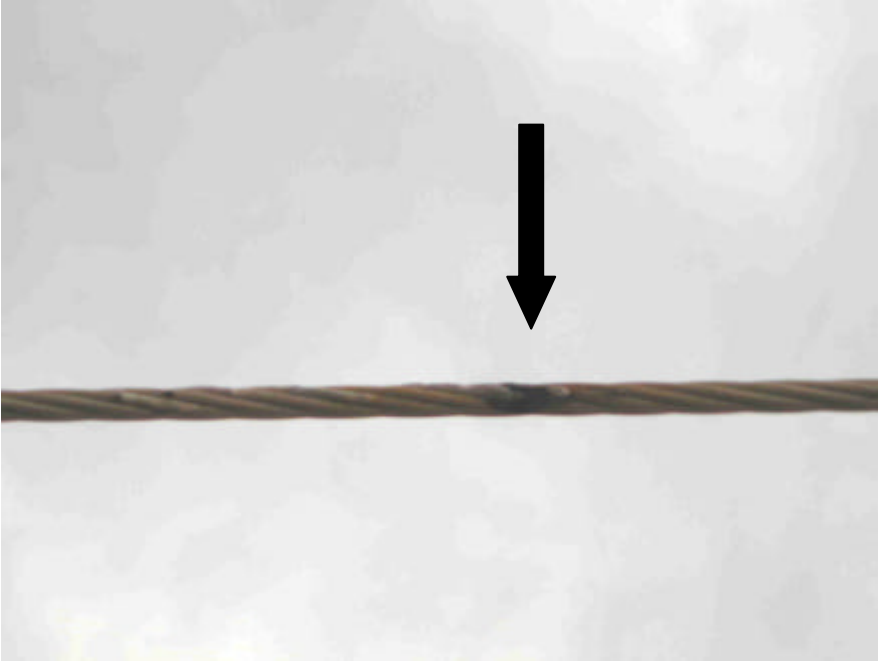
The red phase conductor sample had no signs of Steel or Zinc contamination.

- It is concluded that the red phase conductor flashed over to the blue phase conductor without making contact after the blue phase conductor came into contact with the earth conductor. This is deduced because no zinc or steel trace was found on the red phase conductor but arc burn marks were evident.

Photograph number 5: Burn mark on the red phase conductor

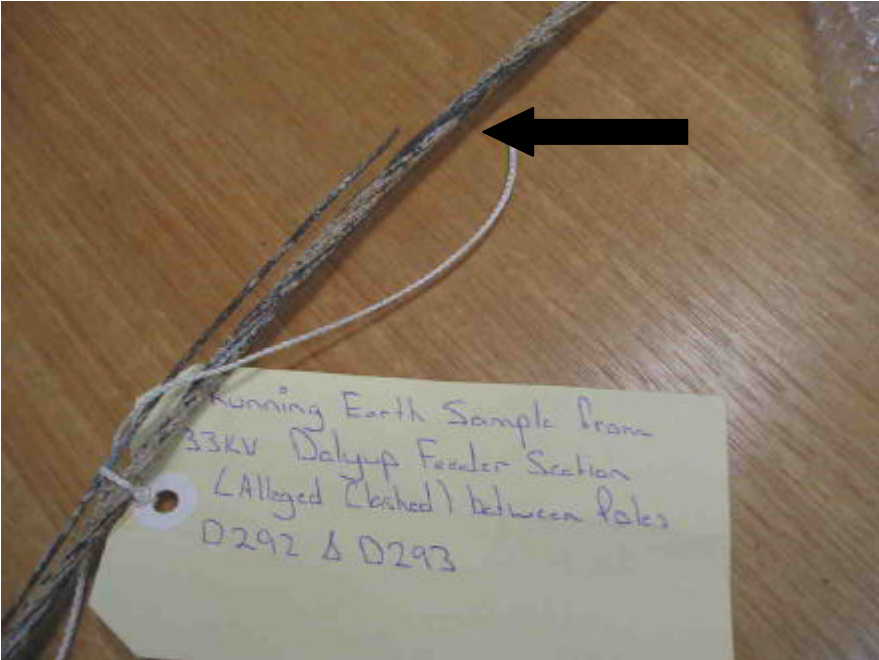
Photograph number 6: Contact marks on the underslung earth conductor

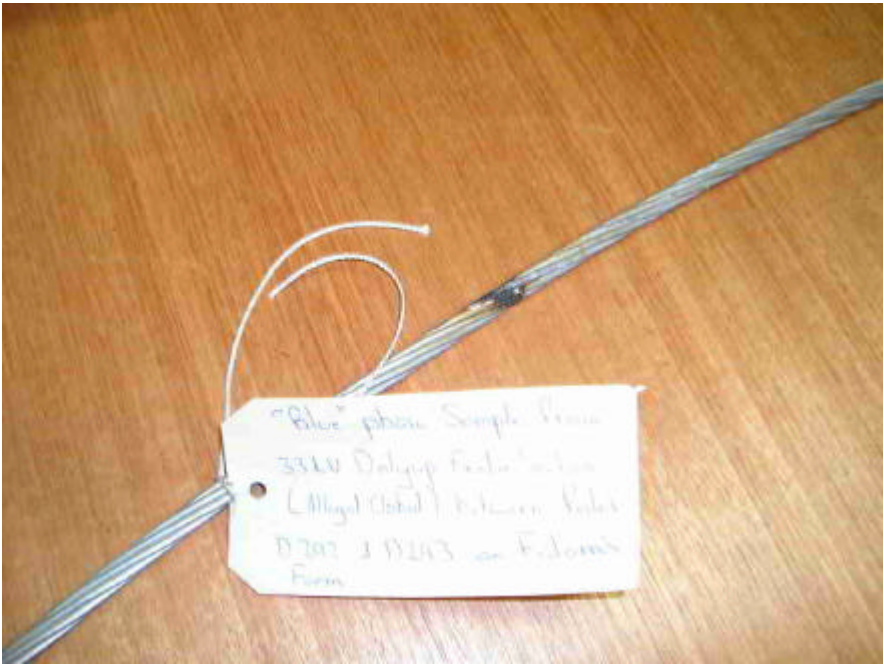
The blue phase conductor has high levels of Zinc (Zn) and Steel (Fe) around the discoloured area. This area also has a texture consistent with the evaporative/sputter coating produced due to arcing. Some areas show clear signs of molten steel-zinc impacting on the aluminium conductor sample and then solidifying.

Photograph number 7: Burn marks on the blue phase conductor

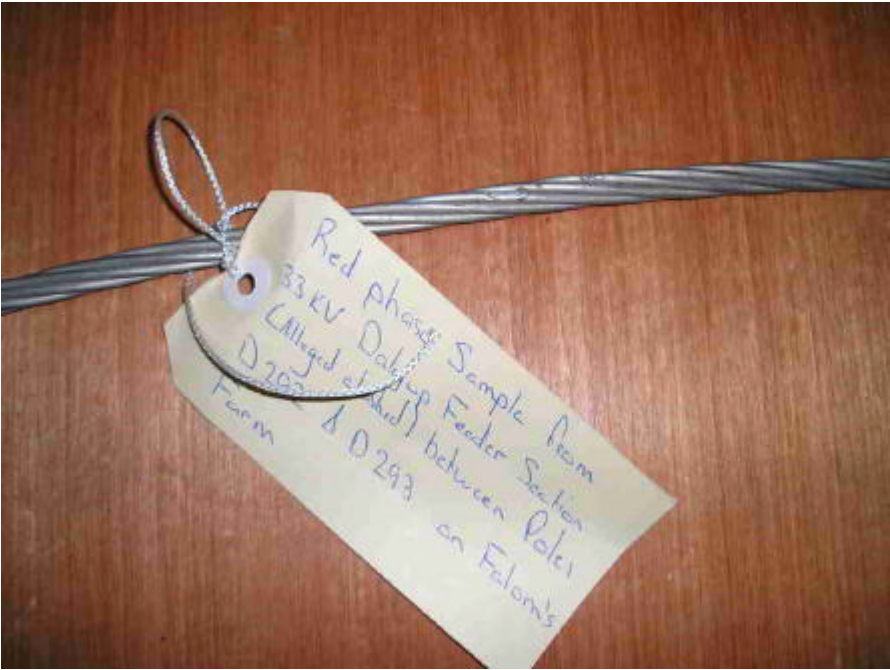
Photograph number 8: Burn marks on the red phase conductor
