# Subfloor ventilation: suspended concrete slabs

**The purpose of this industry bulletin is to remind industry that ground moisture must be considered in the design and construction of suspended concrete slabs of a building, to ensure the performance requirements of the Building Code of Australia (BCA) are met.**

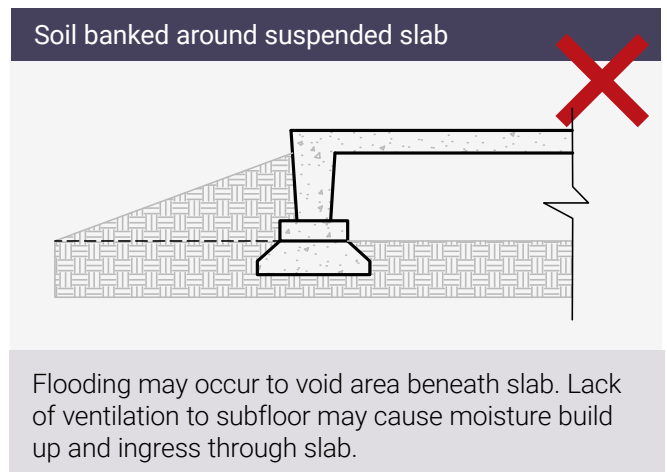
- The practice of placing transportable buildings (that include suspended concrete slabs) close to ground level.

- Where the transportable building is placed on existing ground level, the practice of banking fill around the building effectively encloses the subfloor.

Both these practices as illustrated block the ability to provide adequate ventilation.

Our investigations have shown that these practices have led to undue dampness from the ground which indicates a non-compliance with the Performance Requirement.

Enclosing the subfloor may lead to it being flooded and increases the risk of moisture ingress through the slab.
