ELECTRICAL INCIDENT REPORT

POWER LINE FAULT AND BUSH FIRE NEAR BRINDLE ROAD, PARKERVILLE WESTERN AUSTRALIA ON 3 JANUARY 2008

11 January 2008

EIS 2008-17

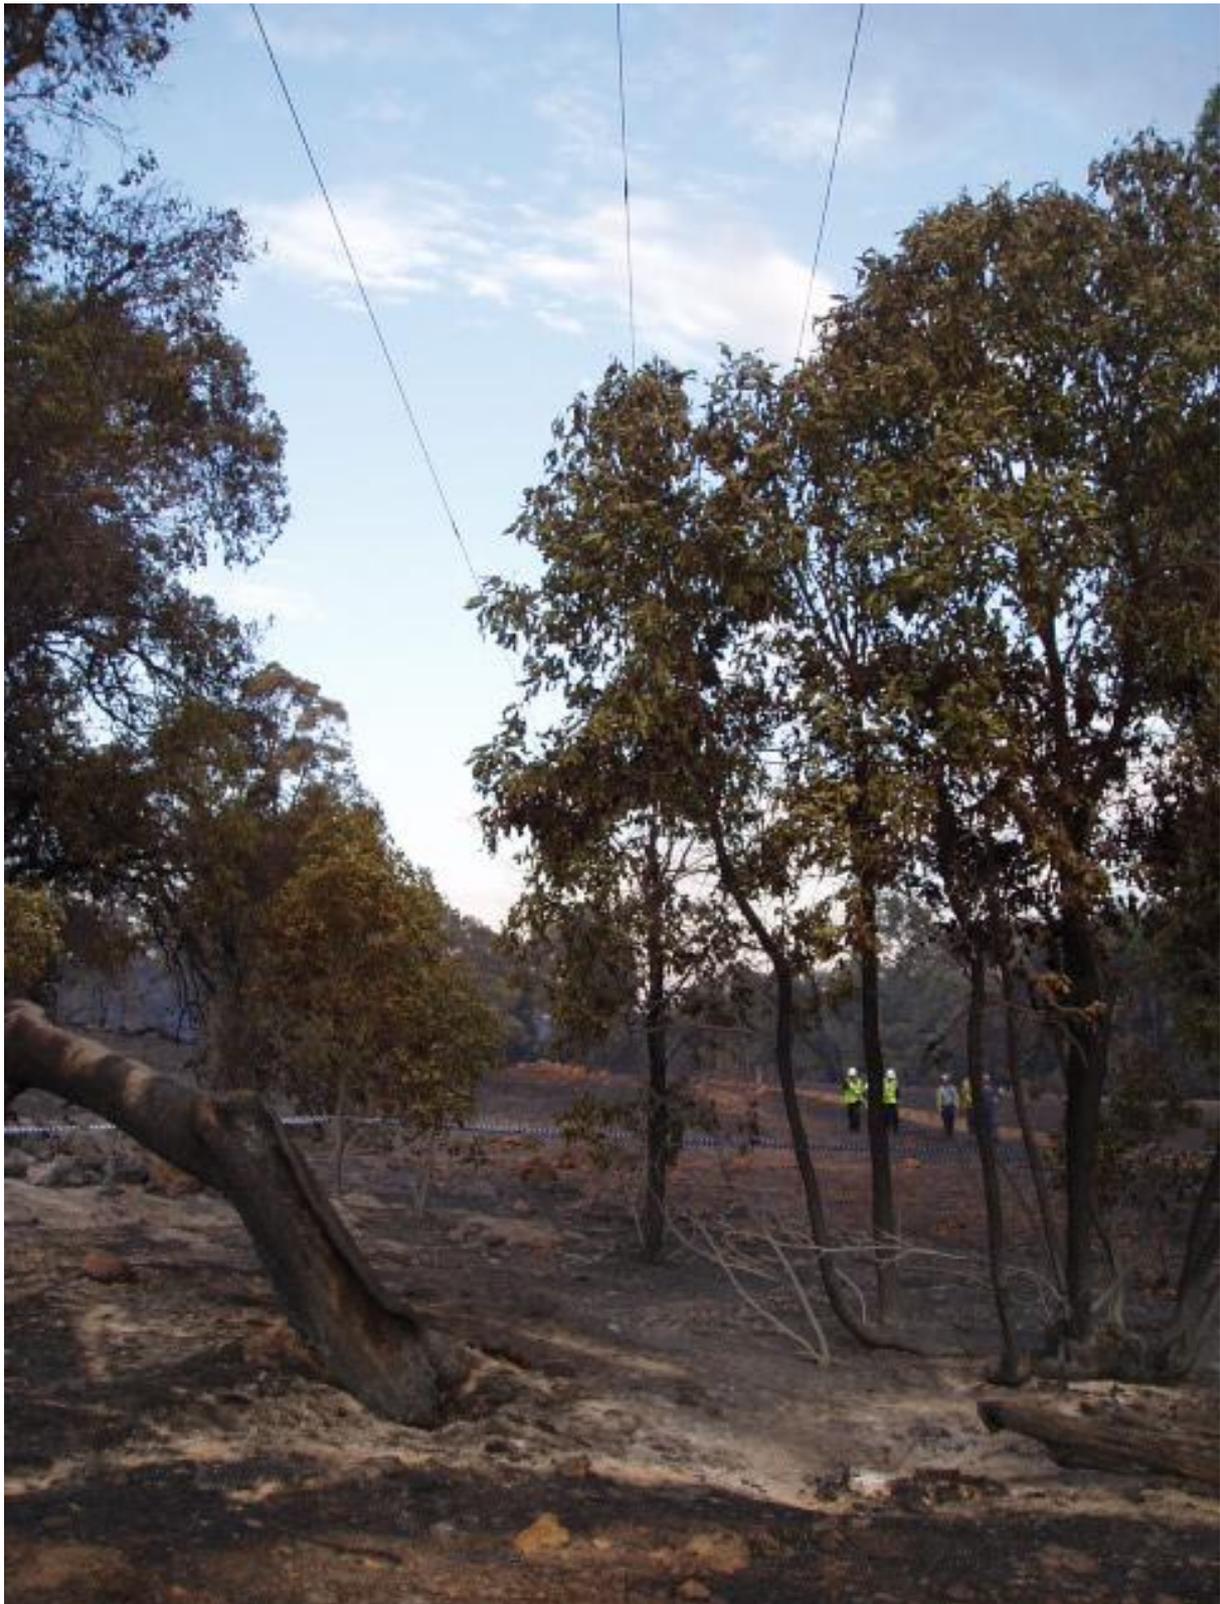
Photograph No 1: - Origin of Bush Fire

FESA and Police investigators estimated that the bush fire's point of ignition was on the ground in a paddock west of Brindle Road and north of Kilburn Road, Parkerville.

An inspection of the ignition point indicated that an area of grass paddock and bush had burnt out adjacent to the Western Power 22 kV overhead power line. The bush fire had continued in an easterly direction towards Stoneville, which is consistent with the bush fire being driven forward from the point of ignition by wind initially coming from the northwest.

Photograph taken near Brindle Road, Parkerville on 3 January 2008 by Senior Electrical Inspector Todd Bell, EnergySafety. The trees on the right side of the picture (beneath the right hand side WP conductor) are near the origin of the bush fire.

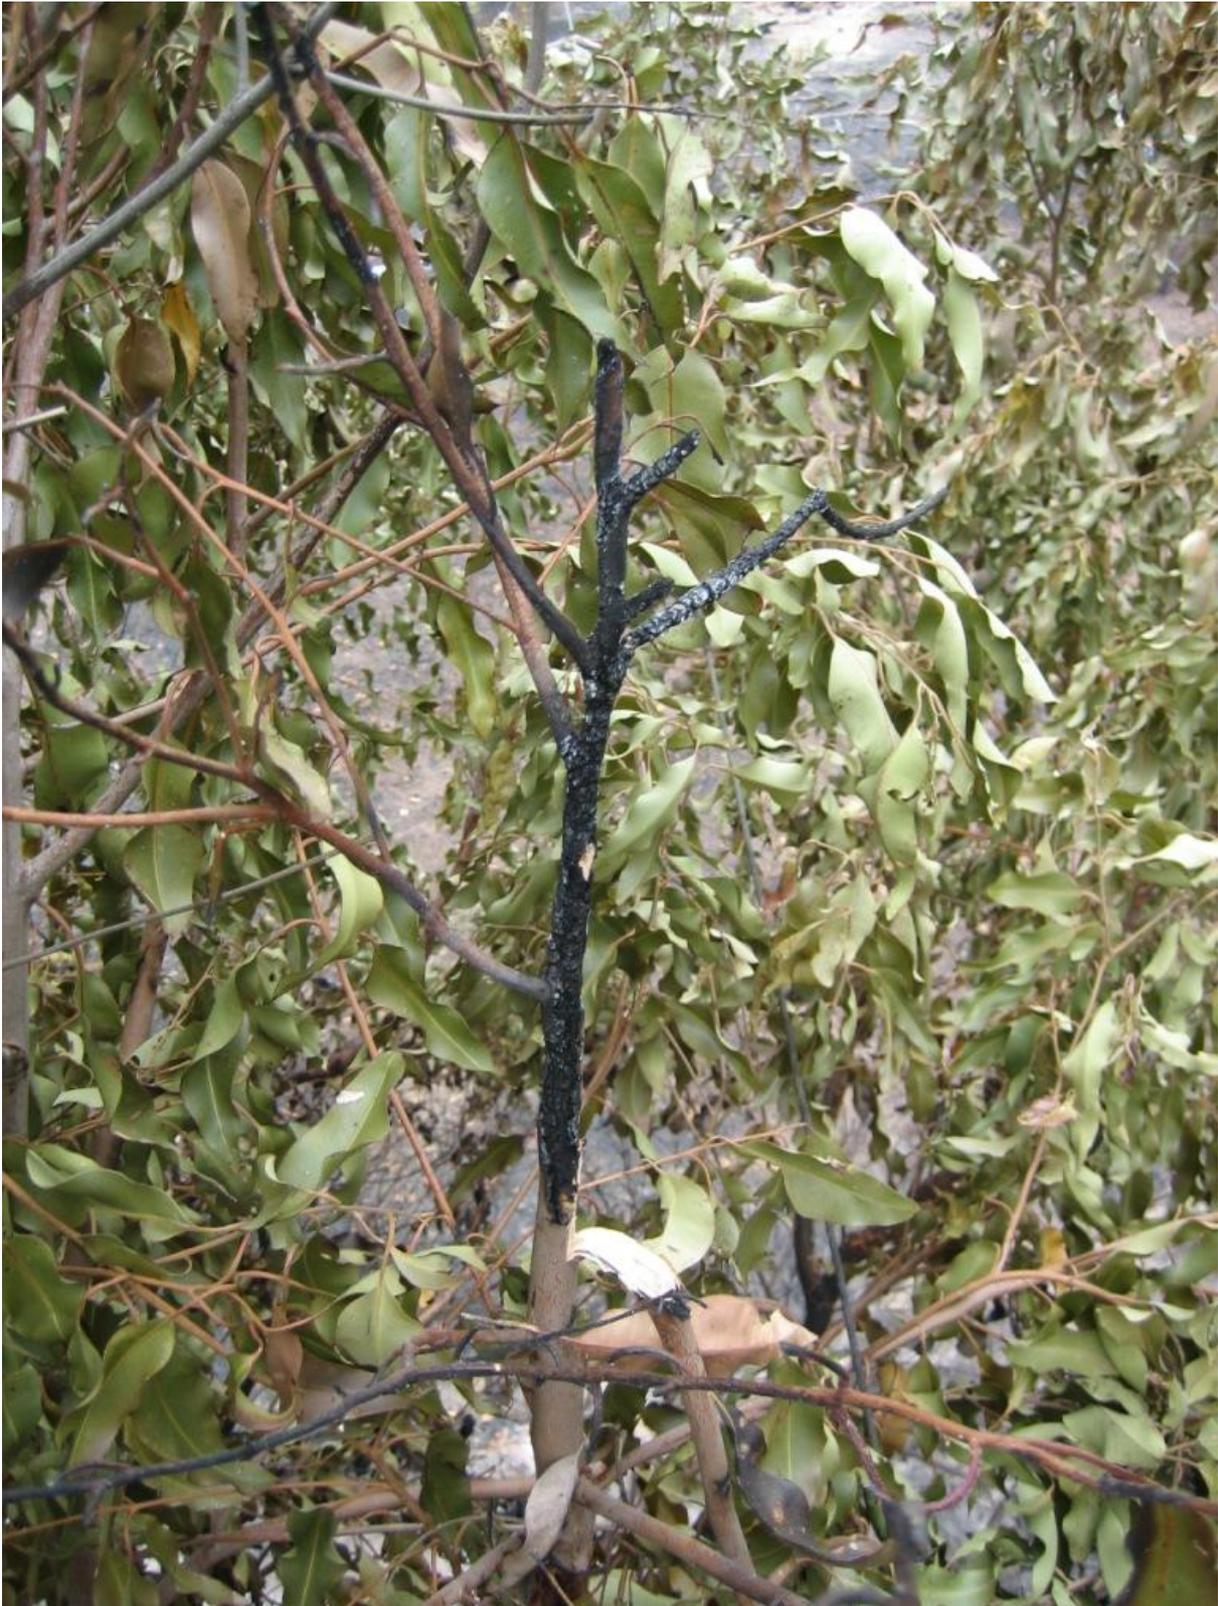
Photograph No 2: - Burn Marks on Tree Branch

At the point where the tree contacted the phase conductor between pole number 251749 and pole number 251750, burn marks were evident on the conductor.

Examination of the small tree around the phase conductor indicated burning to the branch in the locality of the phase conductor. The tree foliage furthest away from where the tree contacted the phase conductor did not indicate signs of burning but it did exhibit the effects of extreme heat (wilting of the leaves). The small tree also showed signs of burning on its trunk which occurred from the subsequent grass fire.

Photograph taken near Brindle Road, Parkerville on 3 January 2008 by Electrical Inspector Stephen Wheatley, EnergySafety. At the time of this photograph the high voltage conductors had sagged due to the failure of a wooden pole caused by the fire.

This contact between the tree branch and high voltage power line would not have occurred if the tree had been adequately pruned to ensure that branches did not encroach within an acceptable safety distance of the power line.

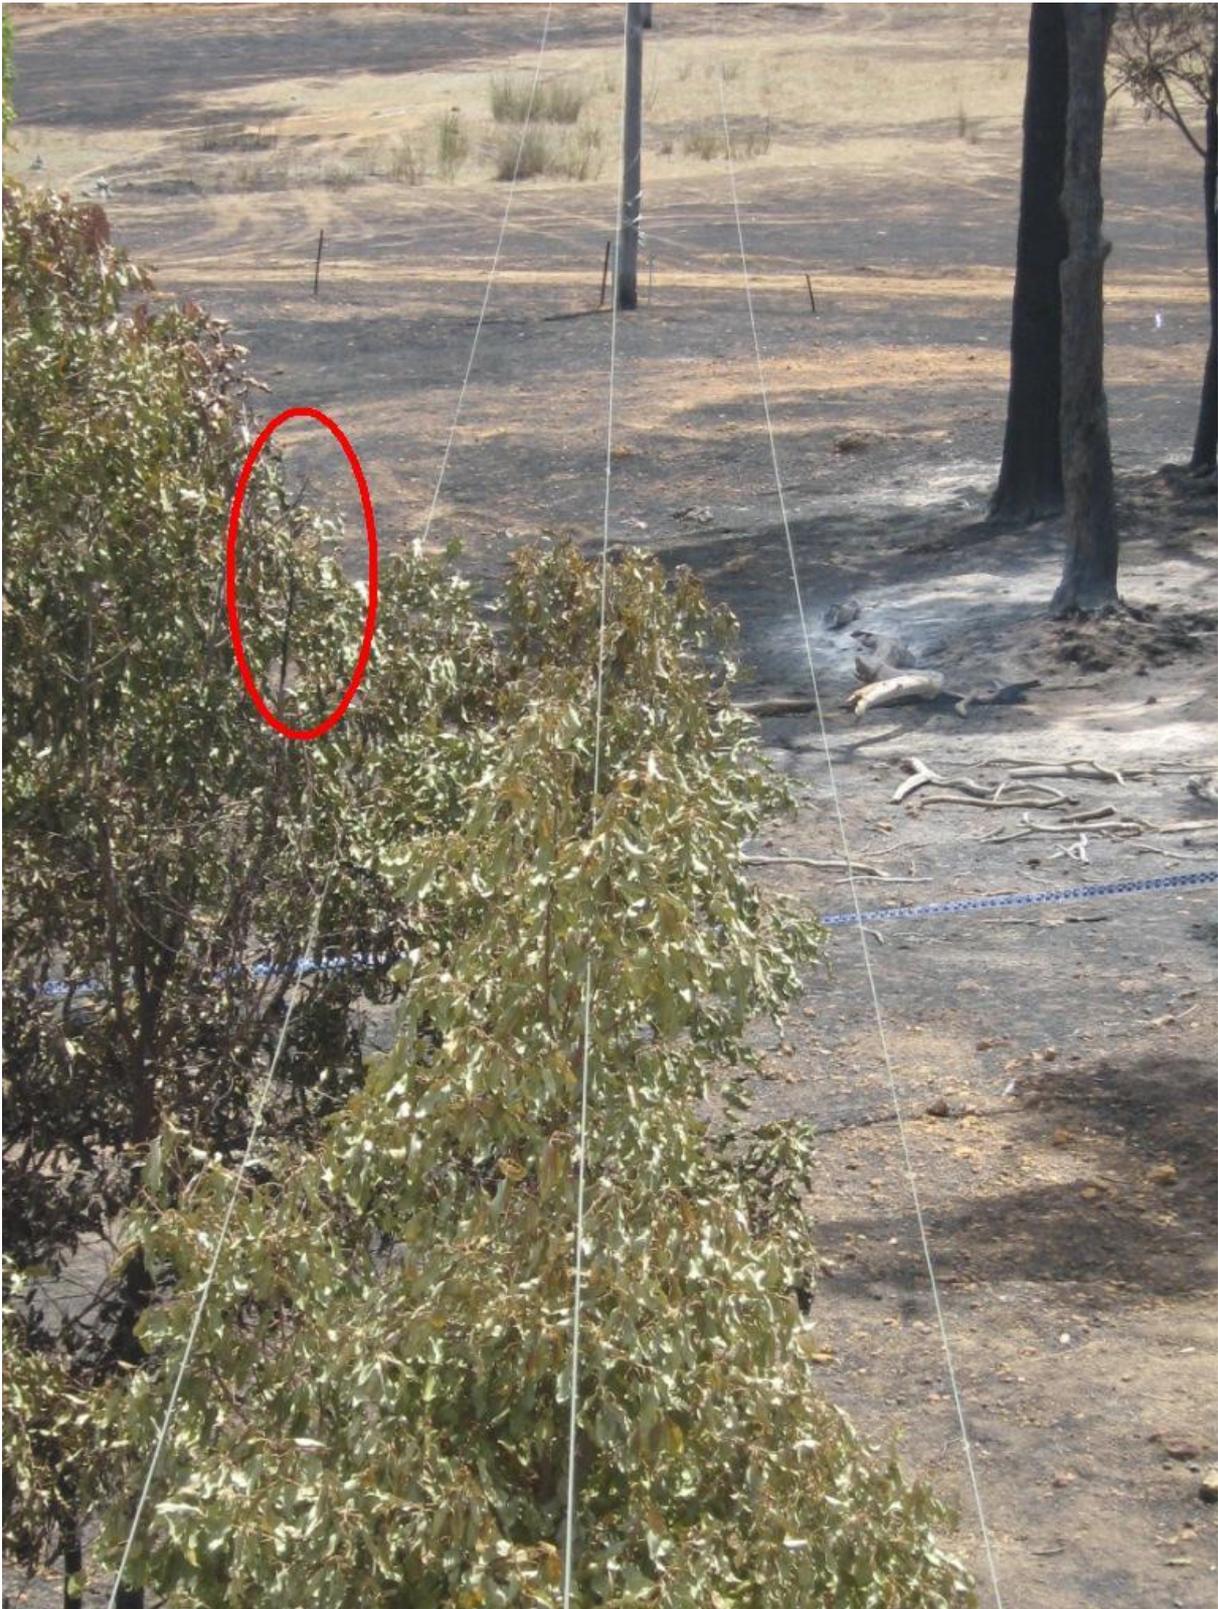
Photograph No 3: - View of Tree Branches and Power Line

A number of small trees had grown directly below the power line approximately mid span between pole numbers 251749 and 251750. These trees had grown from previously cut tree stumps. The tallest of the trees was 7.2 metres in height. The tallest tree had grown through the power line (the conductors of which were lower than the top of the tree branches) and contacted a phase conductor.

Photograph taken near Brindle Road, Parkerville on 4 January 2008 by FESA. At the time of this photograph the high voltage conductors had sagged due to the failure of a wooden pole (which was caused by the fire). The origin and point of ignition of the fire is circled.
