ELECTRICAL INCIDENT REPORT

POWER LINE FAULT AND WILDFIRE NEAR BASTIANI ROAD AND SOUTH COAST HIGHWAY PARRYVILLE WESTERN AUSTRALIA ON 7 MARCH 2007

22 March 2007

EIS 2007-269

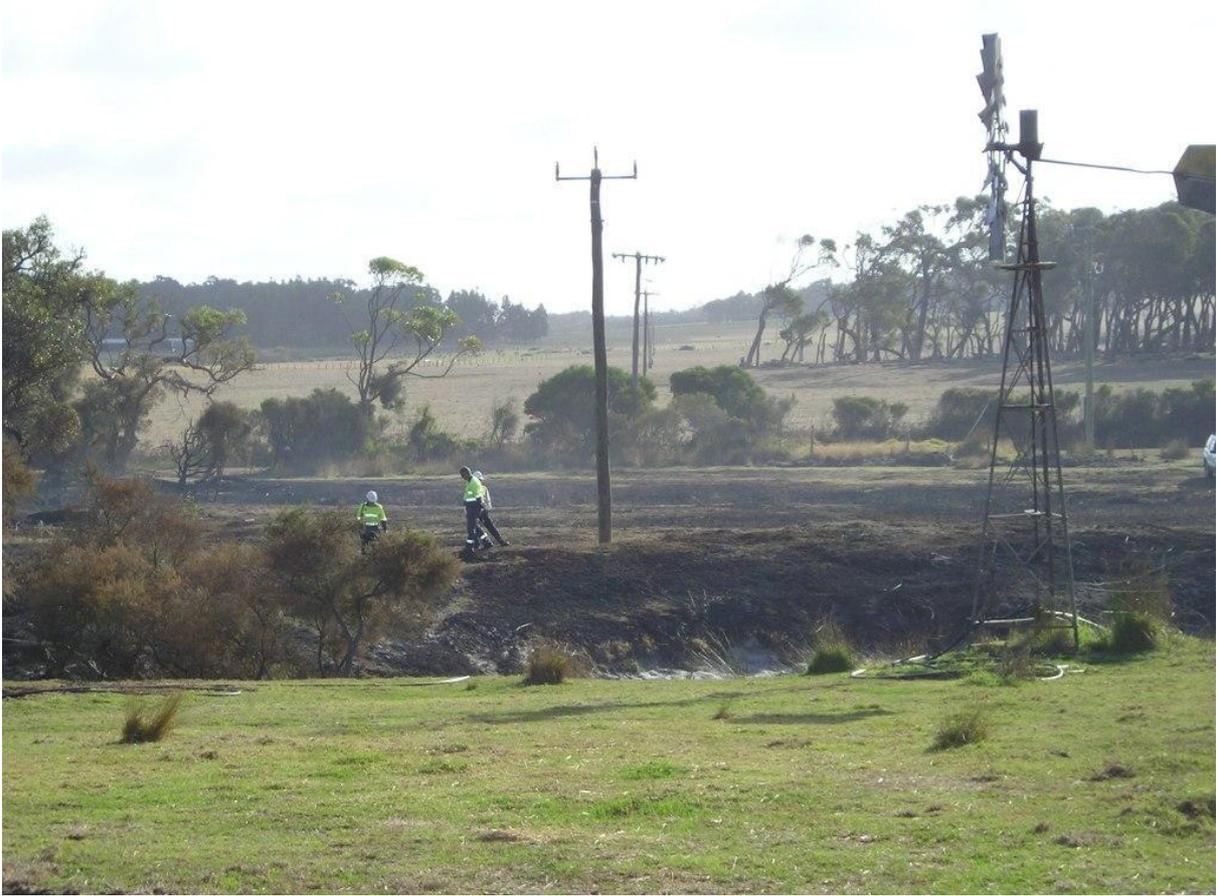
Photograph No 1: - Origin of Wildfire

The FESA investigator estimated that the wildfire's point of ignition was on the ground in a paddock East of Bastiani Road and North of South Coast Highway approximately 20 kilometres West of Denmark.

An inspection of the ignition point (approximately 5 to 6 metres south of WP's power line) indicated that a large area of grass paddock had burnt out adjacent to the Western Power 22 kV overhead power line. The wildfire had continued in a Southerly direction, which is consistent with the wildfire being driven forward from the point of ignition by wind coming from the North.

Photograph taken near Bastiani Road Parryville on 8 March 2007 by Senior Electrical Inspector Ross Reid, EnergySafety. New pole (WP170A) installed (centre of picture) by WP is near origin of the wildfire.

WP considered that the power line was unsafe and installed an additional pole (WP170A) between poles number WP170 and number WP171 thereby reducing the span length to approximately 75 metres and increasing the separation between the phase conductors and earth conductor to within safe limits.

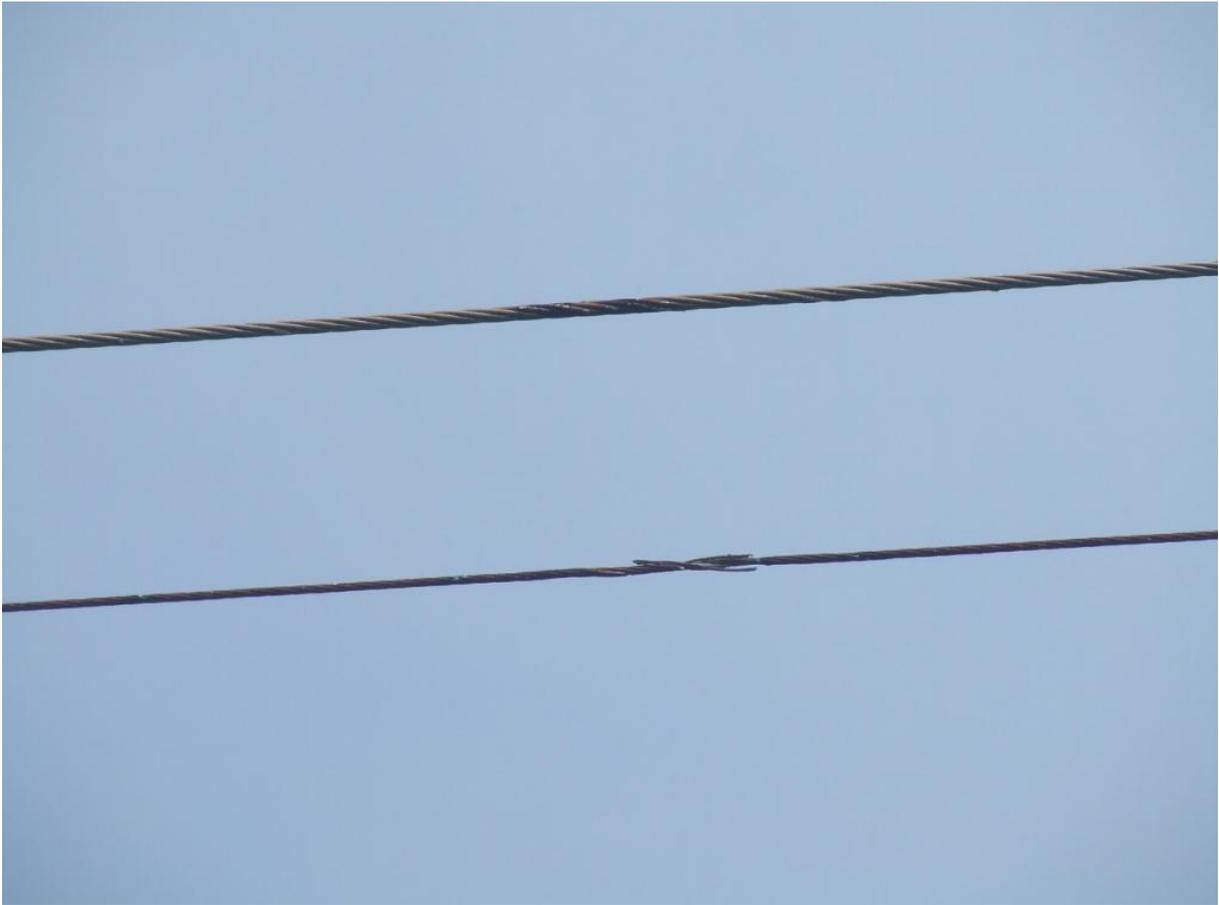
Photograph No 2: - Burn Marks and Damage to Conductors

Investigation found that the middle white phase conductor and the underslung earth conductor made direct contact with each other in the light wind and high ambient air temperature. This is evident from the burn marks and metal globules on the conductors.

Inspection of the power line found evidence of damage to the overhead power line conductors between poles number WP170 and number WP171 on the Albany to Walpole 22 kV Feeder (ALB520). The damage consisted of electric arc burn marks on the middle steel cored aluminium conductor (white phase) and on the underslung earth conductor near and at the point where strands on the earth conductor were broken. This was immediately below the damage to the white phase conductor.

Significantly, the earth conductor exhibited damage that is consistent with electrical arcing between it and a phase conductor and there was evidence of burn marks on the phase conductor.

Photograph taken near Bastiani Road, Parryville on 7 March 2007 by Western Power showing the damage to the earth conductor (smaller conductor) and burn marks on the white phase conductor.

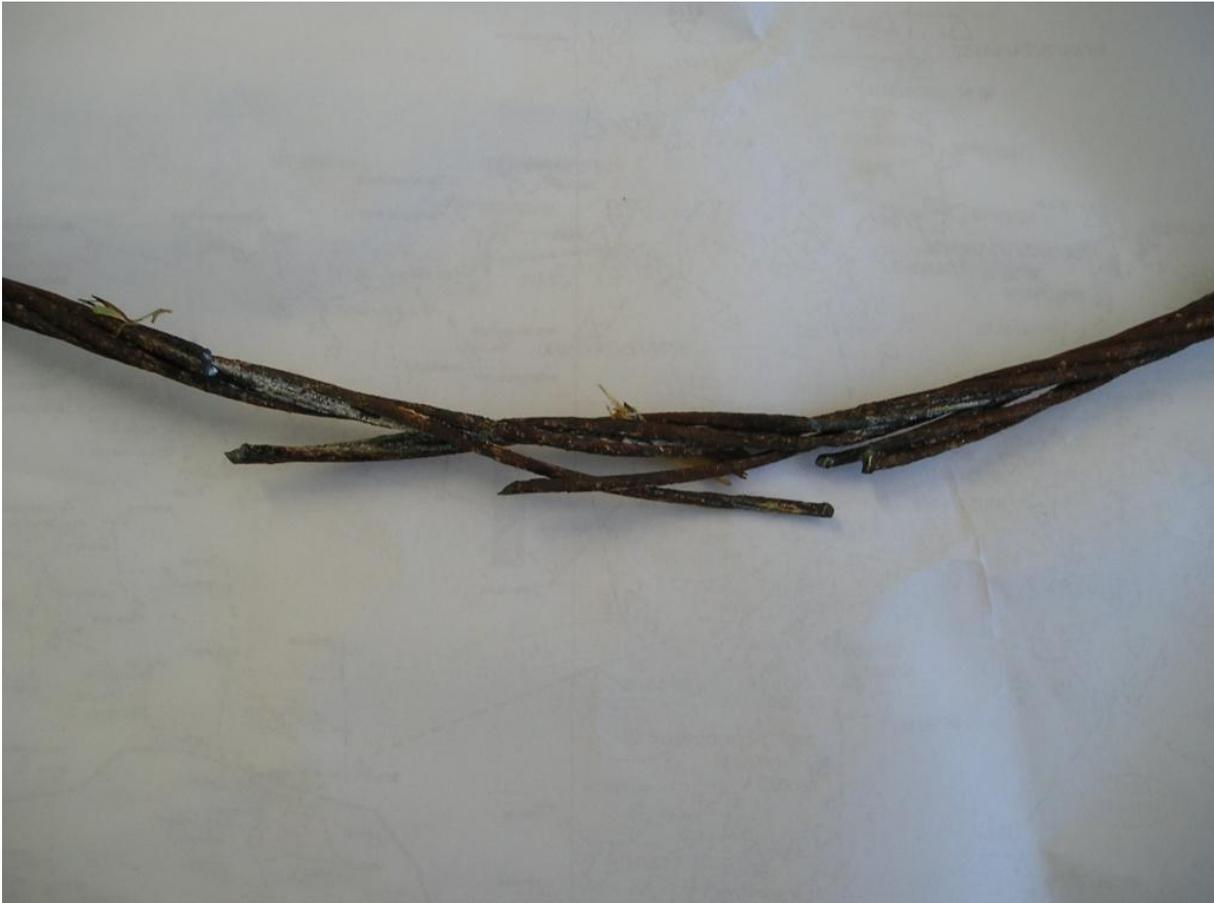
Photograph No 3: - Damage to Underslung Earth Conductor

Photograph taken on 8 March 2007 by Senior Electrical Inspector Ross Reid, Energy Safety.
