Off-highway haul truck tyre blowout in workshop injures workers

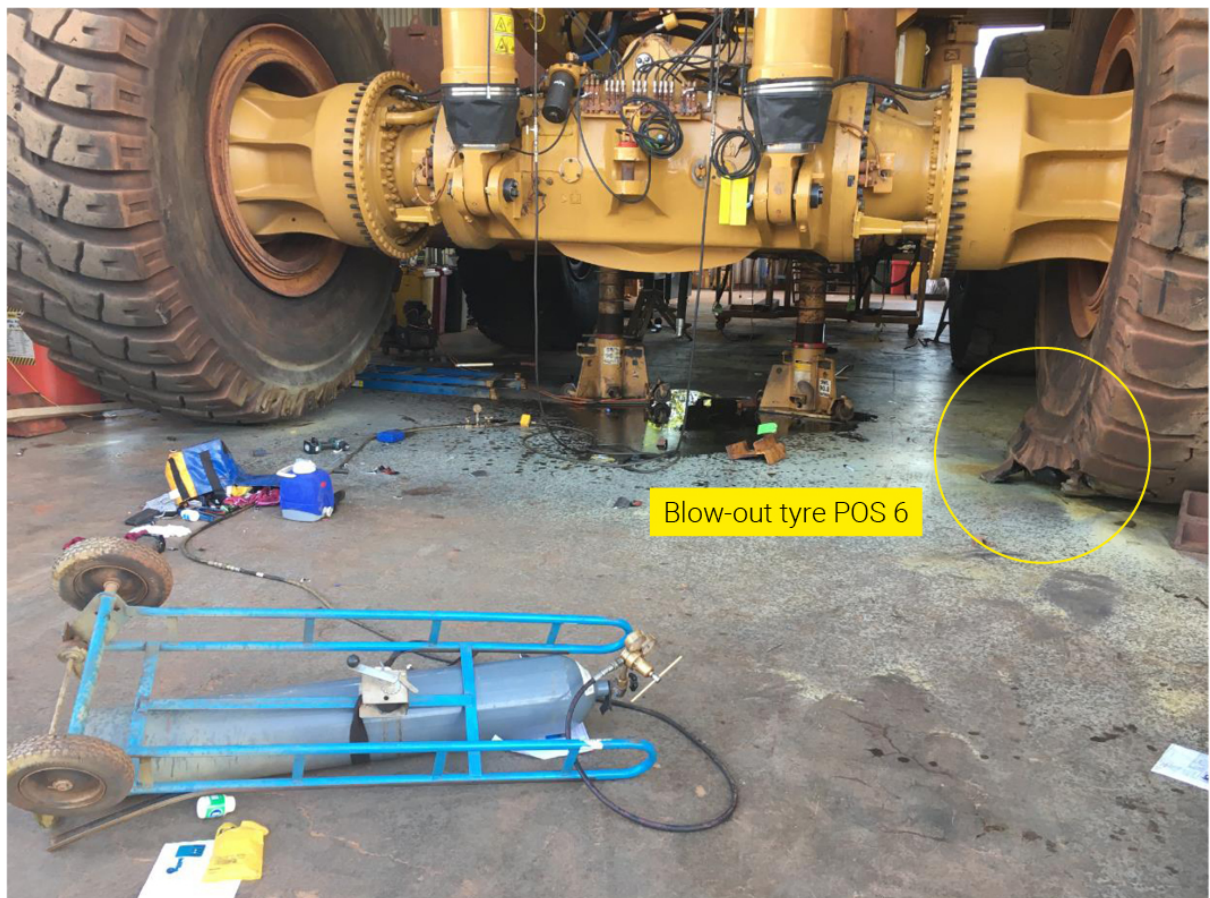
Photo of the haul truck showing the blown out tyre fitted in position 6. Tools and equipment are in their original positions.

The direct (physical) cause was cut damage on the outside edge of a tread lug of the tyre. This exposed the steel reinforcing layers to air and moisture resulting in progressive corrosion and separation damage that reduced the integrity of the tyre casing to resist internal pressure.

- The tyre was not disposed of when it was removed from service in October 2018. It had a large cut caused by a rock during operation which, over time, allowed moisture to enter the steel cord area causing corrosion.
- The tyre was stored in the elements for 16 months before being fitted to transport the truck to the workshop.
- The decision to return the discarded defective tyre to service was not based on an inspection and assessment by a suitably competent person.
- The site did not have a safe system of work for the inspection of tyres used for transportation purposes.
- The damage to the tyre was not obvious due to the steel cord corrosion being internal.
- Persons in the workshop were working in close proximity to fully inflated tyres.

1. Tyres that are known or suspected of being defective are not fit-for-purpose and must not be returned to service unless they have been inspected and assessed as fit-for-purpose by a competent person (r. 4.38 Occupational Safety and Health Regulations 1996).

2. Persons who inspect and assess tyres must be competent, having an appropriate combination of knowledge, experience and qualifications (Section 19(1)(b) *Occupational Safety and Health Act 1984*).

3. As part of a comprehensive tyre management plan, mining operations should have established safe working procedures for the inspection and assessment of tyres that are known or suspected of being damaged.

4. To reduce the hazardous energy, tyres in workshops may be deflated to a lower pressure if persons are working in close proximity. A risk assessment should be conducted to determine if the tyre pressure should be lowered. Because the tyres are not carrying as much load (just the empty weight of the truck), the pressure may be reduced to a lower value as advised by a competent person.
