ELECTRICAL INCIDENT REPORT

BUSHFIRE NEAR RIVER and FOLEWOOD ROADS TOODYAY WESTERN AUSTRALIA 29 DECEMBER 2009

15 February 2010

EIS 2009-2630

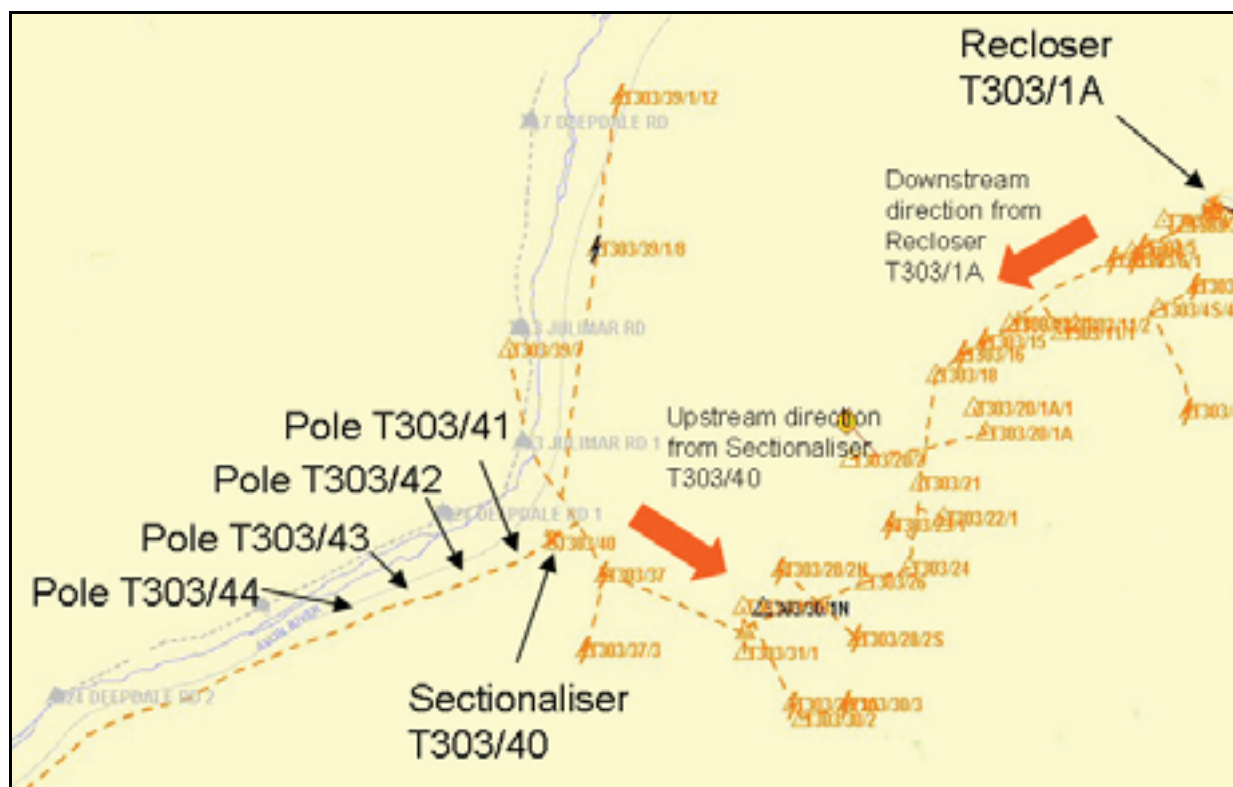
Diagram of T303 Spur Power Line Supplied by Western Power

The sectionaliser at pole T303-40 would have operated if a permanent fault had occurred at poles T303-42 and T303-43. This sectionaliser did not operate but the recloser (at the beginning of the powerline T303-1A) operated and locked out. This indicates that the fault was upstream of the sectionaliser and closer to Toodyay. The actual fault which operated the recloser could not be found due to the extensive fire damage towards, and just south, of Toodyay. A schematic diagram of the T303 spur power line is shown below. The area of origin of the bushfire was located between poles T303-42 and T303-43. The T303 spur power line commences at Toodyay (right hand side of the map).

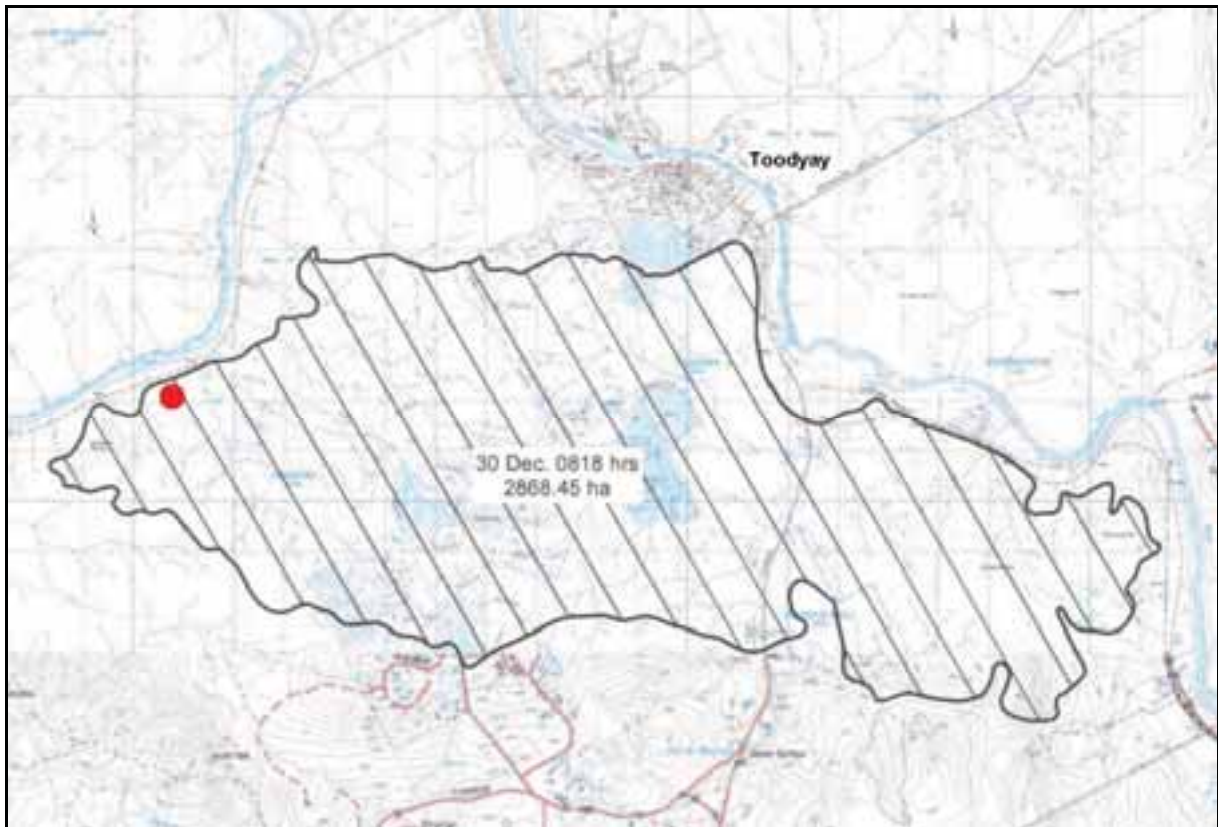
Map Supplied by FESA

FESA and WA Police fire investigators established that the bushfire's "area of origin" was located on the ground in a paddock south of River Road and west of Folewood Road approximately seven kilometres west of Toodyay. The map below shows the fire area. The bushfire's area of origin is marked with a red circle and the hatched area indicates the full extent of the bushfire.

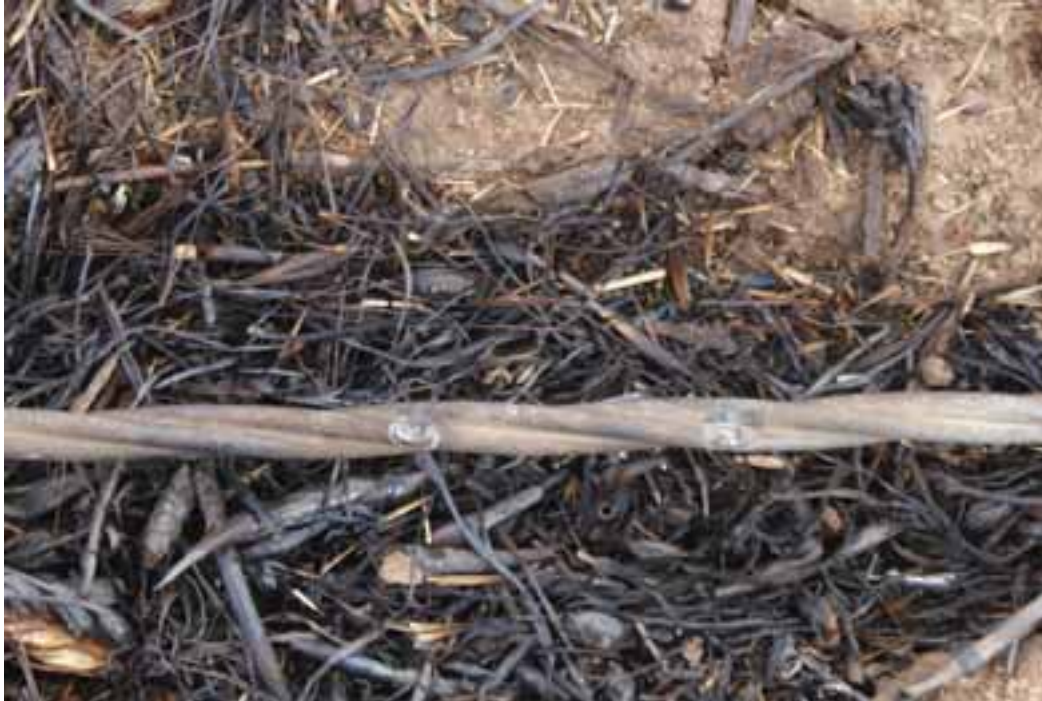
The investigation identified arc marks (melting of the steel) on the active and earth return conductors 9 metres and 14 metres out from Pole T303-43 towards pole T303-42. The arc marks at 14 metres were recent. The marks 9 metres from the pole were old.

Arc Marks at 14 Metres. Photograph Taken by EnergySafety

The arc marks were analysed and found to be consistent with either the conductors clashing or some conductive object causing a short circuit between the two conductors. It has not been possible to determine the cause of these marks. The marks 14 metres from pole T303-43 were made recently because their surface had not begun to rust or corrode (the arc melting had removed the protective galvanising).

The arc marks are therefore more likely to have been caused by a conductive object, such as fencing wire or vegetation, bridging between the active and return conductors. EnergySafety therefore conducted a thorough ground search using a metal detector around the area under and adjacent to the point under the position where the arc marks occurred. Short lengths of wire were found but these were well outside the area underneath the arc marks. The wire found was also too short to reach across the 1.2 metre space between the conductors and would not explain the two arc marks on the active conductor. If such an event happened it would be an act of vandalism and not the responsibility of Western Power. Western Power was not able to offer a reason as to how the arc marks were caused. The cause of the arc marks could not be determined nor could it be determined if they contributed to the cause of the bushfire.

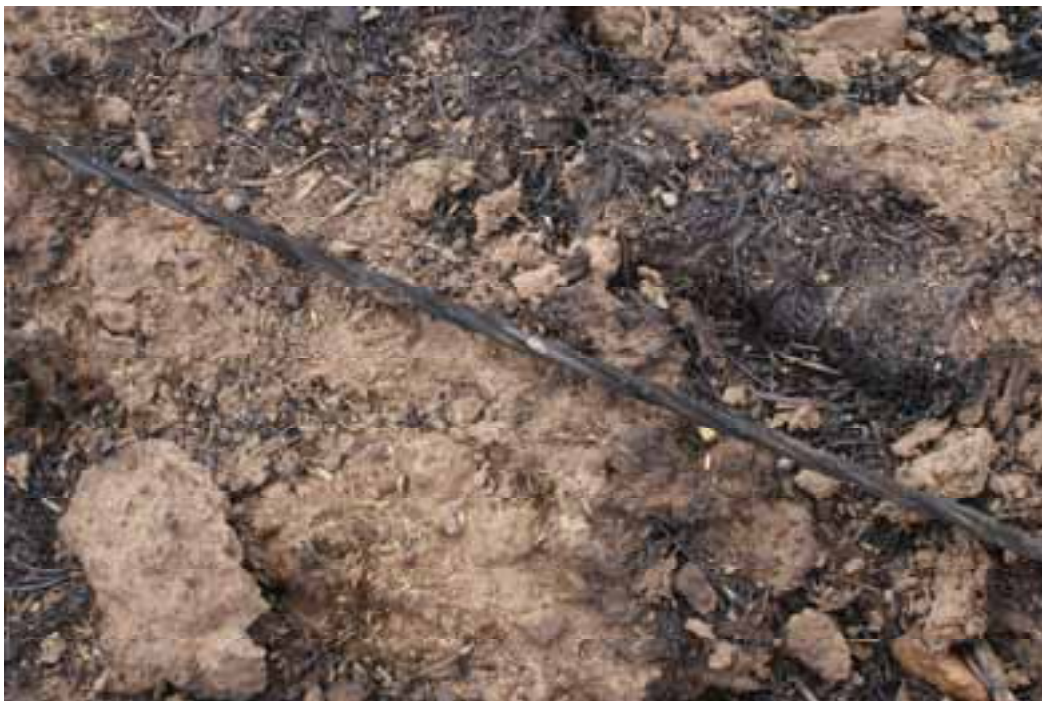
Arc Marks at 9 Metres. Photograph Taken by EnergySafety

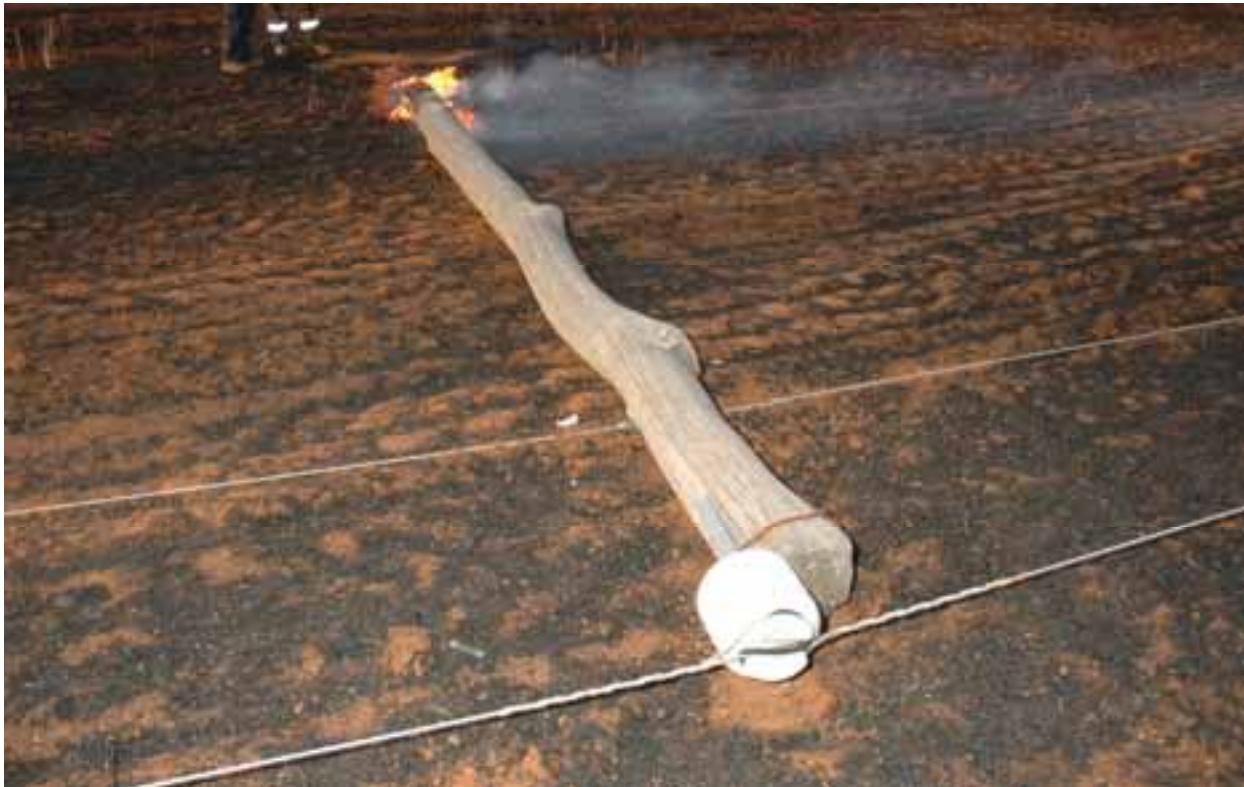
Investigation concluded that Pole T303-42 eventually burnt through near the ground and then fell towards the ground. The fire consumed all except for the top of the pole.

Pole T303-42. Photograph taken by FESA on 29 December 2009

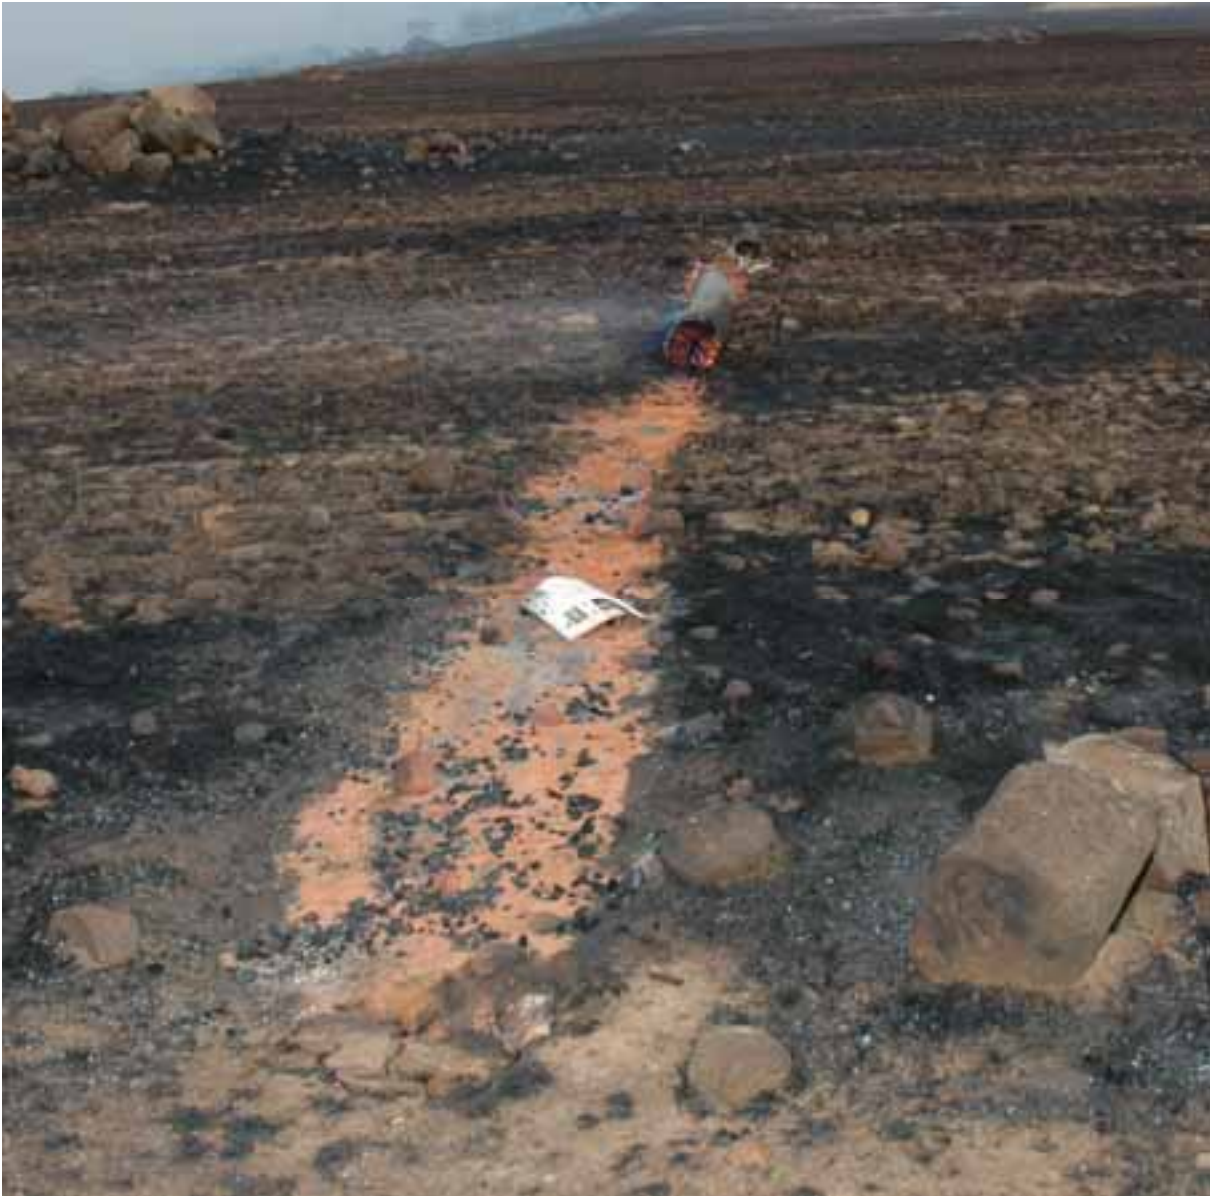
Pole T303-43 was also burning near the ground and then fell to the ground and continued to burn until it was completely consumed. Marks on the ground confirm that the earth return conductor then broke at Pole T303-43 and pulled away from the pole (after it was consumed by the fire).

Remains of Pole T303-43. Photograph taken by FESA on 29 December 2009

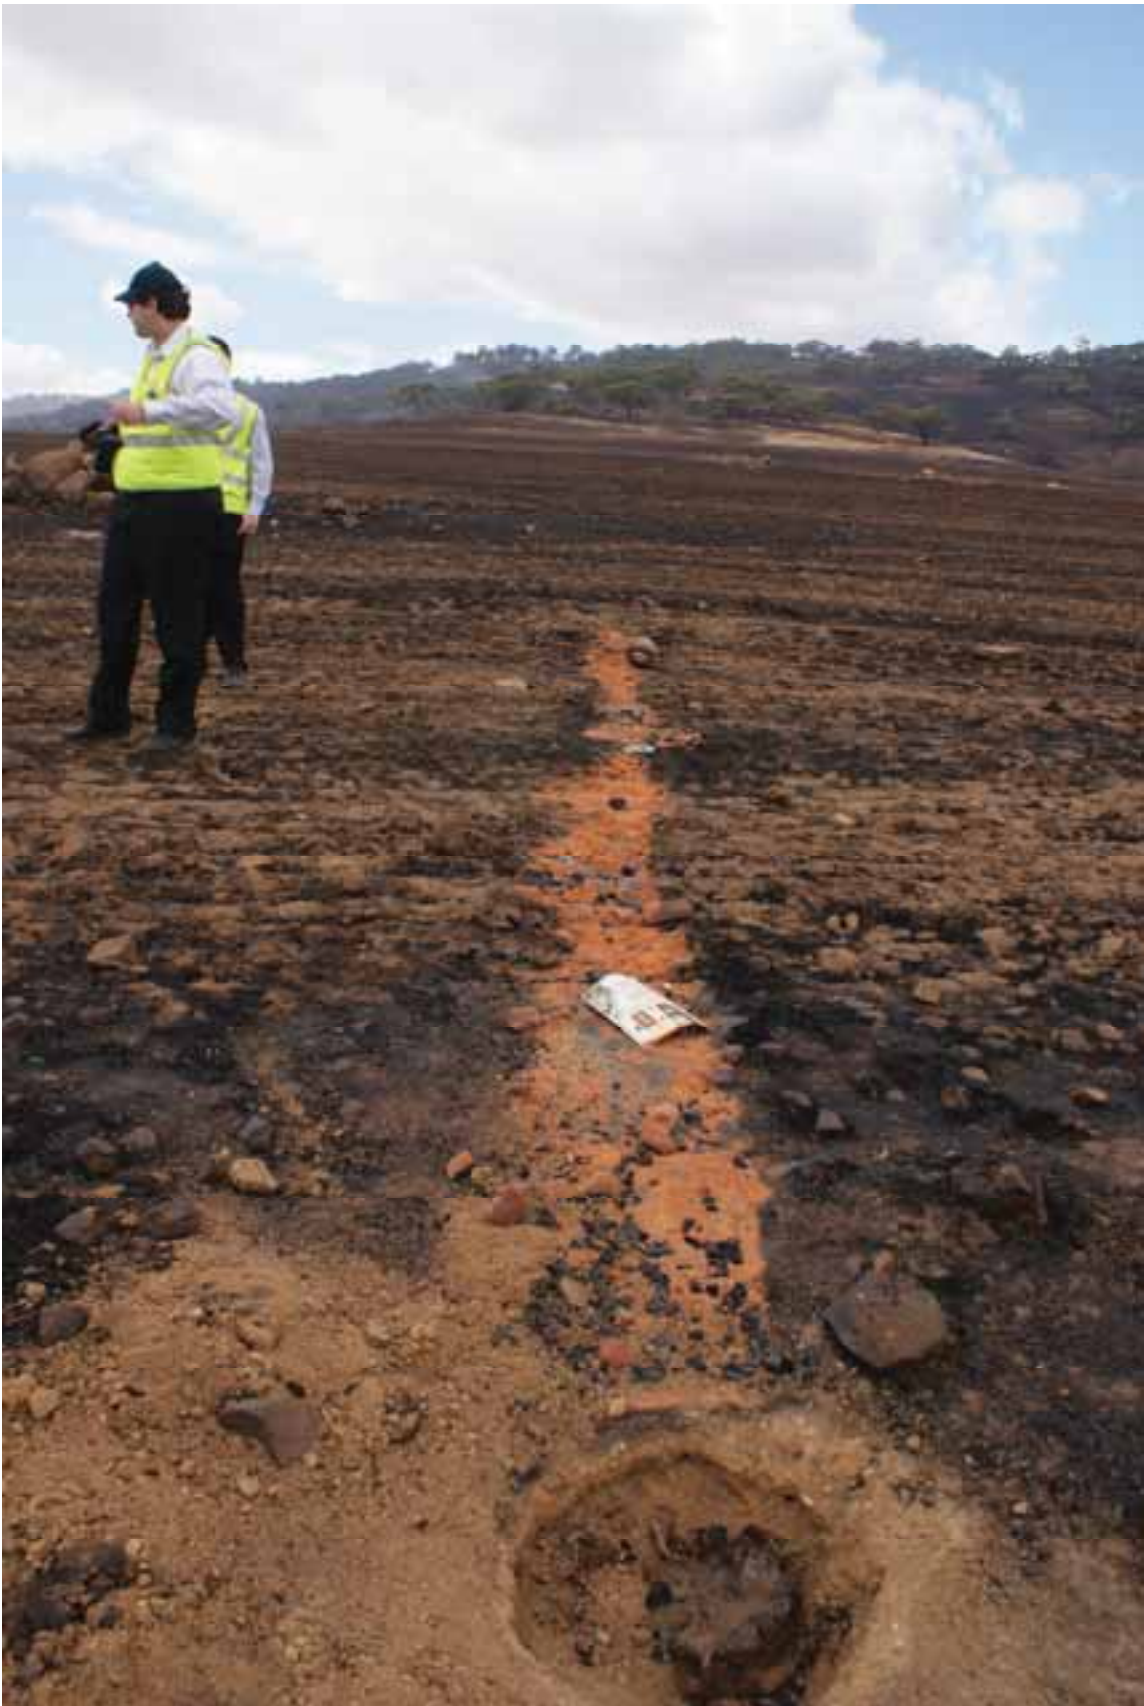
Remains of Pole T303-43. Photograph taken by Energy Safety on 30 December 2009

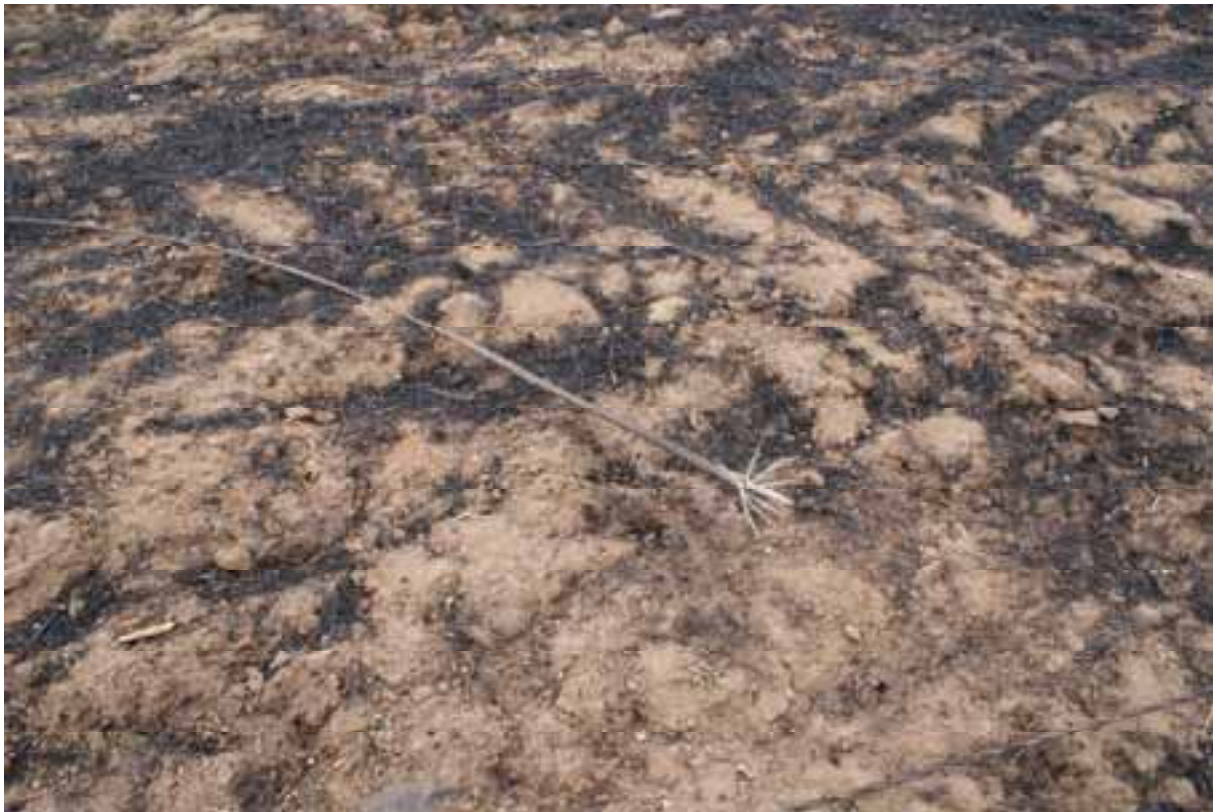
**Broken earth return conductor near pole T303-43 (between poles T303-42 and T303-43).
Photograph taken by EnergySafety on 30 December 2009**

The failure of the earth return conductor at pole T303-43 could not have caused the arc marks as the earth return conductor broke some time after the bushfire commenced and after the recloser had locked out, de-energising the T303 power line.

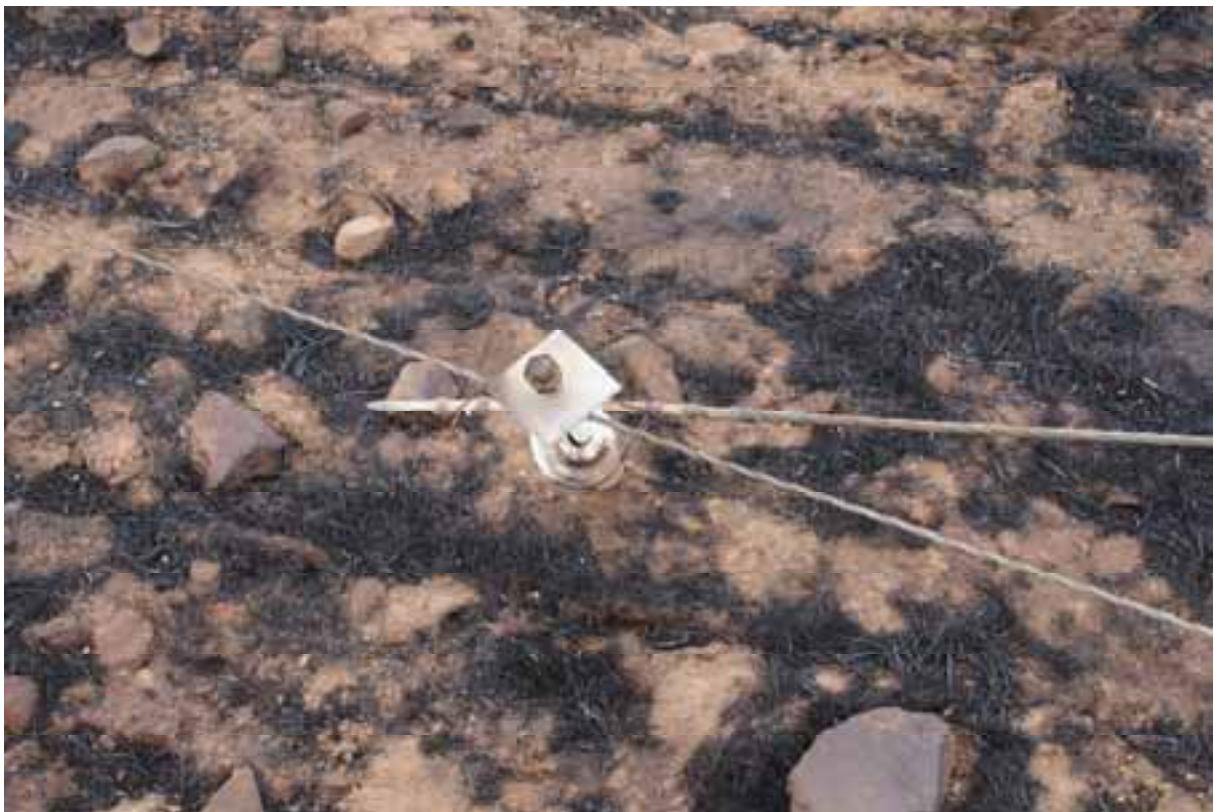
**Broken earth return conductor near pole T303-43 (between poles T303-43 and T303-44).
Photograph taken by EnergySafety on 30 December 2009**

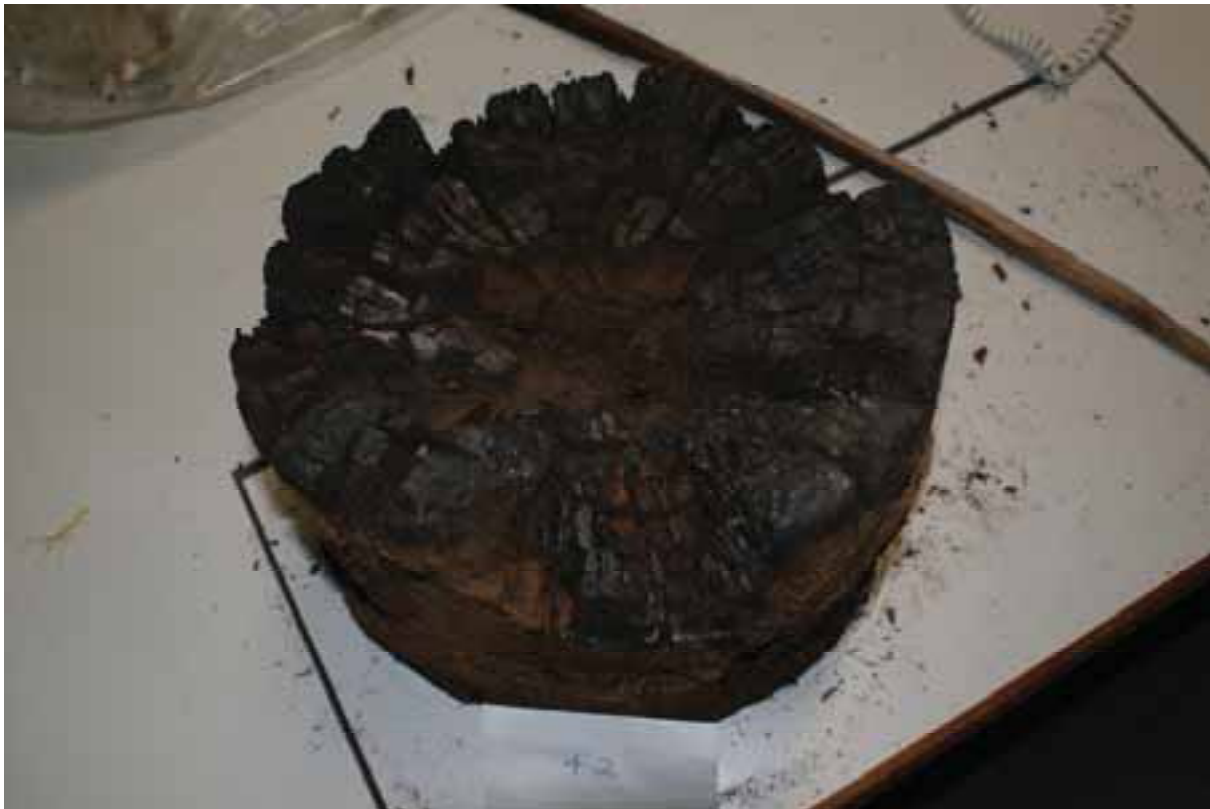
Top of pole butt T303-42

In the wood scientist's opinion, poles T303-42 and T303-43 did not fall down, but were burned through at the ground line and immediately above by the fire and then fell over when there was no longer sufficient unburned wood to support them. The scientist's report finds that these poles were set alight by the bushfire after it was ignited by some other source. EnergySafety agrees with this opinion.
