Bulletin

Energy Bulletin

Wildfires and overhead power lines

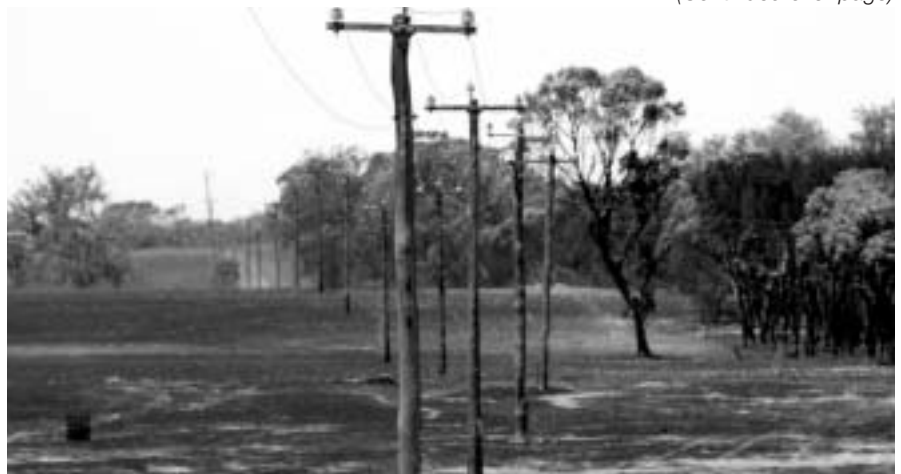
In the case of Tenterden, it was found that the fire resulted from hot metal particles falling to the ground adjacent to an overhead 3-phase 22 kV line. A long span live conductor clashed with an underslung earth wire with a resultant electric arc and short circuit fault. This occurred in conditions of high ambient air temperature that produced considerable conductor sag. This, coupled with strong gusting winds, caused sufficient movement of the conductors to allow them to clash.

Fire damage to the Tenterden power line

There are two lessons to be learned from these occurrences. Firstly, it is essential that trees are kept pruned to ensure they will remain well clear of power lines under all conditions. Secondly, the electricity line operator (whether a utility or other organisation) can mitigate the risks by:

- shortening conductor spans by use of additional poles;
- increasing conductor spacings by using longer cross arms; or

- stabilising conductor movement in strong wind by using appropriately designed and insulated vibration dampers and/or conductor spacers.
