# energy

## Bulletin

ISSN 1323-8957

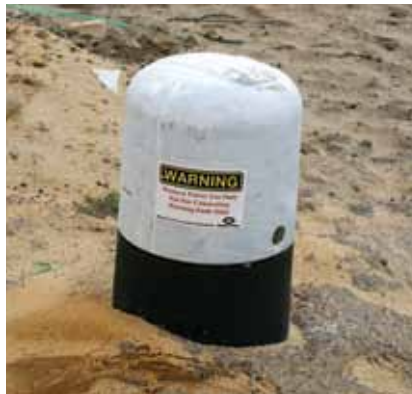
As a part of underground distribution works by network operators, you may come across pillars that cannot be used to connect a customer's installation. These are working end pillars which allow both high voltage (HV) and low voltage (LV) distribution cables to be extended to the subdivision scheme boundary for future extension into the next stage. These are not for property connection and carry a label warning of their limited use.

*Photograph showing a working end pillar as how it should appear.*

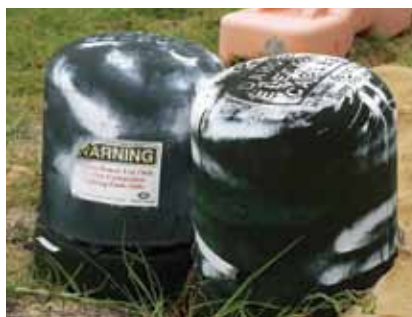
*Photograph showing a poorly painted working end pillar that has the warning label peeling off.*

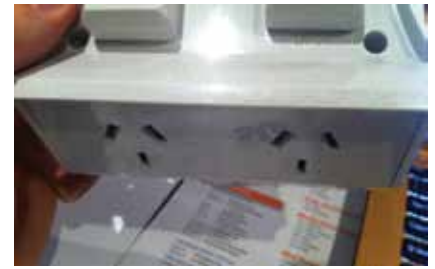
The unit was offered for sale from HQA Wholesale Suppliers as a HQAWPS2 Double weatherproof P/point 10A IP56 and was suitable for 10A 250 volts.

*Photograph showing the weatherproof socket outlet.*

The HQAWPS2 Double weatherproof socket outlet appeared similar in construction to other well known brands (Clipsal and HPM) IP53 rated weatherproof power points, hence the cause for concern.

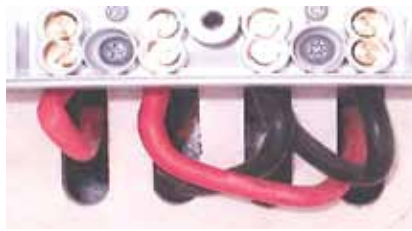
An inspection carried out by a Western Power inspector revealed that the consumers mains active and neutral conductors at the tariff meter of the builder's supply were incorrectly connected. This would have resulted in the earthing system (via the MEN connection) and the conductive parts of the builder's supply enclosure to

*Photograph showing the transposed active and neutral conductors.*

become "live" and dangerous with a touch potential of up to 240 volts AC.

The defects at the two installations left a highly dangerous situation as detailed above. Three people received electric shocks as a result of the serious defects, which could have killed them.

It was clear following the inspections by the Western Power Inspector of the two installations, that the verification (inspection, checking and testing) of the electrical installations by Lippiatt was inadequate and contrary to the requirements in AS/NZS 3000:2007 "Wiring Rules" and was not safe to connect to the electricity supply.
