Government of **Western Australia**  
Department of **Commerce**  
EnergySafety

# **Electrical safety of grid-connected solar installations in Western Australia**

**December 2011**

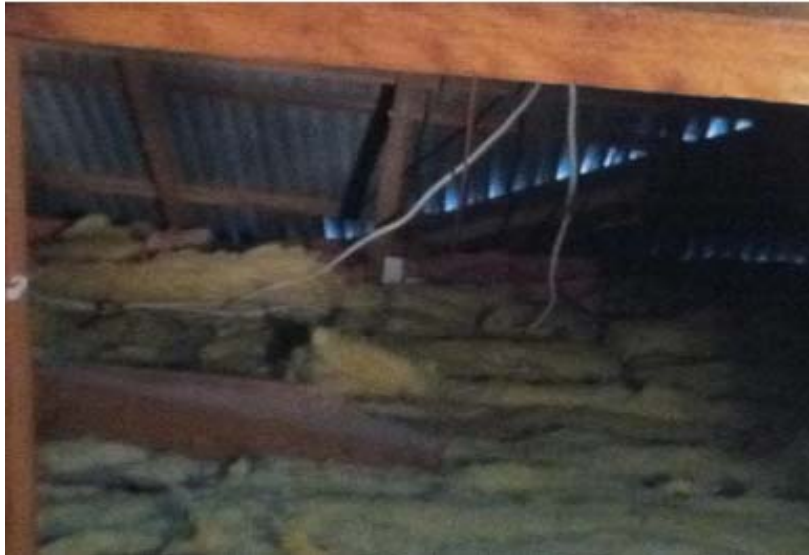
The most common defect identified during the inspections was 'failure to provide adequate mechanical protection to cables'. Clause 3.9 of AS/NZS 3000:2007 requires that all wiring be adequately protected from mechanical damage i.e. in conduits and/or supported at fixed intervals where accessible e.g. in roof/ceiling space.

**Figure 1: Typical case where cable is not properly secured**

Energy Safety is working closely with network operators to ensure that the issues identified during the inspections are addressed. Network operators have been requested to review their inspection practices to treat incorrect wiring of DC circuit breakers, failure to provide adequate mechanical protection to cables, omission of labelling indicating presence of a second energy source and missing shut-down procedures as "serious defects". As such, once the rectification works are completed, network operators' inspectors will re-inspect all these installations, to ensure that the corrective work is adequate.
