Elevating work platform structural failure

Background

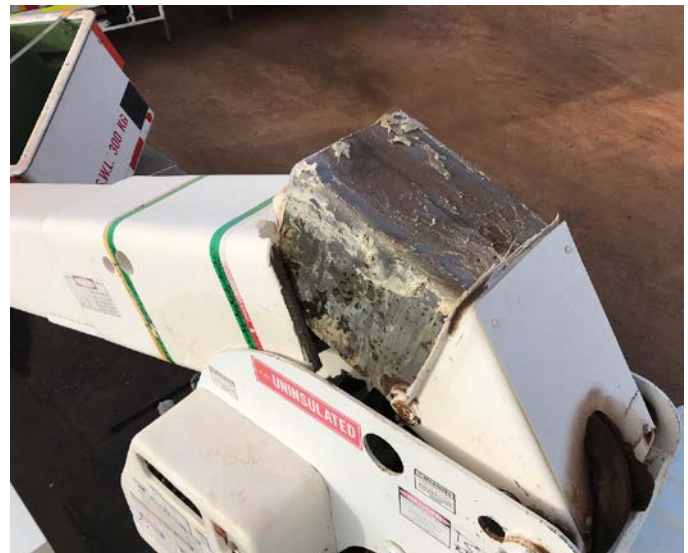
In November 2020, two workers were in the process of tree lopping in a truck-mounted elevating work platform (EWP) when the boom-type EWP suffered a major structural failure, with the metal support separating from the fibreglass joint while in operation. The resulting collapse of the EWP resulted in serious injury to one worker.

- Use of a fibreglass insulated boom-type EWP where the join between the metal support structure and the fibreglass joint is connected with glue.
- Annual inspections failing to identify potential signs of impending structural failure of fibreglass sections.
- Potential design or manufacturing defects in the glued connection between the metal support structure and fibreglass joint section.

EWP boom failure between the metal support structure and fibreglass joint section.

1. Ensure all EWPs are inspected by a competent person in accordance with both the manufacturer's instructions and, in areas not covered explicitly by those instructions, in accordance with AS/NZS 2550.10-2006.
2. Competent persons inspecting boom-type EWPs made out of composites must ensure that the scope of the inspection specifically addresses the signs and failure points associated with this kind of material. Such inspections could include visual inspection for hairline cracks and tap testing to determine potential bonding failures.

3. Owners of boom-type EWPs made from composite materials that are unsure of the scope of previous annual and major inspections should have such EWPs inspected by a competent person as soon as is practicable.
4. Designers, manufacturers and importers of these items of plant are obliged to, as far as practicable, ensure that adequate information in respect of any dangers associated with the plant is provided when the plant is supplied and thereafter whenever requested.
