Exposure to asbestos during demolition works

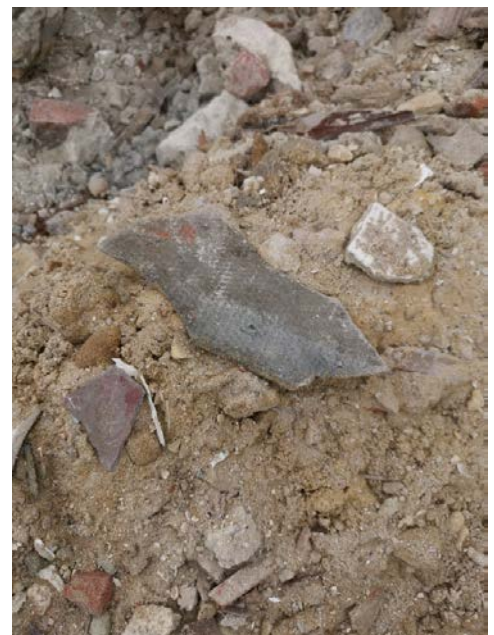
While demolishing the bathroom, asbestos cement material that had been concealed by tiles and the bath was uncovered. At this time, the material was not identified as containing asbestos and it was then broken up by the excavator and distributed through the rubble in that area of the property. Safe work procedures for the removal of asbestos were not in place.

Asbestos was subsequently identified in the rubble and the demolition was stopped. The workers manually removed the asbestos cement fragments using procedures for handling asbestos-containing material, with the area requiring significant remediation to remove the asbestos-containing material. Failure to remove contamination fully can lead to the requirement for specialised, high cost remedial work.

Figure 1: Asbestos-containing debris at a demolition site

3. If there is any doubt about whether a material is asbestos-containing, it must either be tested, or presumed to contain asbestos and removed using full asbestos removal procedures.

7. If any asbestos-containing material is found during the demolition process, the demolition work must cease and the asbestos-containing material removed before demolition work resumes.
