## Health and Safety Bulletin No. 12

### Asbestos containing flooring materials

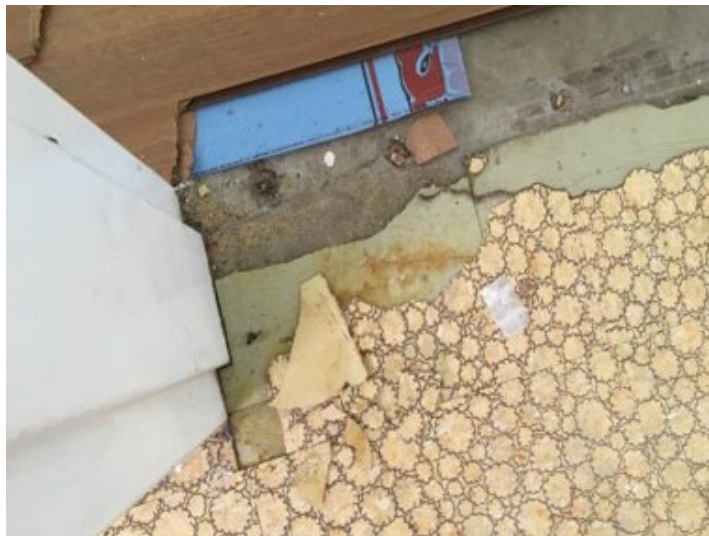
Asbestos vinyl tile under newer vinyl tile.

- To eliminate the risk of exposure, asbestos containing flooring materials should be removed in instances where it will be disturbed during installation of new flooring.
- When conducting work in buildings constructed prior to 31 December 2003, the asbestos register should be reviewed to identify whether asbestos is present.
- Workers must be suitably licensed for asbestos flooring removal work:
  - Class A can remove any quantity of friable or non-friable asbestos
  - Class B can remove any quantity of non-friable asbestos only.
- Removal of asbestos flooring must be undertaken in accordance with WHS legislation and associated codes of practice.
