Significant Incident Summary No. 3

Installing non-original sun visors that reduce field of view – fatal incident

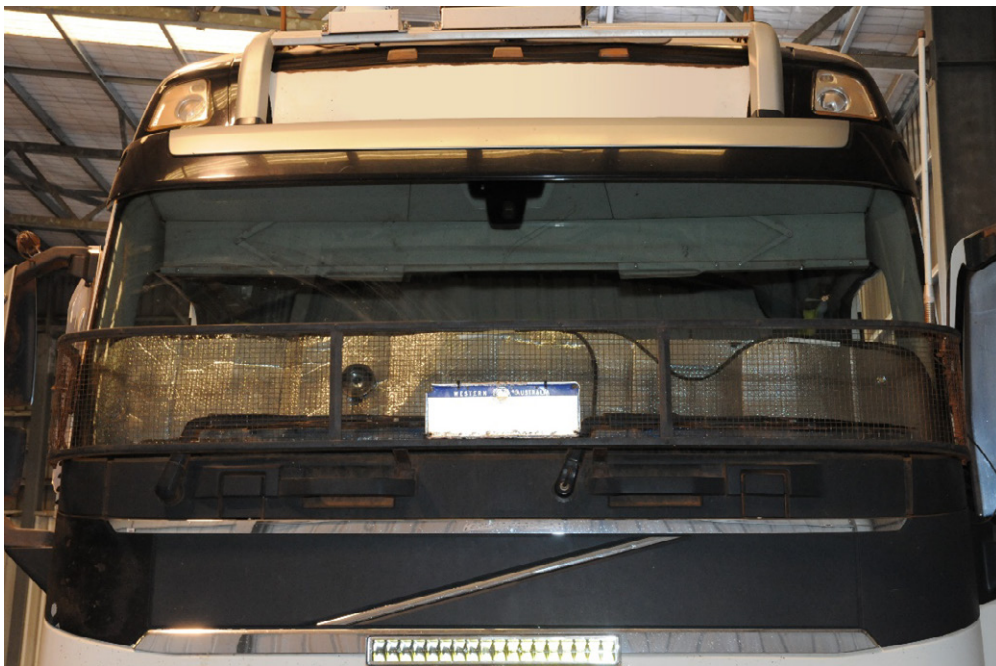
The truck involved in this incident had a non-original, reflective foil visor installed at the base of the windscreen.

Truck with non-original sun visor fitted at base of window.

- Educate workers of the potential dangers from installing non-original items to vehicles that may restrict the field of view and increase the size of blind spots.
- Conduct regular checks of the cab to ensure non-original items have not been added to a vehicle that may restrict the field of view of the driver.
- Encourage workers conducting maintenance on vehicles to alert the PCBU to the presence of such items when completing routine maintenance.
- Remind drivers to conduct a pre-start check before setting off to ensure as far as practicable that no persons are in the vicinity of their intended direction of travel.

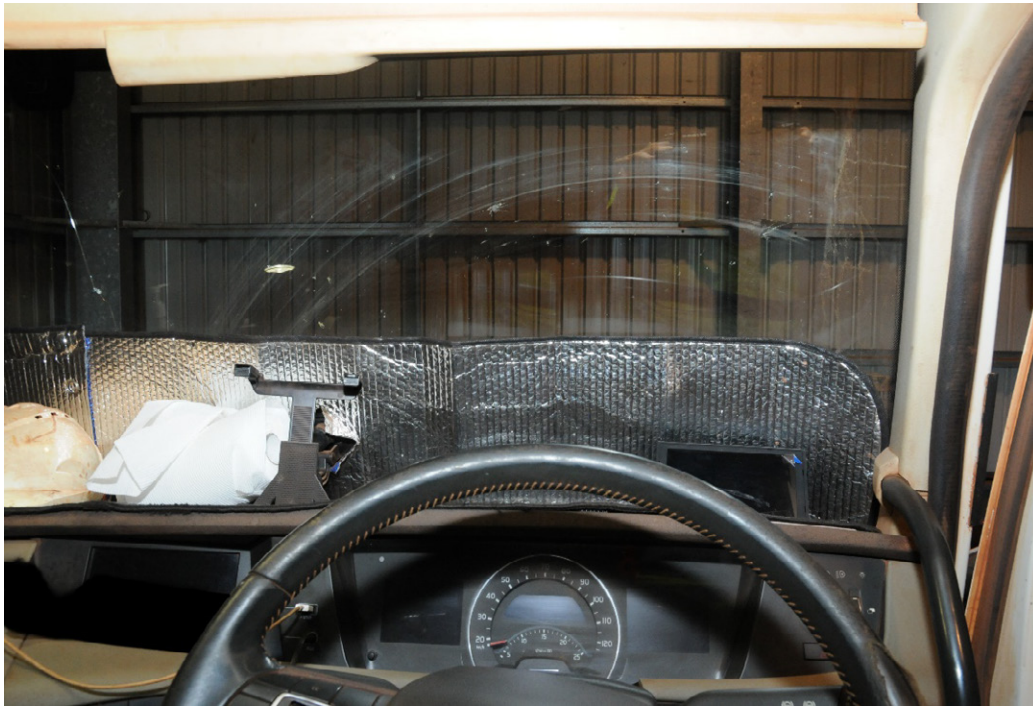
The installation of a non-original visor at the base of a truck's windscreen increases the size of existing blind spots immediately in front of a truck. This increases the risk of exposure to the hazard of a moving vehicle to other people in the immediate vicinity.

View from cab of truck with non-original sun visor fitted.

- The sun visor may have further restricted the view of the driver so that the worker was unseen when the vehicle moved off.
- The person conducting a business or undertaking (PCBU), including persons having control of the workplace, not identifying the potential hazards associated with the installation of non-original sun visors in the windscreen of trucks.
