FINAL REPORT

**General Inspection Report One: A general inspection
into metal roof construction in Western Australia**

April 2016

ROOF CONSTRUCTION: A general inspection report into the construction of sheet metal clad timber framed roofing in Perth metropolitan and South West regions

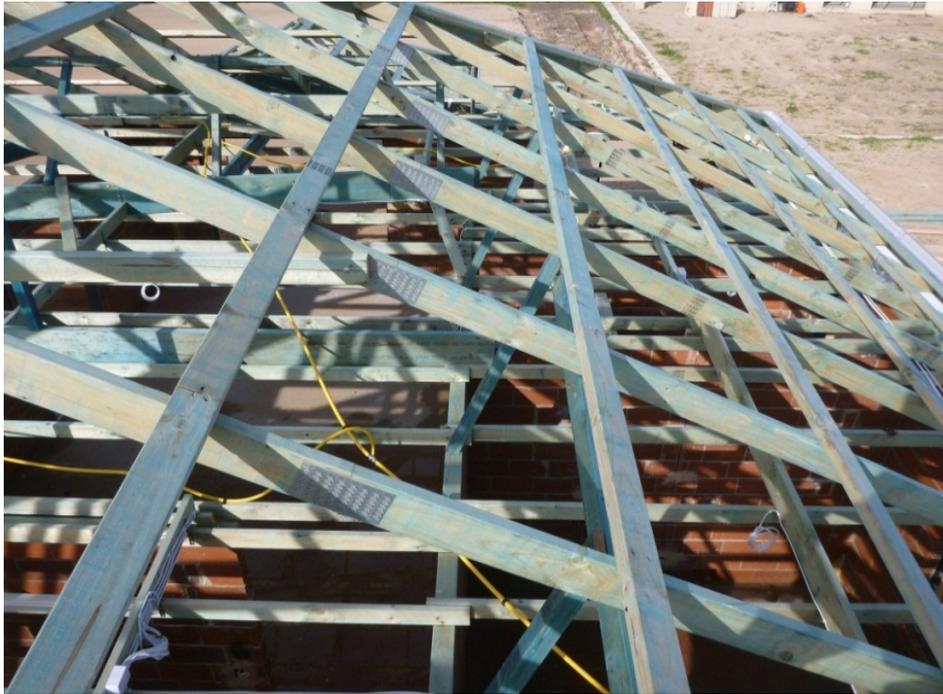
- Figure 14 shows a typical situation where timber battens are fixed to rafters.

Figure 14. Photograph showing typical timber battens fixed to rafters

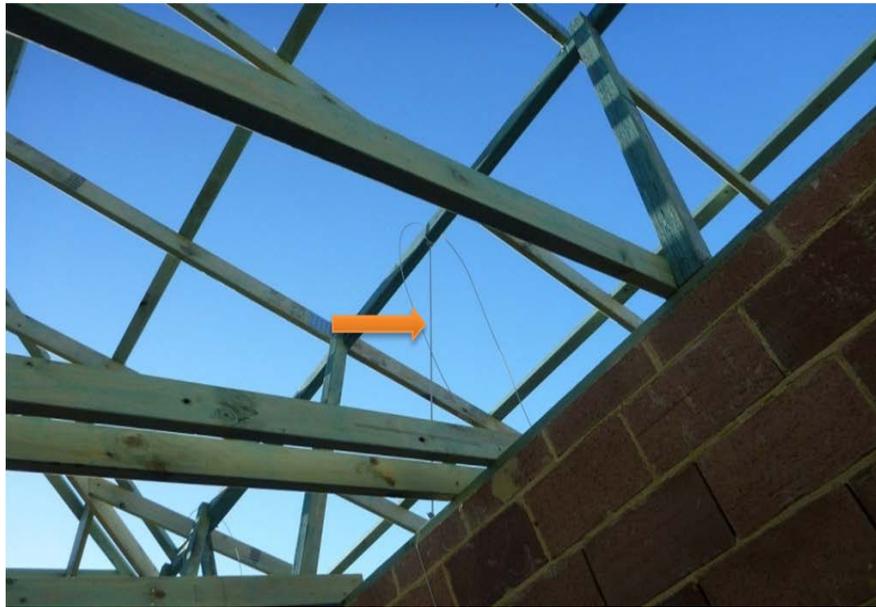
- Some builders use stainless steel wire looped above beams or underpurlins, taken down the interior masonry wall and looped through (or bolted to) the lower courses of masonry to create this chain effect and use the weight of the internal brickwork – eg see Figure 21 and Figure 22.

Like the rafter to top plate connection, rafter to underpurlin and underpurlin to strutting beam loads are most likely to be subject to upward forces from wind loads on sheet metal clad timber framed roofs. Similar connections are therefore appropriate to transfer upward loads across the joint.

Figure 21. Photograph showing an internal hold-down wire fixed over underpurlin

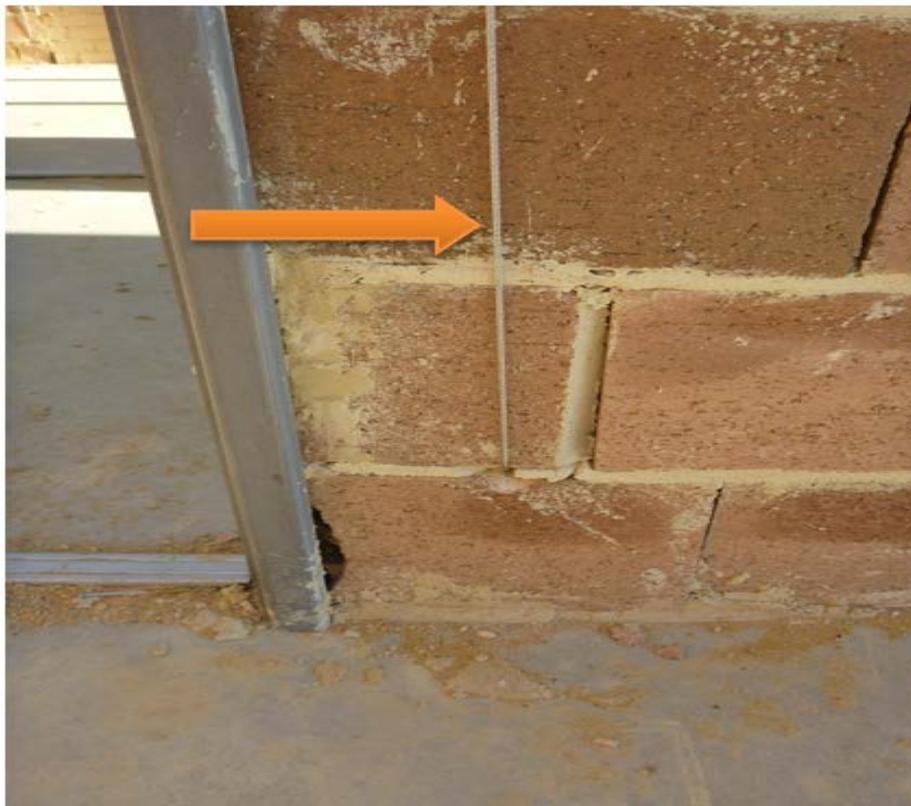
Figure 22. Photograph showing a hold-down wire attached into the internal masonry

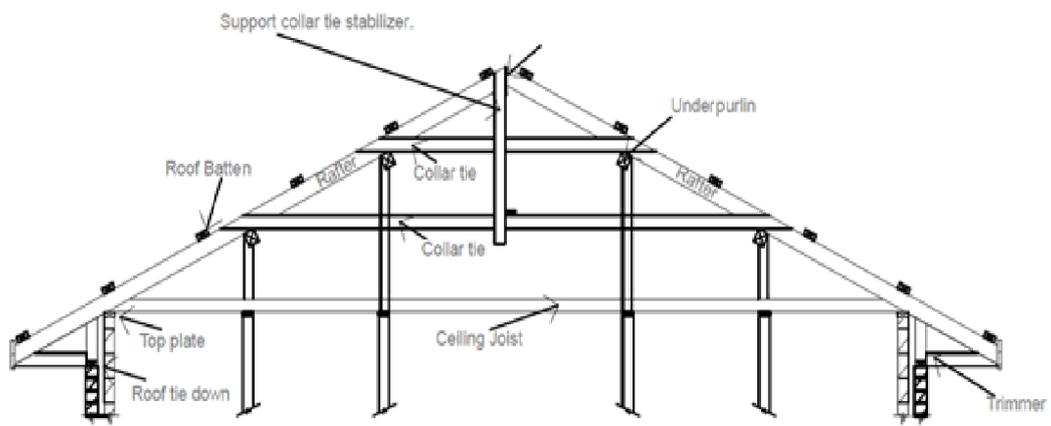
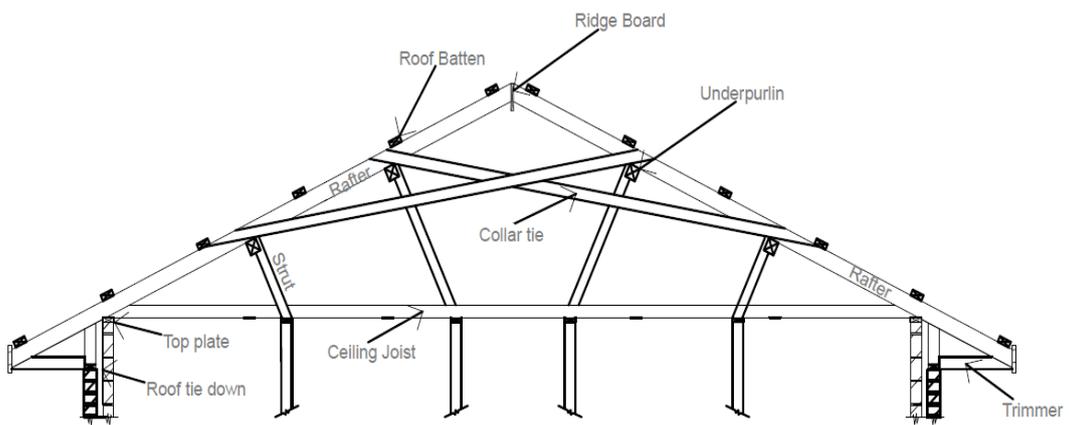
Figure 24. Requirements for collar ties as per AS 1684.2-2010

- In Figure 23 below the orange arrow (A) indicates location of collar ties compared to the red arrow (B) where the underpurlin is located.
- Collar ties should be located immediately above underpurlins as outlined in Figure 24 below.
- Figure 24(A) shows the standard method of fixing collar ties when two underpurlins are necessary.
- Figure 24(B) shows the standard method of fixing scissor collar ties when two underpurlins are necessary.
