ELECTRICAL INCIDENT REPORT

POWER LINE FAULT AND BUSH FIRE NEAR BRINDLE ROAD, PARKERVILLE WESTERN AUSTRALIA ON 3 JANUARY 2008

11 January 2008

EIS 2008-17

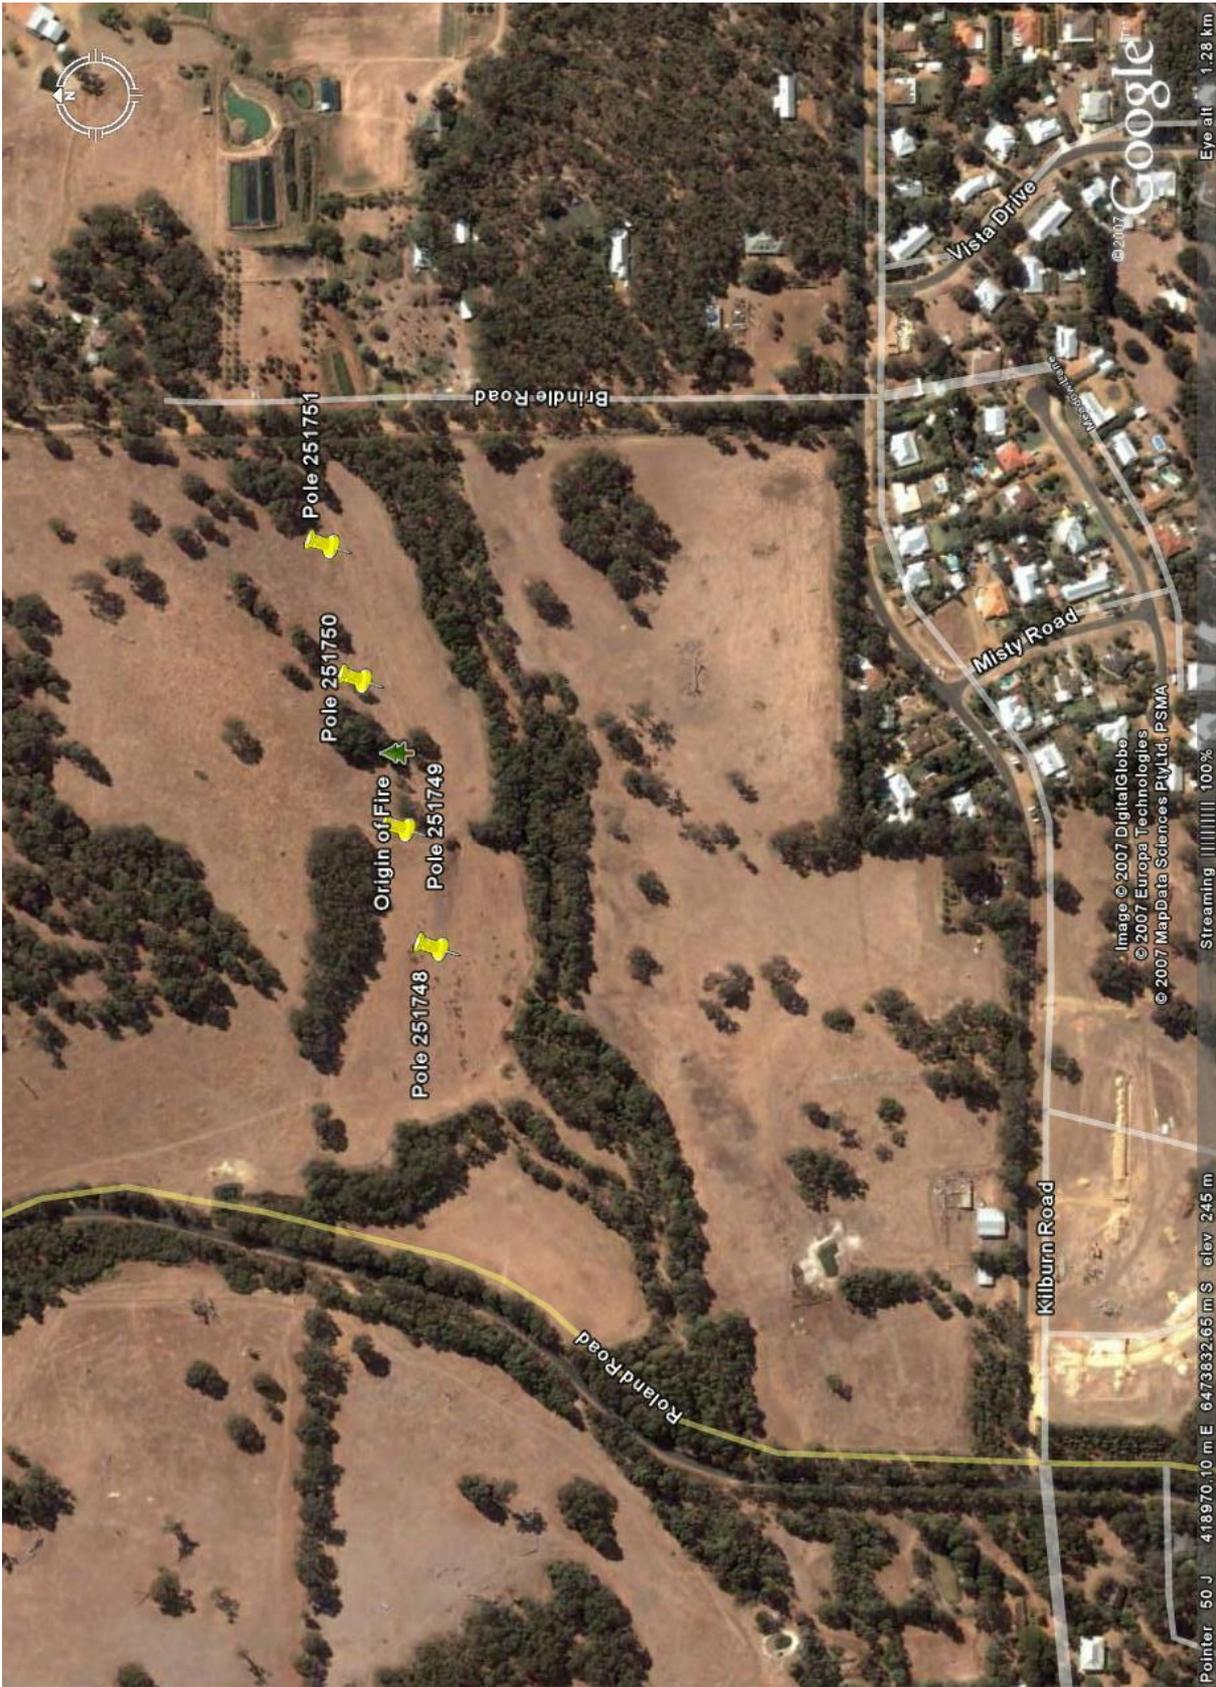
Satellite Image: Showing location, Origin of Bush Fire and Pole Positions

- There are no suspicious circumstances relating to the origin of the bush fire.
- The bush fire incident originated mid span between pole numbers 251749 and 251750 on the Darlington 22kV overhead power line (Feeder D501), west of Brindle Road, east of Roland Road and north of Kilburn Road, Parkerville.
- The bush fire resulted from the ignition of the dry grass and leaves on the ground after a tree branch made direct contact with a high voltage phase conductor of a 22,000 volt overhead power line. This contact between the tree and conductor caused a flow of electric current through the tree branch, heating the branch to ignition point and resulting in hot embers falling to the ground.
- The clearance between the tree branches and high voltage conductors was not adequately maintained by Western Power and as a result was insufficient to avoid such a fault occurring.
