ELECTRICAL INCIDENT REPORT

BUSHFIRE NEAR RIVER and FOLEWOOD ROADS TOODYAY WESTERN AUSTRALIA 29 DECEMBER 2009

15 February 2010

EIS 2009-2630

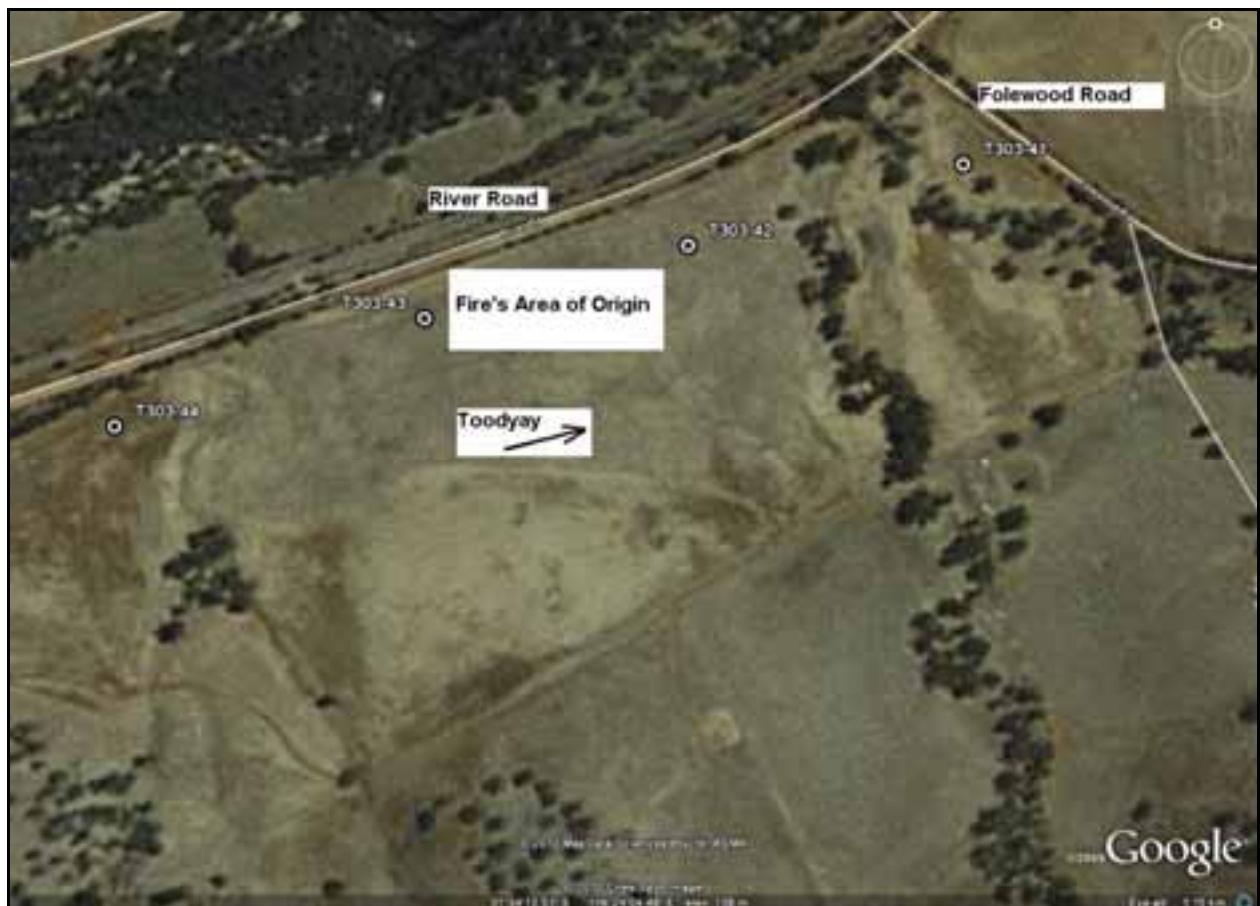
FESA and WA Police Arson Squad fire investigators have tracked the bushfire's path back to an "area of origin"¹ but the exact "point of origin"² was not able to be established. The area of origin is in the vicinity of Western Power's T303 spur power line between wooden poles numbered T303-42 and T303-43. The satellite image below shows the location of these poles (prior to the bushfire) and the bushfire's area of origin.
