Safety alert 13/2009

Unguarded grain and fertiliser auger causes serious injury

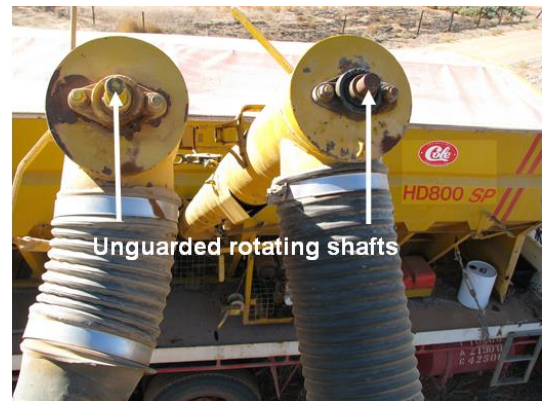
A farm worker was seriously injured when his clothing (shirt) became entangled in an exposed rotating shaft of a twin auger.

The person reached across one of the augers to operate the feed process when the rotating shaft entangled his shirt. The clothing tightened around his neck causing life threatening injuries.

- The shaft ends of the augers were not guarded.
- Location of the controls allowed the person to reach from his work position across dangerous moving parts to operate the controls.
- Type of clothing worn while working in close proximity to unguarded moving parts.

1. Dangerous moving parts of plant must be adequately guarded. This includes the rotating shafts on augers.
2. Ensure controls to operate plant are not located in the vicinity of dangerous moving parts.
