Government of **Western Australia**
Department of **Commerce**
EnergySafety

Electrical safety of grid-connected solar installations in Western Australia

December 2011

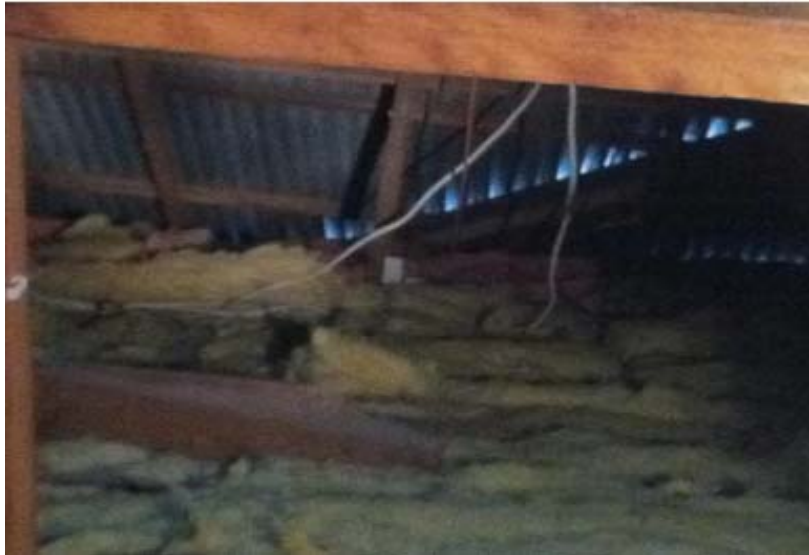
The most common defect identified during the inspections was 'failure to provide adequate mechanical protection to cables'. Clause 3.9 of AS/NZS 3000:2007 requires that all wiring be adequately protected from mechanical damage i.e. in conduits and/or supported at fixed intervals where accessible e.g. in roof/ceiling space.

Figure 1: Typical case where cable is not properly secured

Energy Safety is working closely with network operators to ensure that the issues identified during the inspections are addressed. Network operators have been requested to review their inspection practices to treat incorrect wiring of DC circuit breakers, failure to provide adequate mechanical protection to cables, omission of labelling indicating presence of a second energy source and missing shut-down procedures as "serious defects". As such, once the rectification works are completed, network operators' inspectors will re-inspect all these installations, to ensure that the corrective work is adequate.
